GOVERNMENT OF NEWFOUNDLAND AND LABRADOR Department of Transportation and Infrastructure	<b>BRIDGE INSPECTION REPORT</b> <b>B08032021-4</b>	
<b>Date:</b> 7/5/2021	<b>Inspected By:</b> Justine Geddes	<b>Category:</b> Office - Bridge Office	
<b>BRIDGE INFORMATION</b>			
<b>Site:</b>	3-027 - GANDER BAY CAUSEWAY BRIDGE		
<b>Route:</b>		<b>Overall Length:</b>	191 m
<b>Year Built:</b>	1968	<b>Est:</b> No	<b>Overall Width:</b> 8.7 m
<b>Year Last Rehab.:</b>	1992	<b>Est:</b> No	<b>Roadway Width:</b> 7.3 m
<b>Region:</b>	CENTRAL WEST	<b>Sidewalk Width:</b>	1.5 m
<b>Jurisdiction:</b>	Provincial	<b>Clearance to R.D. or N.W.L.:</b>	3 m
<b>Type of Structure:</b>	01 - AASH to Girder	<b>Max Depth of N.W.L.:</b>	2.5 m
<b>Purpose of Structure:</b>	03 - Over Navigable Waters	<b>Spans:</b>	
<b>Type of Handrail:</b>	01 - Aluminum Rail	<u>Span No.:</u>	<u>Length</u>
<b>Roadway Surface:</b>	01 - Concrete	1	34.7
<b>Alignment Vertical:</b>	01 - Good	2	34.7

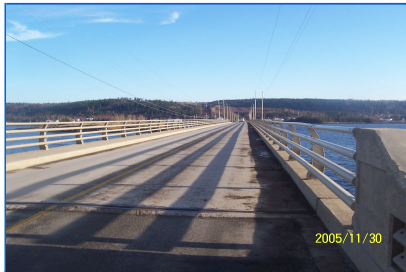
<b>SUBSTRUCTURE</b>			
<b>Condition:</b>	F1 - Fair	<b>Bearings:</b>	G - Good
		<b>Bearing Seat:</b>	F1 - Fair
<b>Comments:</b>	Erosion at piers below icebreakers, one icebreaker has gone. Should followup with a diving inspection in next few years to confirm condition below. Abutments have previous repairs with some shrinkage cracking		
<b>SUPERSTRUCTURE</b>			
<b>Condition:</b>	F1 - Fair	<b>Expansion Joints:</b>	F2 - Fair
<b>Comments:</b>	Edge girders showing hairline cracking with small staining, suspect shear steel is starting to rust behind concrete. Interior girders in good condition.		
<b>DECK</b>			
<b>Condition:</b>	P3 - Poor	<b>Curbs:</b>	F1 - Fair

<b>Hand Rail:</b>	F1 - Fair	<b>Roadway Condition:</b>	F1 - Fair
<b>Approach Rail:</b>	F2 - Fair		
<b>Comments:</b>	exposed concrete deck with potholes starting, should be repaired with deck overlay in next few years and consideration given to paving over if evaluated

<b>Next Rehab. Date:</b>	2023	<b>Replacement Year:</b>	2040
<b>Antic. Rehab. Cost:</b>	\$400000	<b>Replacement Cost:</b>	\$12000000
<b>Recommendations:</b>	Diving and osim inspection with evaluation of bridge recommended. Possibly rehab may include deck repairs, girder repairs/coatings and pier repairs. replacement costs may go as high as \$16 million.
