GOVERNMENT OF NEWFOUNDLAND AND LABRADOR Department of Transportation and Infrastructure	BRIDGE INSPECTION REPORT B09162021-11	
Date: 9/2/2021	Inspected By: Mike Button	Category: Office - Bridge Office	
BRIDGE INFORMATION			
Site:	3-177 - OLD ASPEN BROOK BRIDGE		
Route:	1	Overall Length:	0 m
Year Built:	1950	Overall Width:	0 m
Year Last Rehab.:		Roadway Width:	0 m
Region:	CENTRAL WEST	Sidewalk Width:	0 m
Jurisdiction:	Provincial	Clearance to R.D. or N.W.L.:	0 m
Type of Structure:	03 - Reinforced Concrete Beam/Slab	Max Depth of N.W.L.:	0 m
Purpose of Structure:	04 - Over Non-Navigable Waters	Spans:	
Type of Handrail:	02 - Concrete Rail	Span No.:	Length
Roadway Surface:	01 - Concrete	1	0
Alignment Vertical:	02 - Adequate	2	0
Alignment Horizontal:	02 - Adequate	3	0
Restrictions:	No	6	0
BRIDGE PHOTOS

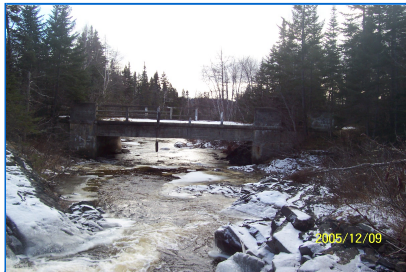
Overall Condition:	P - Poor	Requires Further Inspection:	No
Additional Observations:	- Bridge in poor (P) condition overall. No handrails, heavily deteriorated exterior bearing areas and a disintegrated girder. Recommend closing the structure.

Next Rehab. Date:	2022	Replacement Year:	
Antic. Rehab. Cost:	\$100000	Replacement Cost:	\$0
Recommendations:	- Money to barricade and remove structure.
