| | GOVERNMENT OF NEWFOUNDLAND AND LABRADOR Department of Transportation and Infrastructure | BRIDGE INSPECTION REPORT B08232021-5 | |
| Date: 7/6/2021 | Inspected By: Justine Geddes | Category: Office - Bridge Office | |
| Site: | 3-056 - PETER'S ARM BROOK BRIDGE #2 BOTWOOD | | |

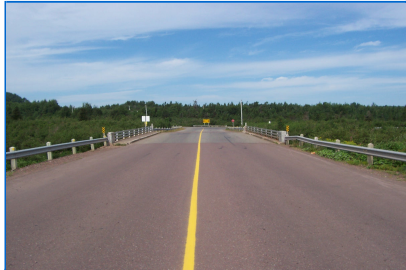
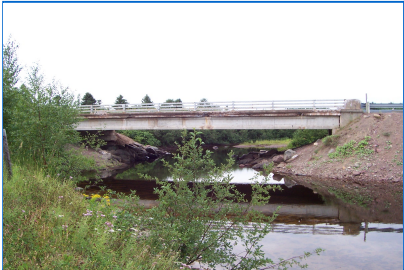
| Comments: | Generally good, some small areas of scour that should have tremie concrete added at some point. bearings are probably undersized but no signs of issues | | |
| Comments: | generally good, one girder needs to be repaired due to area of stony concrete leaving voids. may need additional deck drain due to some water seepage on upstream side. | | |

| Comments: | some water ponding on deck, consider additional deck drains in future rehabs. could do with asphalt drains/curbs to move water away from wingwalls, recommend this is tried before installing rock lined gutters | | |

| Comments: | small areas of scour starting, abutments generally out of the water. appears to have had scour repairs before. | | |

| Recommendations: | small rehab in next 5-10 years or when in area for other bridges. should include tremie concrete, girder repair, deck drain, maybe asphalt drains/curbs at wingwalls. | | |
