GOVERNMENT OF NEWFOUNDLAND AND LABRADOR Department of Transportation and Infrastructure	<b>BRIDGE INSPECTION REPORT</b> <b>B12022005-4</b>	
<b>Date:</b> 11/21/2005	<b>Inspected By:</b> Kendell C	<b>Category:</b> Eng. - Engineering	
<b>BRIDGE INFORMATION</b>			
<b>Site:</b>	3-168 - PILLEY'S ISLAND BRIDGE		
<b>Route:</b>		<b>Overall Length:</b>	8 m
<b>Year Built:</b>	<b>Est:</b> No	<b>Overall Width:</b>	4 m
<b>Year Last Rehab.:</b>	<b>Est:</b> No	<b>Roadway Width:</b>	4 m
<b>Region:</b>	CENTRAL WEST	<b>Sidewalk Width:</b>	0 m
<b>Jurisdiction:</b>	Municipal	<b>Clearance to R.D. or N.W.L.:</b>	0 m
<b>Type of Structure:</b>	04 - Rigid Frame	<b>Max Depth of N.W.L.:</b>	0 m
<b>Purpose of Structure:</b>	04 - Over Non-Navigable Waters	<b>Spans:</b>	
<b>Type of Handrail:</b>	03 - Timber Rail	<u>Span No.:</u>	<u>Length</u>
<b>Roadway Surface:</b>	01 - Concrete	<u>Span No.:</u>	<u>Length</u>
<b>Alignment Vertical:</b>	02 - Adequate	1	6.8

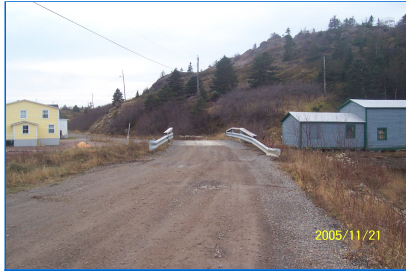
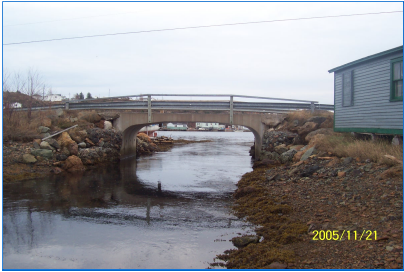
<b>SUBSTRUCTURE</b>			
<b>Condition:</b>	G - Good	<b>Bearings:</b>	I - Inapplicable
		<b>Bearing Seat:</b>	I - Inapplicable
<b>Comments:</b>			
<b>SUPERSTRUCTURE</b>			
<b>Condition:</b>	G - Good	<b>Expansion Joints:</b>	I - Inapplicable
<b>Comments:</b>	One lane structure		
<b>DECK</b>			
<b>Condition:</b>	F2 - Fair	<b>Curbs:</b>	I - Inapplicable
<b>Hand Rail:</b>	F2 - Fair	<b>Roadway Condition:</b>	I - Inapplicable

rotten post NE corner
