GOVERNMENT OF NEWFOUNDLAND AND LABRADOR Department of Transportation and Infrastructure	<b>BRIDGE INSPECTION REPORT</b> <b>B08092021-2</b>	
<b>Date:</b> 7/6/2021	<b>Inspected By:</b> Justine Geddes	<b>Category:</b> Office - Bridge Office	
<b>BRIDGE INFORMATION</b>			
<b>Site:</b>	3-076 - SHOAL TICKLE BRIDGE, TWILLINGATE		
<b>Route:</b>		<b>Overall Length:</b>	36 m
<b>Year Built:</b>	1979	<b>Est:</b> No	<b>Overall Width:</b> 11.5 m
<b>Year Last Rehab.:</b>		<b>Est:</b> No	<b>Roadway Width:</b> 8 m
<b>Region:</b>	CENTRAL WEST	<b>Sidewalk Width:</b>	0 m
<b>Jurisdiction:</b>	Provincial	<b>Clearance to R.D. or N.W.L.:</b>	2.5 m
<b>Type of Structure:</b>	01 - AASH to Girder	<b>Max Depth of N.W.L.:</b>	2 m
<b>Purpose of Structure:</b>	03 - Over Navigable Waters	<b>Spans:</b>	
<b>Type of Handrail:</b>	01 - Aluminum Rail	<u>Span No.:</u>	<u>Length</u>
<b>Roadway Surface:</b>	02 - Asphalt	1	27
<b>Alignment Vertical:</b>	01 - Good	2	0

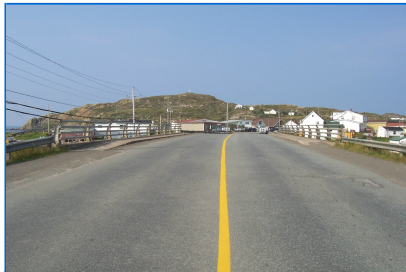
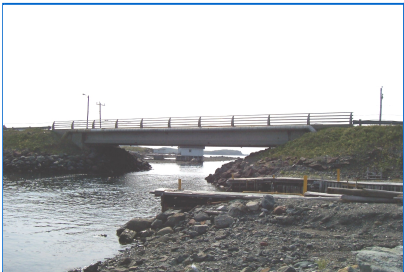
<b>SUBSTRUCTURE</b>			
<b>Condition:</b>	F1 - Fair	<b>Bearings:</b>	P3 - Poor
		<b>Bearing Seat:</b>	F1 - Fair
<b>Comments:</b>	Bearings squished, leakage through north joint		
<b>SUPERSTRUCTURE</b>			
<b>Condition:</b>	P3 - Poor	<b>Expansion Joints:</b>	P3 - Poor
<b>Comments:</b>	South girders all showing signs of concrete spall/rusted stirrups. joints paved over and leaking.		
<b>DECK</b>			
<b>Condition:</b>	F2 - Fair	<b>Curbs:</b>	F1 - Fair
<b>Hand Rail:</b>	F2 - Fair	<b>Roadway Condition:</b>	F1 - Fair

<b>Approach Rail:</b>	P3 - Poor		
<b>Comments:</b>	Edges of curbs starting to spall due to salt and sand. Deck drains blocked, joints leaking and paved over Approach rail missing from northwest corner.		
<b>HYDROLOGY</b>			
<b>Water Velocity:</b>	tidal m/s	<b>Ice Problem:</b>	N - No Problem
<b>Water Depth:</b>	2-3 m	<b>Scour Problem:</b>	N - No Problem
<b>Waterway:</b>	01 - Adequate	<b>Debris Problem:</b>	N - No Problem
<b>Comments:</b>			
<b>REPLACEMENT/REHABILITATION</b>			
<b>Next Rehab. Date:</b>	2025	<b>Replacement Year:</b>	2042
<b>Antic. Rehab. Cost:</b>	\$200000	<b>Replacement Cost:</b>	\$6000000
<b>Recommendations:</b>	Repairs to joints, curbs, underside of girder ends, replace rail with concrete or steel with endblocks, although these could wait for ten years. Replace guiderail with structural rail. Possibly a good candidate to convert to semi-integral, should also consider replacing all bearings if so.
