GOVERNMENT OF NEWFOUNDLAND AND LABRADOR Department of Transportation and Works	<b>BRIDGE INSPECTION REPORT</b> <b>B12112017-4</b> Printed: Tuesday, October 9, 2018	
<b>Date:</b> 10/26/2017	<b>Inspected By:</b> Strugnell/Walsh	<b>Category:</b> Eng. - Engineering	
<b>BRIDGE INFORMATION</b>			
<b>Site:</b>	3-126 - SHOE COVE NORTH BRIDGE		
<b>Route:</b>		<b>Overall Length:</b>	4.2 m
<b>Year Built:</b>	1978	<b>Est: No</b>	<b>Overall Width:</b> 6 m
<b>Year Last Rehab.:</b>		<b>Est: No</b>	<b>Roadway Width:</b> 5.7 m
<b>Region:</b>	CENTRAL WEST	<b>Sidewalk Width:</b>	0 m
<b>Jurisdiction:</b>	Provincial	<b>Clearance to R.D. or N.W.L.:</b>	1 m
<b>Type of Structure:</b>	11 - Timber Bridge	<b>Max Depth of N.W.L.:</b>	0.5 m
<b>Purpose of Structure:</b>	04 - Over Non-Navigable Waters	<b>Spans:</b>	
<b>Type of Handrail:</b>	03 - Timber Rail	<u>Span No.:</u>	<u>Length</u>
<b>Roadway Surface:</b>	03 - Timber	1	4.2

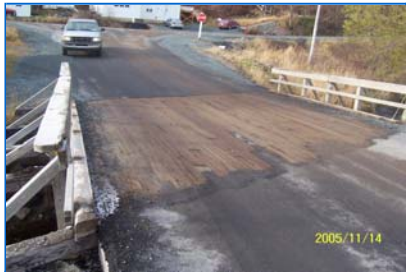
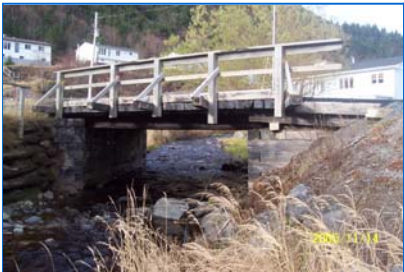
<b>SUBSTRUCTURE</b>			
<b>Condition:</b>	F2 - Fair (Inspection within 2 Years)	<b>Bearings:</b>	I - Inapplicable
		<b>Bearing Seat:</b>	I - Inapplicable
<b>Comments:</b>	Hairline cracks in abutments and wing walls downstream North.		
<b>SUPERSTRUCTURE</b>			
<b>Condition:</b>	F2 - Fair (Inspection within 2 Years)	<b>Expansion Joints:</b>	I - Inapplicable
<b>Comments:</b>	Hairline cracks (vertical) in deck slab upstream and downstream.		
<b>DECK</b>			
<b>Condition:</b>	F2 - Fair (Inspection within 2 Years)	<b>Curbs:</b>	F2 - Fair (Inspection within 2 Years)
<b>Hand Rail:</b>	F2 - Fair (Inspection within 2 Years)	<b>Roadway Condition:</b>	F2 - Fair (Inspection within 2 Years)

<b>Approach Rail:</b>	I - Inapplicable		
<b>Comments:</b>	Asphalt settlement on the South approach. Asphalt cracking and patches on both approaches. Concrete deck surface appears to be okay. There is some cracking in the curbs and sidewalk. The handrail is leaning slightly. The underside of the deck slab is okay.		
<b>HYDROLOGY</b>			
<b>Water Velocity:</b>	Slow m/s	<b>Ice Problem:</b>	N - No Problem
<b>Water Depth:</b>	Low m	<b>Scour Problem:</b>	N - No Problem
<b>Waterway:</b>	01 - Adequate	<b>Debris Problem:</b>	N - No Problem
<b>Comments:</b>	Water was too dark to see bottom of abutments. The rip rap is okay.		
<b>REPLACEMENT/REHABILITATION</b>			
<b>Next Rehab. Date:</b>		<b>Replacement Year:</b>	
<b>Antic. Rehab. Cost:</b>	\$0.00	<b>Replacement Cost:</b>	\$0.00
<b>Recommendations:</b>	Repair asphalt approaches and install hazard markers. Clean deck of sand.		
<b>OBSERVATIONS</b>			
<b>Overall Condition:</b>	F2 - Fair (Inspection within 2 Years)	<b>Requires Further Inspection:</b>	No

<b>Additional Observations:</b>	There are no hazard markers and there is sand build-up on the deck. The sidewalk is on the upstream side.		
<b>LEGEND:</b>			
<b>Condition Definitions:</b>		<b>Problem Definitions:</b>	
1 - *Good - [discontinued code].	F2 - Fair (Inspection within 2 Years).	C - Unsafe (Closed to Public).	N - No Problem.
2 - *Fair - [discontinued code].	F1 - Fair (Inspection within 1 Year).	U - Uninspectable.	P - Possible Problem.
3 - *Poor - [discontinued code].	P3 - Poor (Repair within 3 Years).	I - Inapplicable.	K - Known Problem.
4 - *Unsafe - [discontinued code].	P1 - Poor (Repair within 1 Year).		NA - Not Applicable.
G - Good (Inspection within 2 Years).	P - Poor (Immediate Repair).		
<b>PHOTO GUIDELINES:</b>		<b>Category Definitions:</b>	
<b>Inspection Photos:</b>		Maint. - Maintenance.	
Please provide photos using guidelines below:		Eng. - Engineering.	
<ul style="list-style-type: none"> <li>● Any item which inspector feels should be documented by photograph</li> <li>● All items noted above as being P3, P1, P, or C</li> <li>● Any evidence of known ice, scour, debris, waterway problems</li> </ul>		Office - Bridge Office.
