GOVERNMENT OF NEWFOUNDLAND AND LABRADOR Department of Transportation and Infrastructure	<b>BRIDGE INSPECTION REPORT</b> <b>B08202021-6</b>	
<b>Date:</b> 7/6/2021	<b>Inspected By:</b> Justine Geddes	<b>Category:</b> Office - Bridge Office	
<b>BRIDGE INFORMATION</b>			
<b>Site:</b>	3-054 - SOUTHEAST BROOK BRIDGE (LOON BAY)		
<b>Route:</b>		<b>Overall Length:</b>	15.9 m
<b>Year Built:</b>	1970	<b>Est:</b> No	<b>Overall Width:</b> 12.9 m
<b>Year Last Rehab.:</b>		<b>Est:</b> No	<b>Roadway Width:</b> 9.9 m
<b>Region:</b>	CENTRAL WEST	<b>Sidewalk Width:</b>	0 m
<b>Jurisdiction:</b>	Provincial	<b>Clearance to R.D. or N.W.L.:</b>	4 m
<b>Type of Structure:</b>	02 - Double Tee	<b>Max Depth of N.W.L.:</b>	1 m
<b>Purpose of Structure:</b>	04 - Over Non-Navigable Waters	<b>Spans:</b>	
<b>Type of Handrail:</b>	01 - Aluminum Rail	<u>Span No.:</u>	<u>Length</u>
<b>Roadway Surface:</b>	02 - Asphalt	1	10
<b>Alignment Vertical:</b>	01 - Good	2	0

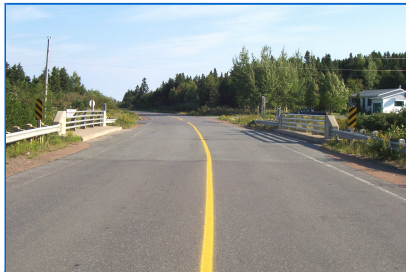
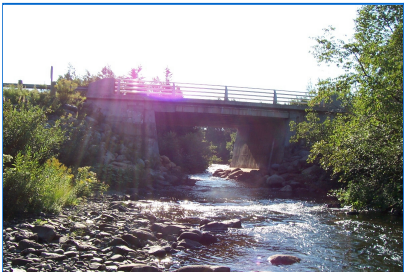
<b>SUBSTRUCTURE</b>			
<b>Condition:</b>	F1 - Fair	<b>Bearings:</b>	I - Inapplicable
		<b>Bearing Seat:</b>	F1 - Fair
<b>Comments:</b>	some spalling at corners of abutment and wingwall. showing		
<b>SUPERSTRUCTURE</b>			
<b>Condition:</b>	P3 - Poor	<b>Expansion Joints:</b>	I - Inapplicable
<b>Comments:</b>	Double Tees at centre of bridge cracking and spalling, cracks starting at north end and migrating to the middle.		
<b>DECK</b>			
<b>Condition:</b>	F1 - Fair	<b>Curbs:</b>	F1 - Fair
<b>Hand Rail:</b>	F1 - Fair	<b>Roadway Condition:</b>	F1 - Fair

<b>Approach Rail:</b>	F1 - Fair		
<b>Comments:</b>	some patches of poor asphalt, erosion at corners of wingwall/approach slab		
<b>HYDROLOGY</b>			
<b>Water Velocity:</b>	slow m/s	<b>Ice Problem:</b>	N - No Problem
<b>Water Depth:</b>	shallow m	<b>Scour Problem:</b>	N - No Problem
<b>Waterway:</b>	01 - Adequate	<b>Debris Problem:</b>	N - No Problem
<b>Comments:</b>	may go slightly wider for new bridge as it appears to be pinching the river slightly		
<b>REPLACEMENT/REHABILITATION</b>			
<b>Next Rehab. Date:</b>	2021	<b>Replacement Year:</b>	2026
<b>Antic. Rehab. Cost:</b>	\$0	<b>Replacement Cost:</b>	\$2000000
<b>Recommendations:</b>	Recommend this bridge is replaced in 5-10 years, preferably closer to 5 - may require monitoring after 5.		
<b>OBSERVATIONS</b>			
<b>Overall Condition:</b>	F1 - Fair	<b>Requires Further Inspection:</b>	No
<b>Additional Observations:</b>	Poor road visibility, shoulder ok to park off. cannot get completely under structure. hazards: traffic, slipping, falling, stinging plants.
