GOVERNMENT OF NEWFOUNDLAND AND LABRADOR Department of Transportation and Infrastructure	BRIDGE INSPECTION REPORT B08032021-2	
Date: 7/5/2021	Inspected By: Justine Geddes	Category: Office - Bridge Office	
BRIDGE INFORMATION			
Site:	3-053 - SOUTHERN BROOK BRIDGE		
Route:		Overall Length:	16 m
Year Built:	1967	Est: No	Overall Width: 8.8 m
Year Last Rehab.:	1985	Est: No	Roadway Width: 7.3 m
Region:	CENTRAL WEST	Sidewalk Width:	0 m
Jurisdiction:	Provincial	Clearance to R.D. or N.W.L.:	2.5 m
Type of Structure:	02 - Double Tee	Max Depth of N.W.L.:	1.5 m
Purpose of Structure:	04 - Over Non-Navigable Waters		Spans:
Type of Handrail:	01 - Aluminum Rail	<u>Span No.:</u>	<u>Length</u>
Roadway Surface:	02 - Asphalt	1	10.3
Alignment Vertical:	01 - Good	2	0
Alignment Horizontal:	02 - Adequate	3	0
Restrictions:	No	6	0
BRIDGE PHOTOS

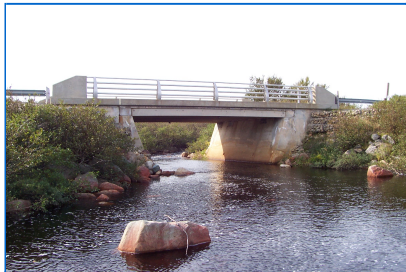
Comments:	Bearing on corner of abutments eroding away, cracking/spalled concrete on upstream, north wingwall.		
SUPERSTRUCTURE			
Condition:	F1 - Fair	Expansion Joints:	U - Uninspectable
Comments:	upstream double tee starting to spall at abutments, rest of double tees have rusted stirrups starting to show. Still at least ten years life left in them. Expansion joints (if exist) are paved over.		
DECK			
Condition:	F1 - Fair	Curbs:	P3 - Poor
Hand Rail:	F1 - Fair	Roadway Condition:	P3 - Poor

Approach Rail:	F1 - Fair		
Comments:	Spalled/eroded concrete on curbs.		
HYDROLOGY			
Water Velocity:	slow m/s	Ice Problem:	N - No Problem
Water Depth:	1-2 m	Scour Problem:	N - No Problem
Waterway:	01 - Adequate	Debris Problem:	N - No Problem
Comments:			
REPLACEMENT/REHABILITATION			
Next Rehab. Date:	2024	Replacement Year:	2032
Antic. Rehab. Cost:	\$50000	Replacement Cost:	\$2000000
Recommendations:	latex modified to abutment corners and curbs and concrete facing to wingwalls, next time in the area for other rehabs or within 3 years. Replacement can probably be either a aluminium or concrete arch in 10 to 15 years.		
OBSERVATIONS			
Overall Condition:	P3 - Poor	Requires Further Inspection:	No
Additional Observations:	good traffic visibility, high traffic speeds. West abutment easiest to get under hazards: traffic, slipping, falling, stinging plants		
LEGEND:			
Condition Definitions:		Problem Definitions:	Category Definitions:
