GOVERNMENT OF NEWFOUNDLAND AND LABRADOR Department of Transportation and Infrastructure	BRIDGE INSPECTION REPORT B01162020-2	
Date: 8/20/2019	Inspected By: Lynch R / Martin L	Category: Eng. - Engineering	
BRIDGE INFORMATION			
Site:	3-034 - TRAVERSE BROOK BRIDGE		
Route:		Overall Length:	47.2 m
Year Built:	1969	Est: No	Overall Width: 12 m
Year Last Rehab.:		Est: No	Roadway Width: 10.3 m
Region:	CENTRAL WEST	Sidewalk Width:	0 m
Jurisdiction:	Provincial	Clearance to R.D. or N.W.L.:	2.2 m
Type of Structure:	01 - AASH to Girder	Max Depth of N.W.L.:	1 m
Purpose of Structure:	04 - Over Non-Navigable Waters		
Type of Handrail:	04 - Steel Rail		
Roadway Surface:	02 - Asphalt	Spans:	
Alignment Vertical:	01 - Good	<u>Span No.:</u>	<u>Length</u>
Alignment Horizontal:	01 - Good	<u>Span No.:</u>	<u>Length</u>
Restrictions:	No	1	34.3
		2	0
		3	0
		4	0
		5	0
		6	0
BRIDGE PHOTOS

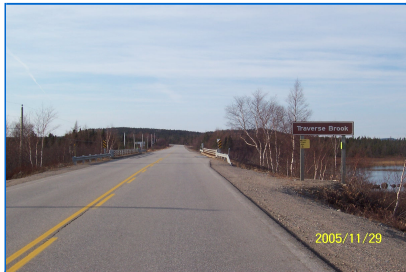
Bearing Seat:	F2 - Fair
Comments:			
SUPERSTRUCTURE			
Condition:	F2 - Fair	Expansion Joints:	F2 - Fair
Comments:	Hairline crack in girder #1, near abutment #1		
DECK			
Condition:	F2 - Fair	Curbs:	I - Inapplicable
Hand Rail:	I - Inapplicable	Roadway Condition:	I - Inapplicable

Approach Rail:	F2 - Fair		
Comments:	Rubber membrane at control joints in asphalt; hooked out by plow in places on both sides causing minor settlement at ends of approach slabs. Concrete spall in jersey barrier on RHS near abutment #2. Minor cracking in jersey barriers also. Post in buried end at abutment #2 exit rail cracked off (plow damage)		
HYDROLOGY			
Water Velocity:	0 m/s	Ice Problem:	N - No Problem
Water Depth:	0 m	Scour Problem:	N - No Problem
Waterway:	01 - Adequate	Debris Problem:	N - No Problem
Comments:	Eel net installed on RHS (downstream)		
REPLACEMENT/REHABILITATION			
Next Rehab. Date:		Replacement Year:	
Antic. Rehab. Cost:	\$0	Replacement Cost:	\$0
Recommendations:	Mill and fill control joints at approach slabs and expansion joints. Install hazard markers. Replace broken guide rail post.		
OBSERVATIONS			
Overall Condition:	F2 - Fair	Requires Further Inspection:	No
Additional Observations:	Hazard markers missing on all corners.
