GOVERNMENT OF NEWFOUNDLAND AND LABRADOR Department of Transportation and Infrastructure	BRIDGE INSPECTION REPORT B01202020-27	
Date: 10/8/2019	Inspected By: Lynch R / Martin L	Category: Eng. - Engineering	
BRIDGE INFORMATION			
Site:	3-151 - WOODEN BRIDGE NO.3, COOMBS COVE.		
Route:	363	Overall Length:	7 m
Year Built:	1965	Est: Yes	Overall Width: 5.6 m
Year Last Rehab.:		Est: No	Roadway Width: 5.6 m
Region:	CENTRAL WEST	Sidewalk Width:	0 m
Jurisdiction:	Provincial	Clearance to R.D. or N.W.L.:	2 m
Type of Structure:	11 - Timber Bridge	Max Depth of N.W.L.:	1 m
Purpose of Structure:	04 - Over Non-Navigable Waters	Spans:	
Type of Handrail:	06 - None	<u>Span No.:</u>	<u>Length</u>
Roadway Surface:	02 - Asphalt	1	4.7
Alignment Vertical:	01 - Good	2	0
Alignment Horizontal:	02 - Adequate	3	0
Restrictions:	No	<u>Span No.:</u>	<u>Length</u>
		4	0
		5	0
		6	0
BRIDGE PHOTOS

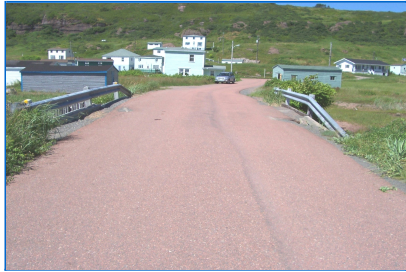
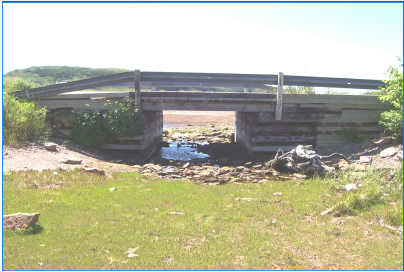
Bearing Seat:	F2 - Fair
Comments:	Loss of material in cribs - Timber seems okay. Crib not closed face.		
SUPERSTRUCTURE			
Condition:	F2 - Fair	Expansion Joints:	I - Inapplicable
Comments:	Minor split in center timber beam from deck nail.		
DECK			
Condition:	P1 - Poor	Curbs:	P1 - Poor
Hand Rail:	I - Inapplicable	Roadway Condition:	P1 - Poor

Approach Rail:	P1 - Poor		
Comments:	Deck timber severely rotten and failing under shoulders. Rail and curbs tipped out and coming detached. Sink holes at deck corners.		
HYDROLOGY			
Water Velocity:	0 m/s	Ice Problem:	N - No Problem
Water Depth:	0 m	Scour Problem:	P - Possible Problem
Waterway:	01 - Adequate	Debris Problem:	N - No Problem
Comments:	Tide low at time of inspection.		
REPLACEMENT/REHABILITATION			
Next Rehab. Date:		Replacement Year:	
Antic. Rehab. Cost:	\$0	Replacement Cost:	\$0
Recommendations:	Install new deck, curbs, and rail posts c/w 2 buried ends, re-surface. Close in cribs or install vertical fenders.		
OBSERVATIONS			
Overall Condition:	P3 - Poor	Requires Further Inspection:	No
Additional Observations:	No hazard markers. Sinkholes at all corners of deck.		
LEGEND:			
Condition Definitions:		Problem Definitions:	
1 - *Good - [discontinued code].	F2 - Fair.	C - Unsafe (Closed to Public).	N - No Problem.
