GOVERNMENT OF NEWFOUNDLAND AND LABRADOR Department of Transportation and Infrastructure	BRIDGE INSPECTION REPORT B10142021-1	
Date: 10/6/2021	Inspected By: Mike Button	Category: Office - Bridge Office	
BRIDGE INFORMATION			
Site:	2-209 - BEAVER POND BRIDGE		
Route:	201-10	Overall Length:	8.6 m
Year Built:	1954	Est: Yes	Overall Width: 6.9 m
Year Last Rehab.:		Est: No	Roadway Width: 5 m
Region:	CENTRAL EAST	Sidewalk Width:	0 m
Jurisdiction:	Provincial	Clearance to R.D. or N.W.L.:	1.1 m
Type of Structure:	03 - Reinforced Concrete Beam/Slab	Max Depth of N.W.L.:	1 m
Purpose of Structure:	04 - Over Non-Navigable Waters	Spans:	
Type of Handrail:	06 - None	<u>Span No.:</u>	<u>Length</u>
Roadway Surface:	01 - Concrete	1	7.6
Alignment Vertical:	02 - Adequate	2	0
Alignment Horizontal:	02 - Adequate	3	0
Restrictions:	No	<u>Span No.:</u>	<u>Length</u>
		4	0
		5	0
		6	0
BRIDGE PHOTOS

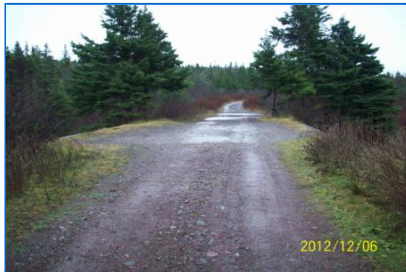
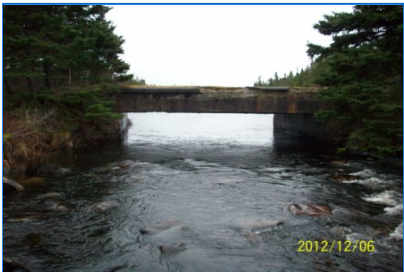
Bearing Seat:	I - Inapplicable
Comments:	- North abutment corners have severe disintegration, P1. South abutment corners are disintegrated and starting to undermine the exterior girder, P1. - Both abutment faces have medium-severe cracking with efflorescence, P3. - No bearings.		
SUPERSTRUCTURE			
Condition:	P1 - Poor	Expansion Joints:	I - Inapplicable
Comments:	- Exterior girders have no finish left on them with extreme disintegration and exposed rebar, P. Interior girders have medium-severe cracking with extreme efflorescence, P1. - Bottom of deck no visible due to deep water.		
DECK			
Condition:	P1 - Poor	Curbs:	I - Inapplicable

Hand Rail:	I - Inapplicable	Roadway Condition:	P1 - Poor
Approach Rail:	I - Inapplicable		
Comments:	- No curbs, guiderail, handrail, end blocks, or hazard markers. - Deck concrete exposed and heavily disintegrated, no exposed rebar, P1.

Next Rehab. Date:		Replacement Year:	2026
Antic. Rehab. Cost:	\$REMOVE	Replacement Cost:	\$200,000
Recommendations:	- Remove structure with 2-000 within 5 years.
