GOVERNMENT OF NEWFOUNDLAND AND LABRADOR Department of Transportation and Infrastructure	BRIDGE INSPECTION REPORT B04282021-11	
Date: 4/21/2021	Inspected By: Butler	Category: Eng. - Engineering	
BRIDGE INFORMATION			
Site:	2-124 - BURNSIDE BAILEY BRIDGE		
Route:	310-37-3	Overall Length:	12 m
Year Built:	1986	Est: No	Overall Width: 4.1 m
Year Last Rehab.:		Est: No	Roadway Width: 3.1 m
Region:	CENTRAL EAST	Sidewalk Width:	0 m
Jurisdiction:	Provincial	Clearance to R.D. or N.W.L.:	1.6 m
Type of Structure:	09 - Bailey Bridge	Max Depth of N.W.L.:	1 m
Purpose of Structure:	03 - Over Navigable Waters	Spans:	
Type of Handrail:	06 - None	<u>Span No.:</u>	<u>Length</u>
Roadway Surface:	03 - Timber	1	7
Alignment Vertical:	01 - Good	2	0
Alignment Horizontal:	01 - Good	3	0
Restrictions:	No	<u>Span No.:</u>	<u>Length</u>
		4	0
		5	0
		6	0
BRIDGE PHOTOS

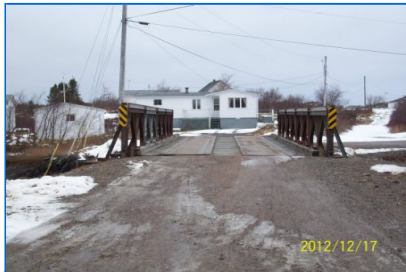
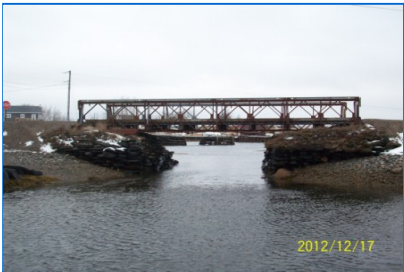
Bearing Seat:	U - Uninspectable
Comments:	Bridge bearing on rock fill. Abutment walls are stacked flat stones, somewhat unstable, some have fallen and fill is being lost. Bearings and seat are buried.		
SUPERSTRUCTURE			
Condition:	P3 - Poor	Expansion Joints:	I - Inapplicable
Comments:	Four panel old style Bailey with top chord reinforcing. Moderate rusting of the panels and chord reinforcing, no major section loss. 11 transom beams, one at each end used for fill retention only. 7 transoms and all sway braces replaced in 2015. Panels 3 and 4 and wheel guard - right, have impact damage, All appear to be solid. Panel on left side has broken steel cross bracing.		
DECK

Condition:	F2 - Fair	Curbs:	F2 - Fair
Hand Rail:	I - Inapplicable	Roadway Condition:	F2 - Fair
Approach Rail:	I - Inapplicable		
Comments:	50mm x 200mm timber chesses, 50mm timber wearing surface, 150mm x 150mm timber curbs all replaced 2015. No approach rail. Abutment 1 left, hazard marker damaged.

Next Rehab. Date:		Replacement Year:	
Antic. Rehab. Cost:	\$0	Replacement Cost:	\$0
Recommendations:	Replace hazard marker. Repair panel. Install class II rip rap and use rock fill to repair fill lose.
