GOVERNMENT OF NEWFOUNDLAND AND LABRADOR Department of Transportation and Infrastructure	BRIDGE INSPECTION REPORT B05292020-25	
Date: 5/28/2020	Inspected By: AB	Category: Eng. - Engineering	
BRIDGE INFORMATION			
Site:	2-103 - CENTRE COVE BROOK BRIDGE		
Route:	2-1-07	Overall Length:	25.5 m
Year Built:	1994	Est: No	Overall Width: 8.7 m
Year Last Rehab.:		Est: No	Roadway Width: 6.5 m
Region:	CENTRAL EAST	Sidewalk Width:	1.1 m
Jurisdiction:	Provincial	Clearance to R.D. or N.W.L.:	3.5 m
Type of Structure:	03 - Reinforced Concrete Beam/Slab	Max Depth of N.W.L.:	1 m
Purpose of Structure:	04 - Over Non-Navigable Waters	Spans:	
Type of Handrail:	01 - Aluminum Rail	<u>Span No.:</u>	<u>Length</u>
Roadway Surface:	02 - Asphalt	1	11.5
Alignment Vertical:	01 - Good	2	0
Alignment Horizontal:	01 - Good	3	0
Restrictions:	No	<u>Span No.:</u>	<u>Length</u>
		4	0
		5	0
		6	0
BRIDGE PHOTOS

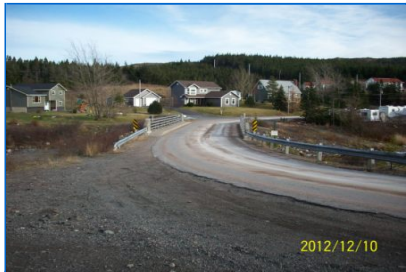
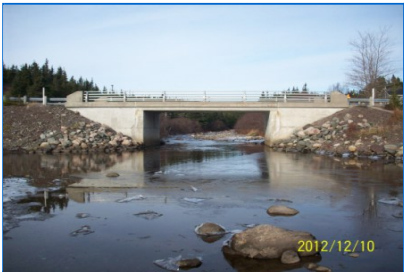
Bearing Seat:	F2 - Fair
Comments:	Concrete abutments and wing walls. Some light cracking and scaling of wing walls and abutments. Medium scaling/erosion of bottom one metre of both abutments due tidal waters. Joints leaking on to bearing seats.		
SUPERSTRUCTURE			
Condition:	F2 - Fair	Expansion Joints:	I - Inapplicable
Comments:	Some light cracking of soffit.		
DECK			
Condition:	F2 - Fair	Curbs:	F2 - Fair
Hand Rail:	F2 - Fair	Roadway Condition:	F2 - Fair

Comments: Aluminum bridge rail system with concrete end blocks. Spall on right end block abutment two from impact. Light cracking and scaling of sidewalks and curbs. Asphalt wearing surface beginning to crack at both approaches. Object markers abutment two missing. Approach two rail ends are damaged (fish tail and buried ends). Approach 1 left rail severely damaged. Gutters and sidewalk have approximately 10-20mm of sand buildup. Water line hangers on sidewalk are a tripping hazard. Bridge rail protrudes past the end block on both approaches. Approach one right has a washout next to the endblock and curb. Brush is growing around rail and obscuring hazard markers.

Water Velocity:	.5 m/s	Ice Problem:	N - No Problem
Water Depth:	1 m	Scour Problem:	N - No Problem
Waterway:	01 - Adequate	Debris Problem:	N - No Problem
Comments:	Tidal. Abutment one and two left side requires hydraulic rip rap.

Next Rehab. Date:		Replacement Year:	
Antic. Rehab. Cost:	\$0	Replacement Cost:	\$0
Recommendations:	Place hydraulic rip rap left side, Replace missing object markers. Clean sand from deck and sidewalk. Repair Guiderail. Fix bridge rail from protruding beyond the end block. Repair washout at Approach one. Clear Brush.
