GOVERNMENT OF NEWFOUNDLAND AND LABRADOR Department of Transportation and Works	BRIDGE INSPECTION REPORT B12222017-4 Printed: Friday, October 5, 2018	
Date: 12/20/2017	Inspected By: AB	Category: Eng. - Engineering	
BRIDGE INFORMATION			
Site:	2-195 - GARDEN COVE BRIDGE (OLD)		
Route:	210	Overall Length:	12 m
Year Built:	1960	Overall Width:	7.8 m
Year Last Rehab.:		Roadway Width:	7.2 m
Region:	CENTRAL EAST	Sidewalk Width:	0 m
Jurisdiction:	Provincial	Clearance to R.D. or N.W.L.:	1.5 m
Type of Structure:	03 - Reinforced Concrete Beam/Slab	Max Depth of N.W.L.:	0.5 m
Purpose of Structure:	04 - Over Non-Navigable Waters	Spans:	
Type of Handrail:	02 - Concrete Rail	Span No.:	Length
Roadway Surface:	01 - Concrete	Span No.:	Length
Alignment Vertical:	01 - Good	1	5.5
Alignment Horizontal:	01 - Good	2	0
Restrictions:	No	3	0
		4	0
		5	0
		6	0
BRIDGE PHOTOS

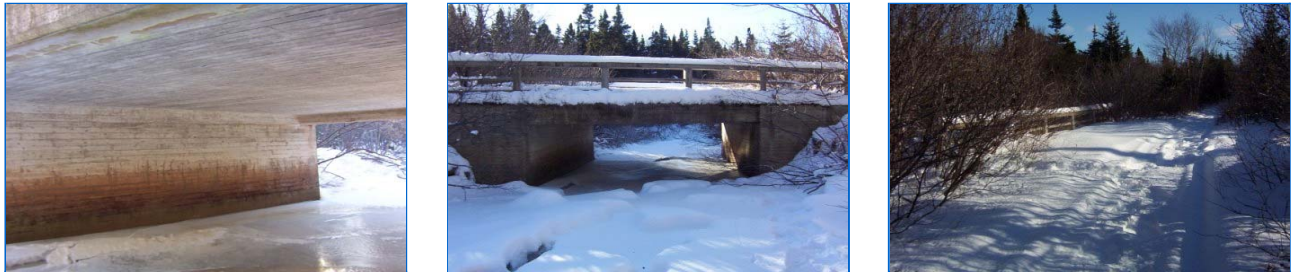
Bearing Seat:	F2 - Fair (Inspection within 2 Years)
Comments:	Concrete abutments and wingwalls. Some cracking and erosion of the concrete.		
SUPERSTRUCTURE			
Condition:	F2 - Fair (Inspection within 2 Years)	Expansion Joints:	I - Inapplicable
Comments:	Reinforced concrete deck slab. Top weathered, some light cracks, noticed during last inspection. Bridge was snow covered during this inspection.		
DECK			
Condition:	U - Uninspectable	Curbs:	U - Uninspectable
Hand Rail:	F2 - Fair (Inspection within 2 Years)	Roadway Condition:	U - Uninspectable

Approach Rail:	I - Inapplicable		
Comments:	Exposed concrete deck. Some vegetation growing on deck. Concrete hand rail, some light cracks. Roadway partly grown in. Bridge was snow covered during this inspection. Appeared to be a settlement adjacent to approach 2.		
HYDROLOGY			
Water Velocity:	0.5 m/s	Ice Problem:	N - No Problem
Water Depth:	0.5 m	Scour Problem:	K - Known Problem
Waterway:	01 - Adequate	Debris Problem:	N - No Problem
Comments:	Minor scour at abutment two, could be causing settlement on approach surface.		
REPLACEMENT/REHABILITATION			
Next Rehab. Date:		Replacement Year:	
Antic. Rehab. Cost:	\$0.00	Replacement Cost:	\$0.00
Recommendations:	Repair scour and settlement.		
OBSERVATIONS			
Overall Condition:	F2 - Fair (Inspection within 2 Years)	Requires Further Inspection:	No
Additional Observations:	Located on old R210 alignment, 100m downstream from Garden Cove Bridge, site #2-092. Used by ATV's. Access by old trail 120m beyond Garden Cove Bridge, site #2-092, on the right.
