GOVERNMENT OF
NEWFOUNDLAND
AND LABRADOR
Department of Transportation and Infrastructure

**BRIDGE INSPECTION REPORT
B08022021-4**

Site:	2-092 - GARDEN COVE ROAD BRIDGE				
Route:	210-13	Overall Length:	6.8 m		
Year Built:	1984	Est: No	Overall Width:	9 m	
Year Last Rehab.:		Est: No	Roadway Width:	8.2 m	
Region:	CENTRAL EAST	Sidewalk Width:	0 m		
Jurisdiction:	Provincial	Clearance to R.D. or N.W.L.:	2 m		
Type of Structure:	03 - Reinforced Concrete Beam/Slab	Max Depth of N.W.L.:	0.5 m		
Purpose of Structure:	04 - Over Non-Navigable Waters	Spans:			
Type of Handrail:	01 - Aluminum Rail	<u>Span No.:</u>	<u>Length</u>	<u>Span No.:</u>	<u>Length</u>
Roadway Surface:	02 - Asphalt	1	5.5	4	0
Alignment Vertical:	01 - Good	2	0	5	0
Alignment Horizontal:	01 - Good	3	0	6	0
Restrictions:	No

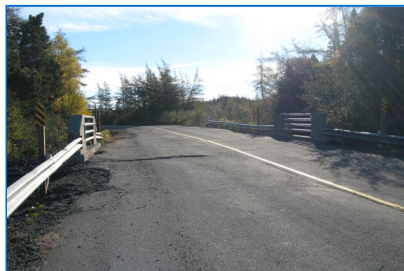
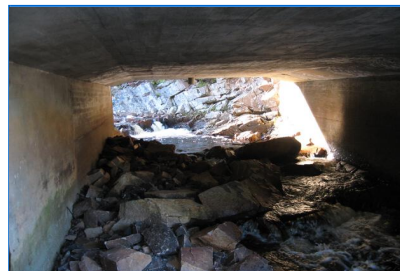
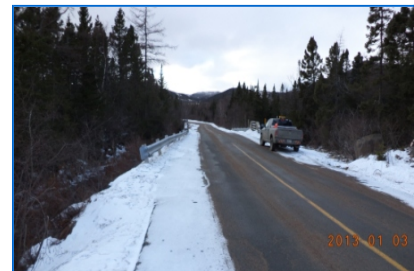
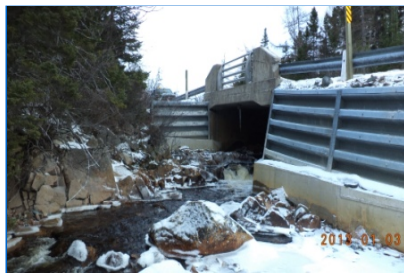
Comments: Concrete abutments, bin wall retaining structures at the corners. Some efflorescence from leakage through structure. Lower sections of bin walls rusted. Some minor impact damage to Abutment 1 left bin wall. Possible ice

damage.			
SUPERSTRUCTURE			
Condition:	F2 - Fair	Expansion Joints:	I - Inapplicable
Comments:	Reinforced concrete deck, some cracking with efflorescence underside.		
DECK			
Condition:	F2 - Fair	Curbs:	F2 - Fair
Hand Rail:	F2 - Fair	Roadway Condition:	F2 - Fair
Approach Rail:	F2 - Fair		
Comments:	Concrete deck with asphalt wearing surface. 4 rail aluminum hand rail with concrete end blocks, some impact damage to aluminum rails. Right side curb weathered. Endblocks were replaced in 2020. Roadway work was ongoing in area during inspection and approach rail and hazard markers were missing.		
HYDROLOGY			
Water Velocity:	1 m/s	Ice Problem:	P - Possible Problem
Water Depth:	0.25 m	Scour Problem:	K - Known Problem
Waterway:	01 - Adequate	Debris Problem:	N - No Problem
Comments:	Scour from hurricane Igor has been repaired. Minor scour along abutment two right side, 0.2-0.5m - no issues currently, remainder founded on solid rock.

REPLACEMENT/REHABILITATION			
Next Rehab. Date:		Replacement Year:	
Antic. Rehab. Cost:	\$0	Replacement Cost:	\$0
Recommendations:	Replace hand rail.		
OBSERVATIONS			
Overall Condition:	F2 - Fair	Requires Further Inspection:	No
Additional Observations:			
LEGEND:			
Condition Definitions:		Problem Definitions:	
1 - *Good - [discontinued code].	F2 - Fair.	C - Unsafe (Closed to Public).	N - No Problem.
2 - *Fair - [discontinued code].	F1 - Fair.	U - Uninspectable.	P - Possible Problem.
3 - *Poor - [discontinued code].	P3 - Poor.	I - Inapplicable.	K - Known Problem.
4 - *Unsafe - [discontinued code].	P1 - Poor.		NA - Not Applicable.
G - Good.	P - Poor.		
Category Definitions:			
Maint. - Maintenance.			
Eng. - Engineering.			
Office - Bridge Office.			
PHOTO GUIDELINES:			
Inspection Photos:			
Please provide photos using guidelines below:			
<ul style="list-style-type: none"> ● Any item which inspector feels should be documented by photograph ● All items noted above as being P3, P1, P, or C ● Any evidence of known ice, scour, debris, waterway problems
