GOVERNMENT OF NEWFOUNDLAND AND LABRADOR Department of Transportation and Infrastructure	BRIDGE INSPECTION REPORT B10192017-6	
Date: 10/13/2017	Inspected By: AB	Category: Eng. - Engineering	
BRIDGE INFORMATION			
Site:	2-093 - LOCKSTON PARK BRIDGE #1		
Route:	236	Overall Length:	17.4 m
Year Built:	1991	Est: No	Overall Width: 10 m
Year Last Rehab.:		Est: No	Roadway Width: 9 m
Region:	CENTRAL EAST	Sidewalk Width:	0 m
Jurisdiction:	Provincial	Clearance to R.D. or N.W.L.:	1 m
Type of Structure:	03 - Reinforced Concrete Beam/Slab	Max Depth of N.W.L.:	1 m
Purpose of Structure:	04 - Over Non-Navigable Waters	Spans:	
Type of Handrail:	01 - Aluminum Rail	<u>Span No.:</u>	<u>Length</u>
Roadway Surface:	01 - Concrete	1	9
Alignment Vertical:	01 - Good	2	0
Alignment Horizontal:	01 - Good	3	0
Restrictions:	No	<u>Span No.:</u>	<u>Length</u>
		4	0
		5	0
		6	0
BRIDGE PHOTOS

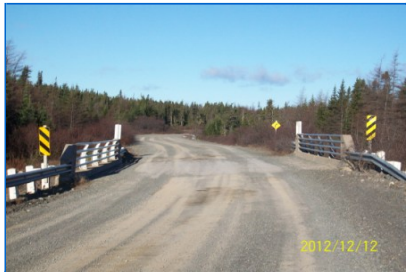
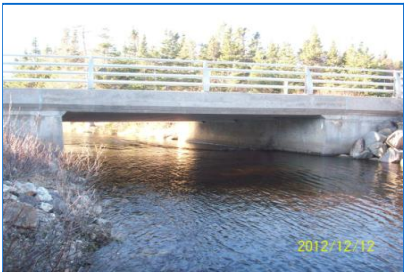
Bearing Seat:	U - Uninspectable
Comments:	Concrete abutments and wing walls. Abutments have efflorescence on them.		
SUPERSTRUCTURE			
Condition:	F2 - Fair	Expansion Joints:	I - Inapplicable
Comments:	Some leaking at joints, evidence of leaking at curb soffit and abutments.		
DECK			
Condition:	F2 - Fair	Curbs:	F2 - Fair
Hand Rail:	F2 - Fair	Roadway Condition:	F2 - Fair

Approach Rail:	P1 - Poor		
Comments:	Exposed concrete deck. Aluminum bridge rail. No michigan shoes. Brush growing over approach rails blocking hazard markers. Bridge deck has a buildup of gravel. all end blocks have cracks on them, abutment #1 left end block has impact damage.		
HYDROLOGY			
Water Velocity:	1.0 m/s	Ice Problem:	N - No Problem
Water Depth:	0.7 m	Scour Problem:	N - No Problem
Waterway:	01 - Adequate	Debris Problem:	N - No Problem
Comments:			
REPLACEMENT/REHABILITATION			
Next Rehab. Date:	2017	Replacement Year:	2017
Antic. Rehab. Cost:	\$0	Replacement Cost:	\$0
Recommendations:			
OBSERVATIONS			
Overall Condition:	F2 - Fair	Requires Further Inspection:	No
Additional Observations:			
LEGEND:			
Condition Definitions:		Problem Definitions:	
1 - *Good - [discontinued code].	F2 - Fair.	C - Unsafe (Closed to Public).	N - No Problem.
2 - *Fair - [discontinued code].	F1 - Fair.	U - Uninspectable.	P - Possible Problem.
