GOVERNMENT OF NEWFOUNDLAND AND LABRADOR Department of Transportation and Works	BRIDGE INSPECTION REPORT B10082021-2 Printed: Friday, October 8, 2021	
Date: 10/5/2021	Inspected By: Mike Button	Category: Office - Bridge Office	
BRIDGE INFORMATION			
Site:	TCH-015 - LOWER SHOAL HARBOUR RIVER BRIDGE		
Route:	1	Overall Length:	21 m
Year Built:	1964	Est: No	Overall Width: 18.2 m
Year Last Rehab.:	1997	Est: No	Roadway Width: 16.4 m
Region:	CENTRAL EAST	Sidewalk Width:	0 m
Jurisdiction:	Provincial	Clearance to R.D. or N.W.L.:	3 m
Type of Structure:	02 - Double Tee	Max Depth of N.W.L.:	0.5 m
Purpose of Structure:	04 - Over Non-Navigable Waters	Spans:	
Type of Handrail:	01 - Aluminum Rail	Span No.:	Length
Roadway Surface:	02 - Asphalt	1	11
Alignment Vertical:	01 - Good	2	0
Alignment Horizontal:	01 - Good	3	0
Restrictions:	No	Span No.:	Length
		4	0
		5	0
		6	0
BRIDGE PHOTOS

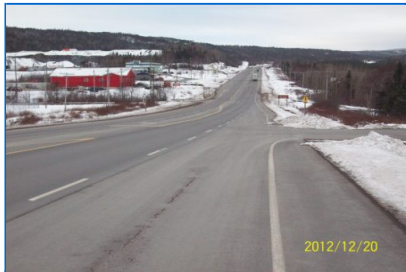
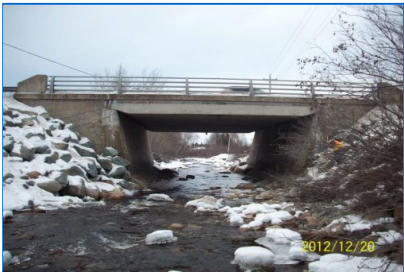
Bearing Seat:	U - Uninspectable
Comments:	- All wingwalls and both abutment faces have mild alligator cracking throughout. Efflorescence on both abutment faces but from leaking joints prior to 2021 rehab. - Bearings and bearing seat too high for inspection but look to be in fair condition from below.		
SUPERSTRUCTURE			
Condition:	F2 - Fair (Inspection within 2 Years)	Expansion Joints:	G - Good (Inspection within 2 Years)
Comments:	- New asphaltic plug joints in 2021. - Bottom of deck and double tees, F1. No leaks between double tee precast panels. - South fascia in fair condition, small rust stain spots over southeast bearing area.		
DECK			
Condition:	F2 - Fair (Inspection within 2 Years)	Curbs:	G - Good (Inspection within 2 Years)
