GOVERNMENT OF NEWFOUNDLAND AND LABRADOR Department of Transportation and Infrastructure	BRIDGE INSPECTION REPORT B10132021-3	
Date: 10/6/2021	Inspected By: Mike Button	Category: Office - Bridge Office	
BRIDGE INFORMATION			
Site:	2-130 - MONROE BRIDGE		
Route:	232	Overall Length:	27 m
Year Built:	1968	Overall Width:	7.6 m
Year Last Rehab.:		Roadway Width:	7 m
Region:	CENTRAL EAST	Sidewalk Width:	0 m
Jurisdiction:	Provincial	Clearance to R.D. or N.W.L.:	6 m
Type of Structure:	11 - Timber Bridge	Max Depth of N.W.L.:	1 m
Purpose of Structure:	04 - Over Non-Navigable Waters		
Type of Handrail:	06 - None	Spans:	
Roadway Surface:	03 - Timber	<u>Span No.:</u>	<u>Length</u>
Alignment Vertical:	02 - Adequate	1	6
Alignment Horizontal:	03 - Poor	2	0
Restrictions:	No	3	0
		<u>Span No.:</u>	<u>Length</u>
		4	0
		5	0
		6	0
BRIDGE PHOTOS

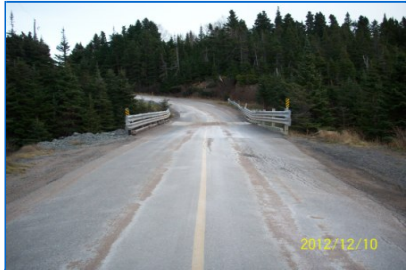
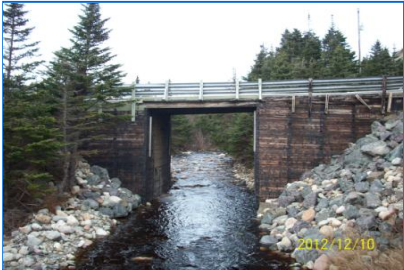
Comments:	- Southeast wingwall retaining structure is tipped/bowed to the south, pulling guiderail posts with it, P1. Top portion of southwest wingwall recently replaced and braced with new pressure treated timbers, F2. - North wingwall retaining structures have severe tipping/bowing to the north with timber to timber connections separated near the top, P1. Both corners need replacement and bracing. - Both abutment face timbers in fair condition, F1. Beams extend back through the face and bearing timbers appear in fair condition, F1.		
SUPERSTRUCTURE			
Condition:	F1 - Fair	Expansion Joints:	I - Inapplicable
Comments:	- Bottom of deck timbers and 12x12 timber beams appear in to be in fair condition, F1.		
DECK

Condition:	F1 - Fair	Curbs:	P1 - Poor
Hand Rail:	P1 - Poor	Roadway Condition:	P3 - Poor
Approach Rail:	P1 - Poor		
Comments:	- Southwest hazard marker missing. - No end blocks. - East approach rails in fair condition. - West approach rails need to be extended. Northwest corner rail needs replacement, likely caused from plough damage. - Structure guiderail over span needs replacement. Posts missing bolts in some locations, tipped outwards and bearing on cantilevered deck timbers. South mid-span post also missing, P1. - Wearing/deck timbers are worn but appear to be in fair condition, replace during rehab if rehab is chosen. - Asphalt approach to deck timbers on both sides of structure settled. - South curb is new 6x6 pressure treated timber, north is worn out and needs replacement.

Next Rehab. Date:	2023	Replacement Year:	2023
Antic. Rehab. Cost:	\$100,000	Replacement Cost:	\$1,200,000
Recommendations:	- Recommend a replacement from creosote environmental concerns. Structure has heavy creosote leakage and can be seen on river rock below. - If a rehab is chosen, tops of wingwalls, guiderails, north curb and wearing surface timbers should be replaced. Repair approach settlement when wingwall tops are being replacement.
