GOVERNMENT OF NEWFOUNDLAND AND LABRADOR Department of Transportation and Infrastructure	BRIDGE INSPECTION REPORT B05122021-11	
Date: 4/27/2021	Inspected By: Butler	Category: Eng. - Engineering	
BRIDGE INFORMATION			
Site:	2-207 - MORLEY'S SIDING TIMBER BRIDGE		
Route:	230-10-1	Overall Length:	12 m
Year Built:	1970	Est: Yes	Overall Width: 7 m
Year Last Rehab.:		Est: No	Roadway Width: 5.7 m
Region:	CENTRAL EAST	Sidewalk Width:	0 m
Jurisdiction:	Provincial	Clearance to R.D. or N.W.L.:	1.2 m
Type of Structure:	11 - Timber Bridge	Max Depth of N.W.L.:	0.5 m
Purpose of Structure:	04 - Over Non-Navigable Waters	Spans:	
Type of Handrail:	03 - Timber Rail	Span No.:	Length
Roadway Surface:	03 - Timber	1	7.5
Alignment Vertical:	01 - Good	2	0
Alignment Horizontal:	01 - Good	3	0
Restrictions:	No	Span No.:	Length
		4	0
		5	0
		6	0
BRIDGE PHOTOS

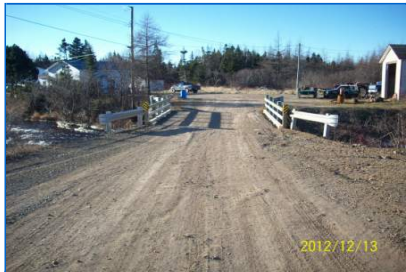
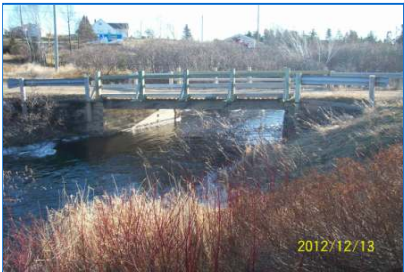
Comments:	Closed face creosote timber abutments and wing walls. Some light cracking and decay. Wing wall abutment one right side leaning. Minor scouring on left side of abutment 1.		
SUPERSTRUCTURE			
Condition:	F2 - Fair	Expansion Joints:	I - Inapplicable
Comments:	7 - 300mm x 450mm creosote timber beams. Some light longitudinal cracking.		
DECK			
Condition:	F2 - Fair	Curbs:	P1 - Poor
Hand Rail:	F2 - Fair	Roadway Condition:	P1 - Poor

Approach Rail:	P - Poor		
Comments:	75mm x 150mm creosote timber chesses. One chess broken near abutment two. 50mm timber wearing surface. 150mm x 150mm timber curb. One section of bridge rail and curb on right side broken and detached from bridge. Wood bridge rail. Object markers missing on abutment two.		
HYDROLOGY			
Water Velocity:	1 m/s	Ice Problem:	N - No Problem
Water Depth:	1 m	Scour Problem:	P - Possible Problem
Waterway:	01 - Adequate	Debris Problem:	N - No Problem
Comments:	Overtopped during Hurricane Igor.		
REPLACEMENT/REHABILITATION			
Next Rehab. Date:		Replacement Year:	
Antic. Rehab. Cost:	\$0	Replacement Cost:	\$0
Recommendations:	Repair broken curb and rail.		
OBSERVATIONS			
Overall Condition:	F2 - Fair	Requires Further Inspection:	No
Additional Observations:			
LEGEND:			
Condition Definitions:		Problem Definitions:	
1 - *Good - [discontinued code].	F2 - Fair.	C - Unsafe (Closed to Public).	N - No Problem.
