GOVERNMENT OF NEWFOUNDLAND AND LABRADOR Department of Transportation and Infrastructure	BRIDGE INSPECTION REPORT B08022021-3	
Date: 5/6/2021	Inspected By: Butler	Category: Eng. - Engineering	
BRIDGE INFORMATION			
Site:	2-177 - NORTH HARBOUR BRIDGE (OLD)		
Route:	210	Overall Length:	12 m
Year Built:	1950	Est: Yes	Overall Width: 6 m
Year Last Rehab.:		Est: No	Roadway Width: 5.5 m
Region:	CENTRAL EAST	Sidewalk Width:	0 m
Jurisdiction:	Provincial	Clearance to R.D. or N.W.L.:	3 m
Type of Structure:	03 - Reinforced Concrete Beam/Slab	Max Depth of N.W.L.:	1 m
Purpose of Structure:	04 - Over Non-Navigable Waters	Spans:	
Type of Handrail:	02 - Concrete Rail	Span No.:	Length
Roadway Surface:	01 - Concrete	1	6
Alignment Vertical:	01 - Good	2	0
Alignment Horizontal:	01 - Good	3	0
Restrictions:	Yes	Span No.:	Length
Describe Restrictions:	Approach sign "This road not maintained by Dept. Of Trans. Use at own risk"

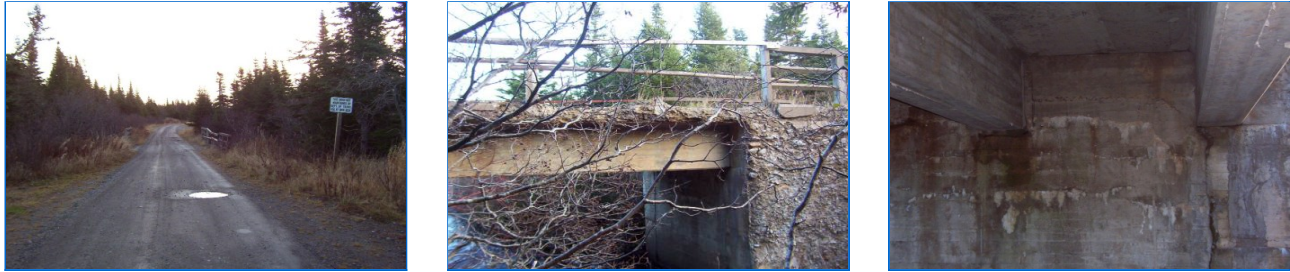
BRIDGE PHOTOS

SUBSTRUCTURE			
Condition:	P3 - Poor	Bearings:	U - Uninspectable
		Bearing Seat:	U - Uninspectable
Comments:	Concrete abutments and wingwalls. Severe deterioration of all components.		
SUPERSTRUCTURE			
Condition:	F1 - Fair	Expansion Joints:	I - Inapplicable
Comments:	3 reinforced concrete beams. Beam one has significant longitudinal cracking with efflorescence, mostly bottom half of beam.		
DECK			
Condition:	P3 - Poor	Curbs:	I - Inapplicable
Hand Rail:	P - Poor	Roadway Condition:	I - Inapplicable

Approach Rail:	P - Poor		
Comments:	Exposed concrete deck with gravel approaches. Deck is covered with gravel, underside has some cracking with efflorescence. Deck edges and curbs are severely disintegrated. Timber hand rail installed on bridge.		
HYDROLOGY			
Water Velocity:	1.5 m/s	Ice Problem:	N - No Problem
Water Depth:	1.5 m	Scour Problem:	N - No Problem
Waterway:	01 - Adequate	Debris Problem:	N - No Problem
Comments:	Significant debris - trees and brush - upstream of structure may move and block opening. The stream bank holding the vegetation in place does not appear solid.		
REPLACEMENT/REHABILITATION			
Next Rehab. Date:		Replacement Year:	
Antic. Rehab. Cost:	\$0	Replacement Cost:	\$0
Recommendations:	Remove structure. This bridge is on a cabin road, has 2 entrances and does not require a through road.		
OBSERVATIONS			
Overall Condition:	P - Poor	Requires Further Inspection:	No
Additional Observations:	Bridge is located 800m from R210, turn off right at km 8.7, onto the old R210 alignment. Bridge can also be accessed from a road opposite from the North Harbour Intersection, 4.2km from R210.
