GOVERNMENT OF
NEWFOUNDLAND
AND LABRADOR
Department of Transportation and Infrastructure

**BRIDGE INSPECTION REPORT
B11062019-1**

Site:	2-026 - SALT POND BRIDGE #1				
Route:	220	Overall Length:	16.5 m		
Year Built:	1966	Est: No	Overall Width:	9.1 m	
Year Last Rehab.:	1987	Est: No	Roadway Width:	6.7 m	
Region:	CENTRAL EAST				
Jurisdiction:	Provincial				
Type of Structure:	02 - Double Tee	Clearance to R.D. or N.W.L.:	0.5 m		
Purpose of Structure:	04 - Over Non-Navigable Waters				
Type of Handrail:	01 - Aluminum Rail	Max Depth of N.W.L.:	1 m		
Roadway Surface:	02 - Asphalt	Spans:			
Alignment Vertical:	01 - Good	<u>Span No.:</u>	<u>Length</u>	<u>Span No.:</u>	<u>Length</u>
Alignment Horizontal:	01 - Good	1	10.4	4	0
Restrictions:	No	2	0	5	0
		3	0	6	0

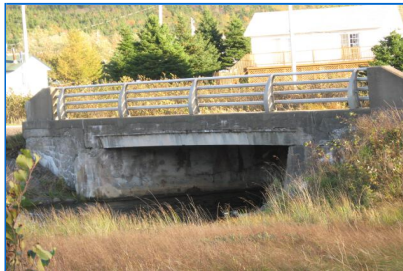
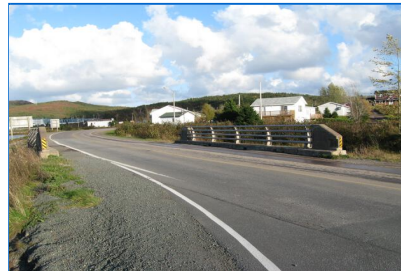
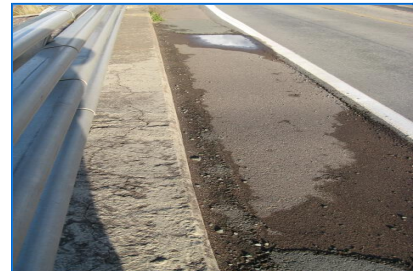
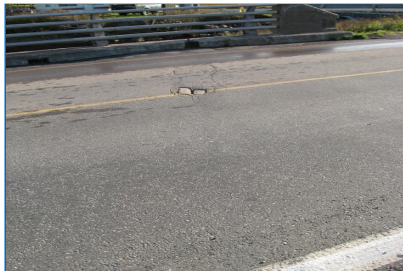
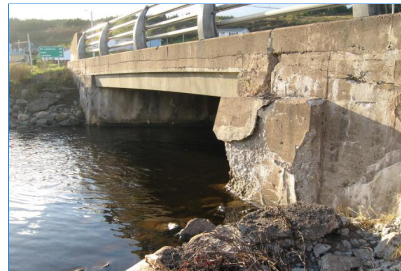
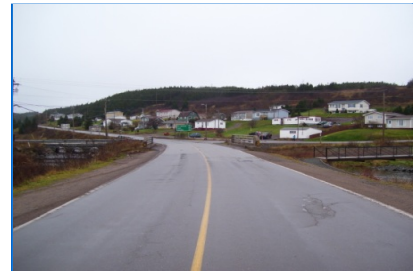
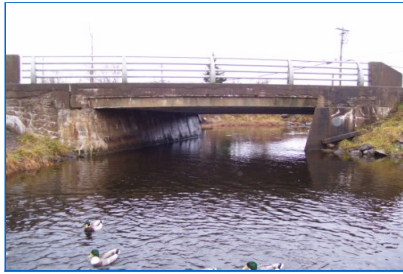
Condition:	P - Poor	Bearings:	P - Poor
		Bearing Seat:	P - Poor
Comments:	Significant deterioration of all components. Abutments have large cracking throughout and significant deterioration with concrete loss at all corners. The bearing seats are deteriorated to the point of bearing loss at some girder ends.

Condition:	P - Poor	Expansion Joints:	P - Poor
Comments:	Significant deterioration on most double tee girders, especially at the ends where some have concrete loss along the bottom edges near the bearing seats, compromising the bearing area. It appears some girders may be hanging from the deck slab with no contact with the bearing area. Both expansion joints are leaking badly and have been damaged by plow equipment.

Condition:	P3 - Poor	Curbs:	P3 - Poor
Hand Rail:	F2 - Fair	Roadway Condition:	P3 - Poor
Approach Rail:	I - Inapplicable		
Comments:	Concrete deck with asphalt wearing surface. Some areas are leaking through deck, evidence of leakage on the underside. Aluminum hand rail and concrete end blocks in fair condition. Cracking and deterioration along sections of the curb. Roadway rough, especially at approaches.

Next Rehab. Date:	2019	Replacement Year:	2019
Antic. Rehab. Cost:	\$0	Replacement Cost:	\$500000
Recommendations:	This structure should be considered for immediate replacement. Propose using two aluminum pipe arch structures or an aluminum box culvert with full invert as replacement structure.
