GOVERNMENT OF NEWFOUNDLAND AND LABRADOR Department of Transportation and Works	BRIDGE INSPECTION REPORT B10162017-2 Printed: Friday, October 5, 2018	
Date: 10/16/2017	Inspected By: AB	Category: Eng. - Engineering	
BRIDGE INFORMATION			
Site:	2-202 - SNOOKS BROOK BRIDGE (OLD)		
Route:	232	Overall Length:	10 m
Year Built:	1945	Est: No	Overall Width: 5.6 m
Year Last Rehab.:		Est: No	Roadway Width: 0 m
Region:	CENTRAL EAST	Sidewalk Width:	0 m
Jurisdiction:	Provincial	Clearance to R.D. or N.W.L.:	1 m
Type of Structure:	03 - Reinforced Concrete Beam/Slab	Max Depth of N.W.L.:	1 m
Purpose of Structure:	04 - Over Non-Navigable Waters	Spans:	
Type of Handrail:	06 - None	<u>Span No.:</u>	<u>Length</u>
Roadway Surface:	01 - Concrete	<u>Span No.:</u>	<u>Length</u>
Alignment Vertical:	01 - Good	1	6
Alignment Horizontal:	01 - Good	2	0
Restrictions:	Yes	3	0
Describe Restrictions:	Located upstream from Route 232 culvert. Not used.

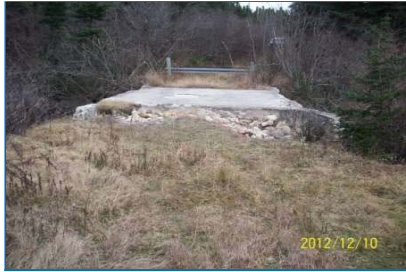
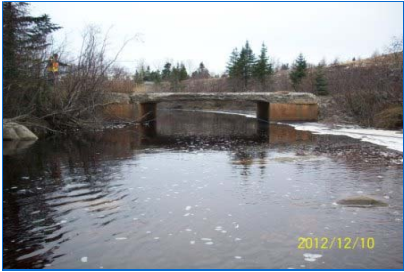
BRIDGE PHOTOS

SUBSTRUCTURE			
Condition:	C - Unsafe (Closed to Public)	Bearings:	I - Inapplicable
		Bearing Seat:	I - Inapplicable
Comments:	Concrete abutments and wing walls. Severe disintegration, cracking and delamination of all.		
SUPERSTRUCTURE			
Condition:	C - Unsafe (Closed to Public)	Expansion Joints:	I - Inapplicable
Comments:	Soffit has disintegration, delamination and spalling.		
DECK			
Condition:	C - Unsafe (Closed to Public)	Curbs:	I - Inapplicable
Hand Rail:	C - Unsafe (Closed to Public)	Roadway Condition:	I - Inapplicable

Approach Rail:	I - Inapplicable		
Comments:	Bridge rail missing. Exposed concrete deck poor condition.		
HYDROLOGY			
Water Velocity:	.2 m/s	Ice Problem:	N - No Problem
Water Depth:	1.5 m	Scour Problem:	P - Possible Problem
Waterway:	01 - Adequate	Debris Problem:	N - No Problem
Comments:	Unable to check for scour		
REPLACEMENT/REHABILITATION			
Next Rehab. Date:	2017	Replacement Year:	2017
Antic. Rehab. Cost:	\$0.00	Replacement Cost:	\$0.00
Recommendations:	Remove structure.		
OBSERVATIONS			
Overall Condition:	C - Unsafe (Closed to Public)	Requires Further Inspection:	No
Additional Observations:	Approach abutment one washed out, approach abutment two barricaded with guide rail. Bridge is inaccessible. Bridge located upstream from 3000mm culvert across R232.		
LEGEND:			
Condition Definitions:		Problem Definitions:	
1 - *Good - [discontinued code].	F2 - Fair (Inspection within 2 Years).	C - Unsafe (Closed to Public).	N - No Problem.
