GOVERNMENT OF NEWFOUNDLAND AND LABRADOR Department of Transportation and Infrastructure	BRIDGE INSPECTION REPORT B12282017-6	
Date: 12/20/2017	Inspected By: AB	Category: Eng. - Engineering	
BRIDGE INFORMATION			
Site:	2-196 - SOCK POND BRIDGE		
Route:	210	Overall Length:	10 m
Year Built:	1960	Est: No	Overall Width: 7.5 m
Year Last Rehab.:		Est: No	Roadway Width: 7 m
Region:	CENTRAL EAST	Sidewalk Width:	0 m
Jurisdiction:	Provincial	Clearance to R.D. or N.W.L.:	1 m
Type of Structure:	03 - Reinforced Concrete Beam/Slab	Max Depth of N.W.L.:	1 m
Purpose of Structure:	04 - Over Non-Navigable Waters	Spans:	
Type of Handrail:	02 - Concrete Rail	<u>Span No.:</u>	<u>Length</u>
Roadway Surface:	01 - Concrete	1	6
Alignment Vertical:	01 - Good	2	0
Alignment Horizontal:	01 - Good	3	0
Restrictions:	No	<u>Span No.:</u>	<u>Length</u>
		4	0
		5	0
		6	0
BRIDGE PHOTOS

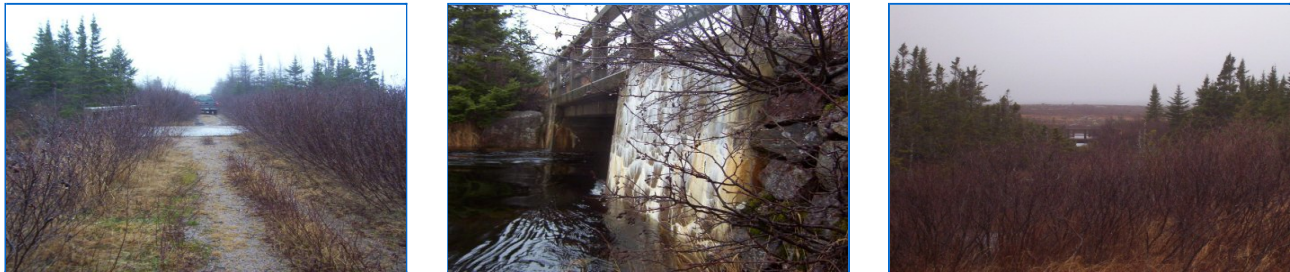
Bearing Seat:	F2 - Fair
Comments:	Concrete abutments and wingwalls. some cracking with efflorescence throughout.		
SUPERSTRUCTURE			
Condition:	F2 - Fair	Expansion Joints:	I - Inapplicable
Comments:	Reinforced concrete deck, some light cracks.		
DECK			
Condition:	U - Uninspectable	Curbs:	U - Uninspectable
Hand Rail:	P3 - Poor	Roadway Condition:	U - Uninspectable

Approach Rail:	I - Inapplicable		
Comments:	Exposed concrete deck with gravel approaches (noted during previous inspection). Cracking and disintegration of the deck surface, some vegetation growth (noted during previous inspection). Concrete hand rail is cracked, disintegrated and has exposed rebar in several areas. Roadway is grown in with alders.		
HYDROLOGY			
Water Velocity:	1.0 m/s	Ice Problem:	N - No Problem
Water Depth:	2.0 m	Scour Problem:	N - No Problem
Waterway:	01 - Adequate	Debris Problem:	K - Known Problem
Comments:	Bridge opening has been dammed by a beaver - water 1.5m from deck. Dam appears to have been breached with no recent beaver activity.		
REPLACEMENT/REHABILITATION			
Next Rehab. Date:		Replacement Year:	
Antic. Rehab. Cost:	\$0	Replacement Cost:	\$0
Recommendations:	Remove structure.		
OBSERVATIONS			
Overall Condition:	F1 - Fair	Requires Further Inspection:	No
Additional Observations:	Located on old R210 about 4.5km south of Sandy Harbour River Bridge.
