GOVERNMENT OF NEWFOUNDLAND AND LABRADOR Department of Transportation and Infrastructure	BRIDGE INSPECTION REPORT B04282021-3	
Date: 4/20/2021	Inspected By: Butler	Category: Eng. - Engineering	
BRIDGE INFORMATION			
Site:	TCH-030 - SOULIS BROOK BRIDGE		
Route:	1	Overall Length:	21 m
Year Built:	1990	Overall Width:	13.4 m
Year Last Rehab.:		Roadway Width:	12 m
Region:	CENTRAL EAST	Sidewalk Width:	0 m
Jurisdiction:	Provincial	Clearance to R.D. or N.W.L.:	2.5 m
Type of Structure:	04 - Rigid Frame	Max Depth of N.W.L.:	1 m
Purpose of Structure:	04 - Over Non-Navigable Waters		
Type of Handrail:	01 - Aluminum Rail	Spans:	
Roadway Surface:	02 - Asphalt	<u>Span No.:</u>	<u>Length</u>
Alignment Vertical:	01 - Good	1	19
Alignment Horizontal:	01 - Good	2	0
Restrictions:	No	3	0
		<u>Span No.:</u>	<u>Length</u>
		4	0
		5	0
		6	0
BRIDGE PHOTOS

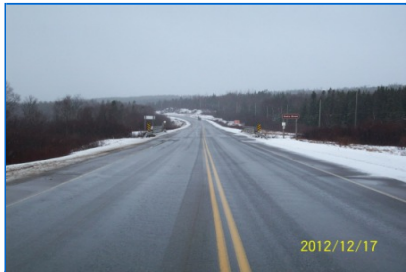
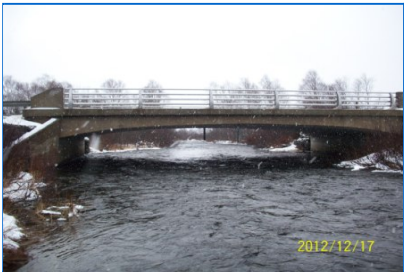
Comments:	Concrete abutments. Some erosion of abutment walls. Concrete wing walls right side only, not attached to structure. Abutment one wing wall leaning significantly (aprox. 40mm at top) due to the roadway/bridge water draining next to it. Both wing walls severe scaling, some delamination and cracking. All Gabions are in poor condition due the ones at waterline being severely rusted and missing ballast. Longitudinal cracks are evident in several places connecting both abutments through the deck the worst appears to the center joint, all are minor.		
SUPERSTRUCTURE			
Condition:	F2 - Fair	Expansion Joints:	F2 - Fair
Comments:	Soffit and fascia in fair condition with minor cracking.		
DECK

Condition:	F2 - Fair	Curbs:	F2 - Fair
Hand Rail:	F2 - Fair	Roadway Condition:	F2 - Fair
Approach Rail:	F2 - Fair		
Comments:	Asphalt wearing surface. Light cracking of curbs. Aluminum 4 rail system with concrete end blocks, rust staining. Guide rail not structural.

Next Rehab. Date:		Replacement Year:	
Antic. Rehab. Cost:	\$50000	Replacement Cost:	\$0
Recommendations:	Install structural rail, steel bridge rail, replace gabions with armor stone.
