GOVERNMENT OF NEWFOUNDLAND AND LABRADOR Department of Transportation and Infrastructure	<b>BRIDGE INSPECTION REPORT</b> <b>B08272015-1</b>	
<b>Date:</b> 7/30/2015	<b>Inspected By:</b> Kent Randell	<b>Category:</b> Eng. - Engineering	
<b>BRIDGE INFORMATION</b>			
<b>Site:</b>	5-020 - MUD LAKE BRIDGE		
<b>Route:</b>		<b>Overall Length:</b>	43.5 m
<b>Year Built:</b>	1973	<b>Est: Yes</b>	<b>Overall Width:</b> 4.7 m
<b>Year Last Rehab.:</b>		<b>Est: No</b>	<b>Roadway Width:</b> 28.5 m
<b>Region:</b>	LABRADOR	<b>Sidewalk Width:</b>	0 m
<b>Jurisdiction:</b>	Provincial	<b>Clearance to R.D. or N.W.L.:</b>	1.7 m
<b>Type of Structure:</b>	09 - Bailey Bridge	<b>Max Depth of N.W.L.:</b>	2.9 m
<b>Purpose of Structure:</b>	04 - Over Non-Navigable Waters		
<b>Type of Handrail:</b>	06 - None	<b>Spans:</b>	
<b>Roadway Surface:</b>	03 - Timber	<u>Span No.:</u>	<u>Length</u>
<b>Alignment Vertical:</b>	01 - Good	1	43.5
<b>Alignment Horizontal:</b>	01 - Good	2	0

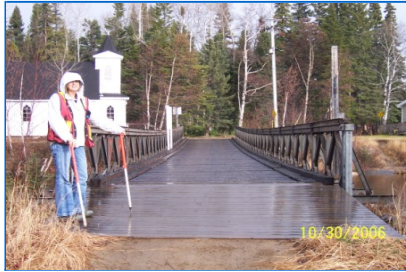
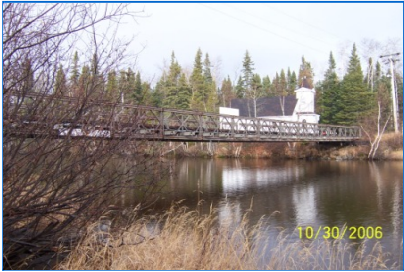
<b>SUBSTRUCTURE</b>			
<b>Condition:</b>	P3 - Poor	<b>Bearings:</b>	P3 - Poor
		<b>Bearing Seat:</b>	P3 - Poor
<b>Comments:</b>	Some rot occurring in the upper most levels of the abutment crib.		
<b>SUPERSTRUCTURE</b>			
<b>Condition:</b>	F1 - Fair	<b>Expansion Joints:</b>	I - Inapplicable
<b>Comments:</b>	Requires replacement of several transom clamps.		
<b>DECK</b>			
<b>Condition:</b>	P3 - Poor	<b>Curbs:</b>	F2 - Fair
<b>Hand Rail:</b>	F2 - Fair	<b>Roadway Condition:</b>	F2 - Fair

<b>Approach Rail:</b>	I - Inapplicable		
<b>Comments:</b>	Deck boards are worn and require replacement.		
<b>HYDROLOGY</b>			
<b>Water Velocity:</b>	0 m/s	<b>Ice Problem:</b>	N - No Problem
<b>Water Depth:</b>	0 m	<b>Scour Problem:</b>	N - No Problem
<b>Waterway:</b>	01 - Adequate	<b>Debris Problem:</b>	N - No Problem
<b>Comments:</b>			
<b>REPLACEMENT/REHABILITATION</b>			
<b>Next Rehab. Date:</b>	2015	<b>Replacement Year:</b>	2015
<b>Antic. Rehab. Cost:</b>	\$0	<b>Replacement Cost:</b>	\$0
<b>Recommendations:</b>			
<b>OBSERVATIONS</b>			
<b>Overall Condition:</b>	P3 - Poor	<b>Requires Further Inspection:</b>	No
<b>Additional Observations:</b>	Bridge is very low over navigable waters. Bridge can be raised and approaches replaced during abutment repairs.		
<b>LEGEND:</b>			
<b>Condition Definitions:</b>		<b>Problem Definitions:</b>	
1 - *Good - [discontinued code].	F2 - Fair.	C - Unsafe (Closed to Public).	N - No Problem.
