| | GOVERNMENT OF NEWFOUNDLAND AND LABRADOR Department of Transportation and Infrastructure | BRIDGE INSPECTION REPORT B07062017-5 | |
| Date: 6/23/2017 | Inspected By: Kent Randell | Category: Eng. - Engineering | |
| Site: | 5-025 - WABUSH NARROWS BRIDGE | | |

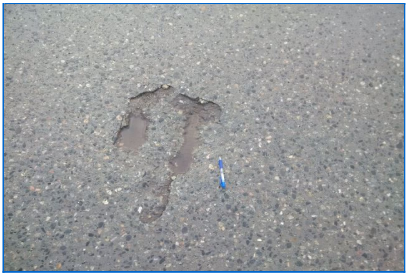
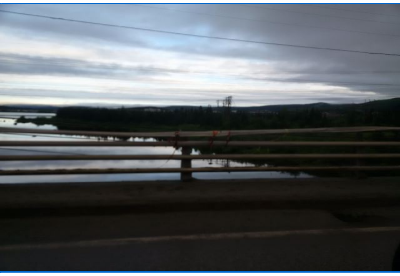
| Comments: | Expansion joints are leaking east and west. Surface rust flaking off the bottom flange of 2 beam from south side. | | |

| Comments: | Pothole developing in east end lane 0.6x0.4. Rebar exposed. 16 m, 32m and 3 uprights of handrail need to be addressed. |

| Recommendations: | Bridge office to determine replacement and cost. | | |
