GOVERNMENT OF NEWFOUNDLAND AND LABRADOR Department of Transportation and Infrastructure	BRIDGE INSPECTION REPORT B01222021-5	
Date: 5/20/2020	Inspected By: Terrance Coates	Category: Eng. - Engineering	
BRIDGE INFORMATION			
Site:	4-104 - CELLAR BROOK BRIDGE		
Route:	431	Overall Length:	29.8 m
Year Built:	1978	Est: Yes	Overall Width: 11.3 m
Year Last Rehab.:		Est: No	Roadway Width: 10.6 m
Region:	WEST COAST/NORTHERN		Sidewalk Width: 0 m
Jurisdiction:	Provincial	Clearance to R.D. or N.W.L.:	4 m
Type of Structure:	01 - AASH to Girder	Max Depth of N.W.L.:	0.4 m
Purpose of Structure:	03 - Over Navigable Waters		
Type of Handrail:	01 - Aluminum Rail	Spans:	
Roadway Surface:	02 - Asphalt	<u>Span No.:</u>	<u>Length</u>
Alignment Vertical:	01 - Good	1	20.8
Alignment Horizontal:	02 - Adequate	2	0
Restrictions:	No	3	0
		<u>Span No.:</u>	<u>Length</u>
		4	0
		5	0
		6	0
BRIDGE PHOTOS

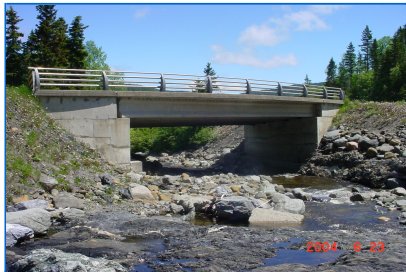
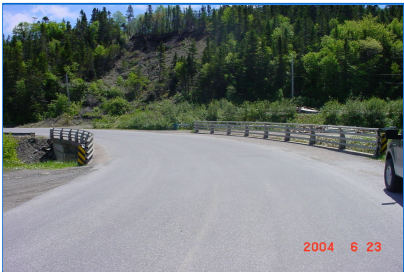
Bearing Seat:	G - Good
Comments:	Minor cracking in abutment walls. Deterioration in backwall with exposed rebar. Bearing pads have cracks in them.		
SUPERSTRUCTURE			
Condition:	P3 - Poor	Expansion Joints:	P3 - Poor
Comments:	Expansion joints have been paved over. Older style angle iron expansion joints. No end blocks on structure.		
DECK			
Condition:	F2 - Fair	Curbs:	I - Inapplicable
Hand Rail:	G - Good	Roadway Condition:	I - Inapplicable

Comments: 1 approach has 2 lengths of guide rail and a buried end. This rail is not structural rail and the buried end is damaged. Remaining 3 corners of structure do not have any approach rail. No curbs on structure. Due to grade of deck and no curbs the downstream side deck fascia and soffit is severely deteriorated with exposed rebar that is corroded. Upstream curb and fascia is in good condition.

Recommendations: Repair fascia and soffit. Construct new concrete curbs and end blocks. Install new deck drains. Install new handrail. Replace expansion joints. Install new structural approach rail. Install traffic barrier parallel to brook on corner where there is a driveway. Install hazard markers.
