GOVERNMENT OF NEWFOUNDLAND AND LABRADOR Department of Transportation and Infrastructure	<b>BRIDGE INSPECTION REPORT</b> <b>B01182021-2</b>	
<b>Date:</b> 5/27/2020	<b>Inspected By:</b> Mike Fleming	<b>Category:</b> Eng. - Engineering	
<b>BRIDGE INFORMATION</b>			
<b>Site:</b>	4-098 - COX'S COVE BRIDGE		
<b>Route:</b>	440	<b>Overall Length:</b>	23.7 m
<b>Year Built:</b>	1974	<b>Est:</b> No	<b>Overall Width:</b> 9.4 m
<b>Year Last Rehab.:</b>		<b>Est:</b> No	<b>Roadway Width:</b> 6.2 m
<b>Region:</b>	WEST COAST/NORTHERN		<b>Sidewalk Width:</b> 0 m
<b>Jurisdiction:</b>	Provincial	<b>Clearance to R.D. or N.W.L.:</b>	1.3 m
<b>Type of Structure:</b>	02 - Double Tee	<b>Max Depth of N.W.L.:</b>	0.3 m
<b>Purpose of Structure:</b>	03 - Over Navigable Waters		<b>Spans:</b>
<b>Type of Handrail:</b>	01 - Aluminum Rail	<u>Span No.:</u>	<u>Length</u>
<b>Roadway Surface:</b>	02 - Asphalt	1	16
<b>Alignment Vertical:</b>	02 - Adequate	2	0

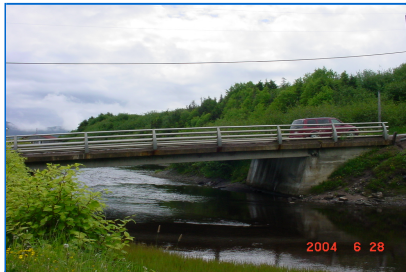
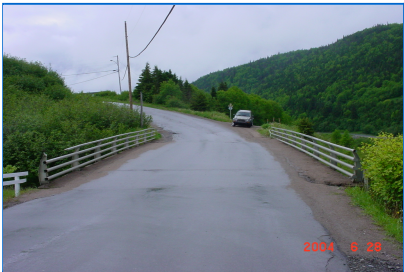
<b>SUBSTRUCTURE</b>			
<b>Condition:</b>	F2 - Fair	<b>Bearings:</b>	P3 - Poor
		<b>Bearing Seat:</b>	F2 - Fair
<b>Comments:</b>	Heavy efflorescence accumulation and moderate spalling on abutment walls. Deterioration noted on bearing seats.		
<b>SUPERSTRUCTURE</b>			
<b>Condition:</b>	P3 - Poor	<b>Expansion Joints:</b>	P1 - Poor
<b>Comments:</b>	Expansion joints paved over and leaking on abutments, section of approach slab damaged and moderate to severe corrosion to exposed reinforcement		
<b>DECK</b>			
<b>Condition:</b>	F2 - Fair	<b>Curbs:</b>	I - Inapplicable

<b>Hand Rail:</b>	P1 - Poor	<b>Roadway Condition:</b>	I - Inapplicable
<b>Approach Rail:</b>	P1 - Poor		
<b>Comments:</b>	Missing top handrail, no approach rail noted, no end block, no curb, driving surface rough, moderate spalling and delamination of soffit		
<b>HYDROLOGY</b>			
<b>Water Velocity:</b>	0 m/s	<b>Ice Problem:</b>	K - Known Problem
<b>Water Depth:</b>	0 m	<b>Scour Problem:</b>	P - Possible Problem
<b>Waterway:</b>	01 - Adequate	<b>Debris Problem:</b>	P - Possible Problem
<b>Comments:</b>			
<b>REPLACEMENT/REHABILITATION</b>			
<b>Next Rehab. Date:</b>	2021	<b>Replacement Year:</b>	2021
<b>Antic. Rehab. Cost:</b>	\$0	<b>Replacement Cost:</b>	\$0
<b>Recommendations:</b>	Replace handrail, install curb, end block, structural rail, repair soffit, deck repairs		
<b>OBSERVATIONS</b>			
<b>Overall Condition:</b>	P3 - Poor	<b>Requires Further Inspection:</b>	Yes
<b>Additional Observations:</b>	Winter-sand accumulation near rail buildup near rail, no bridge sign, inspect in one year. Inspections photos on file.
