GOVERNMENT OF NEWFOUNDLAND AND LABRADOR Department of Transportation and Infrastructure	BRIDGE INSPECTION REPORT B01212021-3																	
Date: 1/21/2021	Inspected By: Mike Fleming	Category: Eng. - Engineering																	
BRIDGE INFORMATION																			
Site:	4-167 - EAST BRANCH BRIDGE																		
Route:	422	Overall Length:	9.4 m																
Year Built:	1950	Est: No	Overall Width: 11.2 m																
Year Last Rehab.:		Est: No	Roadway Width: 10.7 m																
Region:	WEST COAST/NORTHERN		Sidewalk Width: 0 m																
Jurisdiction:	Provincial	Clearance to R.D. or N.W.L.:	3.3 m																
Type of Structure:	03 - Reinforced Concrete Beam/Slab		Max Depth of N.W.L.: 0.2 m																
Purpose of Structure:	03 - Over Navigable Waters		Spans:																
Type of Handrail:	02 - Concrete Rail

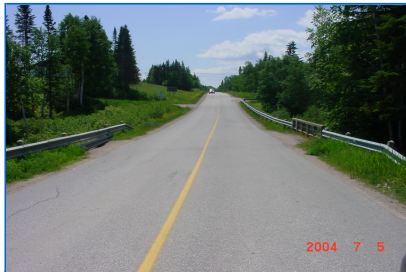
SUBSTRUCTURE																			
Condition:	P3 - Poor	Bearings:	I - Inapplicable																
		Bearing Seat:	I - Inapplicable																
Comments:	Cracking and spalling noted on abutments and wingwalls. Light scouring noted on the bottom of abutments.																		
SUPERSTRUCTURE																			
Condition:	P1 - Poor	Expansion Joints:	I - Inapplicable																
Comments:	Severely spalled and deteriorated fascia with exposed and moderately corroded reinforcement on the fascia.																		
DECK																			
Condition:	P1 - Poor	Curbs:	I - Inapplicable																
Hand Rail:	P - Poor	Roadway Condition:	I - Inapplicable

Approach Rail:	P3 - Poor		
Comments:	Guiderail installed for handrail on one side that is damaged creating an open cavity between the rail and the deck. Light amount of patched potholes noted on deck. Approach rail is damaged and leaning.		
HYDROLOGY			
Water Velocity:	0 m/s	Ice Problem:	N - No Problem
Water Depth:	0 m	Scour Problem:	K - Known Problem
Waterway:	01 - Adequate	Debris Problem:	P - Possible Problem
Comments:			
REPLACEMENT/REHABILITATION			
Next Rehab. Date:	2021	Replacement Year:	2021
Antic. Rehab. Cost:	\$0	Replacement Cost:	\$0
Recommendations:			
OBSERVATIONS			
Overall Condition:	P1 - Poor	Requires Further Inspection:	No
Additional Observations:	Hazard markers missing. Inspection pictures on file.		
LEGEND:			
Condition Definitions:		Problem Definitions:	
1 - *Good - [discontinued code].	F2 - Fair.	C - Unsafe (Closed to Public).	N - No Problem.
2 - *Fair - [discontinued code].	F1 - Fair.	U - Uninspectable.	P - Possible Problem.
