GOVERNMENT OF NEWFOUNDLAND AND LABRADOR Department of Transportation and Infrastructure	BRIDGE INSPECTION REPORT B01182021-6	
Date: 5/25/2020	Inspected By: Mike Fleming	Category: Eng. - Engineering	
BRIDGE INFORMATION			
Site:	4-100 - FAIRFAX BROOK BRIDGE		
Route:		Overall Length:	28.9 m
Year Built:	1978	Est: Yes	Overall Width: 11.4 m
Year Last Rehab.:		Est: No	Roadway Width: 10.4 m
Region:	WEST COAST/NORTHERN		Sidewalk Width: 0 m
Jurisdiction:	Provincial		Clearance to R.D. or N.W.L.: 5.1 m
Type of Structure:	02 - Double Tee		Max Depth of N.W.L.: 0.2 m
Purpose of Structure:	03 - Over Navigable Waters		Spans:
Type of Handrail:	01 - Aluminum Rail		<u>Span No.:</u> <u>Length</u> <u>Span No.:</u> <u>Length</u>
Roadway Surface:	02 - Asphalt		1 11.9 4 0
Alignment Vertical:	01 - Good		2 0 5 0
Alignment Horizontal:	02 - Adequate		3 0 6 0
Restrictions:	No		
BRIDGE PHOTOS			
<div style="display: flex; justify-content: space-around;">

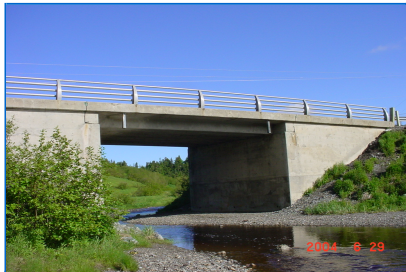
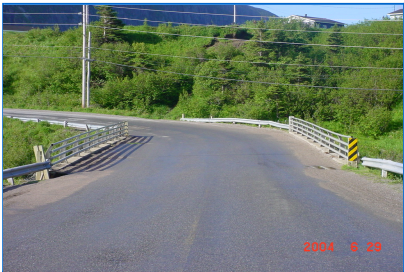
SUBSTRUCTURE			
Condition:	F2 - Fair	Bearings:	G - Good
		Bearing Seat:	G - Good
Comments:	Minor cracking and spalling on abutments. Minor spalling on underside of deck.		
SUPERSTRUCTURE			
Condition:	F2 - Fair	Expansion Joints:	I - Inapplicable
Comments:			
DECK			
Condition:	F2 - Fair	Curbs:	P1 - Poor
Hand Rail:	F2 - Fair	Roadway Condition:	P1 - Poor

Approach Rail:	P1 - Poor		
Comments:	Approach rail is in poor condition and needs to be replaced. Curb is heavily deteriorated with moderately corroded exposed rebar.		
HYDROLOGY			
Water Velocity:	0 m/s	Ice Problem:	P - Possible Problem
Water Depth:	0 m	Scour Problem:	P - Possible Problem
Waterway:	01 - Adequate	Debris Problem:	N - No Problem
Comments:			
REPLACEMENT/REHABILITATION			
Next Rehab. Date:	2021	Replacement Year:	2021
Antic. Rehab. Cost:	\$0	Replacement Cost:	\$0
Recommendations:	Install end blocks, repair curb, replace approach rail. Remove sand from curb, clean drains, install hazard markers.		
OBSERVATIONS			
Overall Condition:	F2 - Fair	Requires Further Inspection:	No
Additional Observations:	Inspection pictures on file.		
LEGEND:			
Condition Definitions:		Problem Definitions:	Category Definitions:
1 - *Good - [discontinued code].	F2 - Fair.	C - Unsafe (Closed to Public).	N - No Problem.
