GOVERNMENT OF NEWFOUNDLAND AND LABRADOR Department of Transportation and Infrastructure	<b>BRIDGE INSPECTION REPORT</b> <b>B01202021-9</b>	
<b>Date:</b> 5/20/2020	<b>Inspected By:</b> Terrance Coates	<b>Category:</b> Eng. - Engineering	
<b>BRIDGE INFORMATION</b>			
<b>Site:</b>	4-220 - FEEDER BROOK BRIDGE NORTH		
<b>Route:</b>		<b>Overall Length:</b>	12.3 m
<b>Year Built:</b>	1994	<b>Est:</b> No	<b>Overall Width:</b> 6.1 m
<b>Year Last Rehab.:</b>		<b>Est:</b> No	<b>Roadway Width:</b> 4.5 m
<b>Region:</b>	WEST COAST/NORTHERN	<b>Sidewalk Width:</b>	2.2 m
<b>Jurisdiction:</b>	Provincial	<b>Clearance to R.D. or N.W.L.:</b>	1.6 m
<b>Type of Structure:</b>	09 - Bailey Bridge	<b>Max Depth of N.W.L.:</b>	0 m
<b>Purpose of Structure:</b>	03 - Over Navigable Waters	<b>Spans:</b>	
<b>Type of Handrail:</b>	03 - Timber Rail	<u>Span No.:</u>	<u>Length</u>
<b>Roadway Surface:</b>	03 - Timber	1	12.3
<b>Alignment Vertical:</b>	01 - Good	2	0

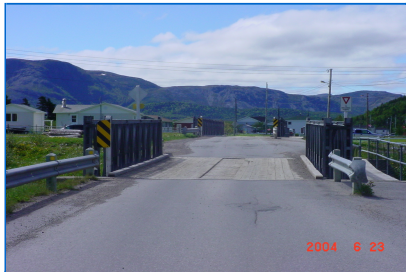
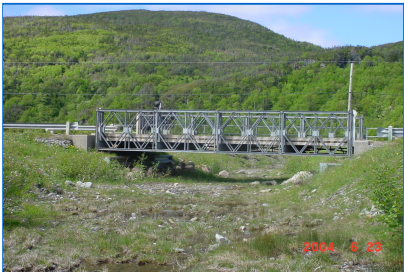
<b>SUBSTRUCTURE</b>			
<b>Condition:</b>	G - Good	<b>Bearings:</b>	G - Good
		<b>Bearing Seat:</b>	G - Good
<b>Comments:</b>	Bin walls rusting where winter sand/salt is coming down through the bailey bridge structure.		
<b>SUPERSTRUCTURE</b>			
<b>Condition:</b>	G - Good	<b>Expansion Joints:</b>	I - Inapplicable
<b>Comments:</b>	Some stringers are rusted.		
<b>DECK</b>			
<b>Condition:</b>	G - Good	<b>Curbs:</b>	F2 - Fair
<b>Hand Rail:</b>	F2 - Fair	<b>Roadway Condition:</b>	F2 - Fair

<b>Approach Rail:</b>	P1 - Poor		
<b>Comments:</b>	Timber deck. Handrail along sidewalk is damaged. Approach guide rail is damaged (not structural). Timber wheel guard is damaged. Asphalt deteriorating on approach.		
<b>HYDROLOGY</b>			
<b>Water Velocity:</b>	0 m/s	<b>Ice Problem:</b>	N - No Problem
<b>Water Depth:</b>	0 m	<b>Scour Problem:</b>	N - No Problem
<b>Waterway:</b>	01 - Adequate	<b>Debris Problem:</b>	N - No Problem
<b>Comments:</b>			
<b>REPLACEMENT/REHABILITATION</b>			
<b>Next Rehab. Date:</b>	2021	<b>Replacement Year:</b>	2021
<b>Antic. Rehab. Cost:</b>	\$0	<b>Replacement Cost:</b>	\$0
<b>Recommendations:</b>	Repair timber wheel guard. Install hazard markers. Replace sidewalk handrail. Repair asphalt on approaches.		
<b>OBSERVATIONS</b>			
<b>Overall Condition:</b>	G - Good	<b>Requires Further Inspection:</b>	No
<b>Additional Observations:</b>			
<b>LEGEND:</b>			
<b>Condition Definitions:</b>		<b>Problem Definitions:</b>
