GOVERNMENT OF NEWFOUNDLAND AND LABRADOR Department of Transportation and Infrastructure	BRIDGE INSPECTION REPORT B07202021-2	
Date: 7/8/2021	Inspected By: McCaw J	Category: Eng. - Engineering	
BRIDGE INFORMATION			
Site:	4-042 - GILES' BROOK BRIDGE		
Route:	420	Overall Length:	36.1 m
Year Built:	1962	Est: No	Overall Width: 8.8 m
Year Last Rehab.:		Est: Yes	Roadway Width: 7.3 m
Region:	WEST COAST/NORTHERN		Sidewalk Width: 0 m
Jurisdiction:	Provincial	Clearance to R.D. or N.W.L.:	7.2 m
Type of Structure:	01 - AASH to Girder	Max Depth of N.W.L.:	0 m
Purpose of Structure:	03 - Over Navigable Waters		
Type of Handrail:	01 - Aluminum Rail	Spans:	
Roadway Surface:	02 - Asphalt	<u>Span No.:</u>	<u>Length</u>
Alignment Vertical:	01 - Good	1	23.7
Alignment Horizontal:	01 - Good	2	0
Restrictions:	No	3	0
		<u>Span No.:</u>	<u>Length</u>
		4	0
		5	0
		6	0
BRIDGE PHOTOS

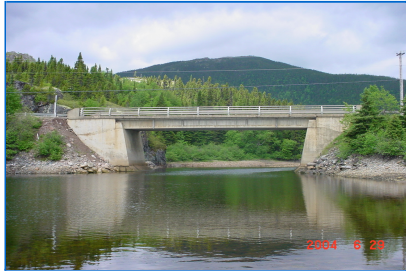
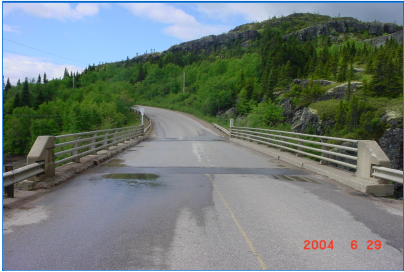
Bearing Seat:	F2 - Fair
Comments:	Abutments eroding near water mark. Lots of debris on bearing seats. Efflor. along walls.		
SUPERSTRUCTURE			
Condition:	F2 - Fair	Expansion Joints:	P3 - Poor
Comments:	Joints are leaking. Damage to expansion joints visible on road surface.		
DECK			
Condition:	F2 - Fair	Curbs:	P3 - Poor
Hand Rail:	P3 - Poor	Roadway Condition:	P3 - Poor

Approach Rail:	F2 - Fair		
Comments:	Curbs have spalling with rebar visible. Longitudinal crack visible on deck. Plow damage to rail.		
HYDROLOGY			
Water Velocity:	0.3 m/s	Ice Problem:	N - No Problem
Water Depth:	1.5 m	Scour Problem:	N - No Problem
Waterway:	01 - Adequate	Debris Problem:	N - No Problem
Comments:	Very steep slopes at wingwall which are susceptible to erosion.		
REPLACEMENT/REHABILITATION			
Next Rehab. Date:	2024	Replacement Year:	2050
Antic. Rehab. Cost:	\$300000	Replacement Cost:	\$4000000
Recommendations:	Install new curbs and bridge rail. Complete deck repairs and build out slopes. Hazards: Traffic, Slipping, Water		
OBSERVATIONS			
Overall Condition:	F2 - Fair	Requires Further Inspection:	No
Additional Observations:	Parking limited, required blocking of one traffic lane. Hazards: Traffic, Slipping, Water		
LEGEND:			
Condition Definitions:			
1 - *Good - [discontinued code].	F2 - Fair.	C - Unsafe (Closed to Public).	Problem Definitions:
