GOVERNMENT OF NEWFOUNDLAND AND LABRADOR Department of Transportation and Infrastructure	<b>BRIDGE INSPECTION REPORT</b> <b>B07202021-4</b>	
<b>Date:</b> 7/8/2021	<b>Inspected By:</b> McCaw J	<b>Category:</b> Eng. - Engineering	
<b>BRIDGE INFORMATION</b>			
<b>Site:</b>	4-123 - ROCKY BROOK BRIDGE (HAMPDEN)		
<b>Route:</b>	421	<b>Overall Length:</b>	9.6 m
<b>Year Built:</b>	1942	<b>Est:</b> Yes	<b>Overall Width:</b> 13.9 m
<b>Year Last Rehab.:</b>	1983	<b>Est:</b> Yes	<b>Roadway Width:</b> 7 m
<b>Region:</b>	WEST COAST/NORTHERN		<b>Sidewalk Width:</b> 0 m
<b>Jurisdiction:</b>	Provincial	<b>Clearance to R.D. or N.W.L.:</b>	7 m
<b>Type of Structure:</b>	04 - Rigid Frame	<b>Max Depth of N.W.L.:</b>	1 m
<b>Purpose of Structure:</b>	03 - Over Navigable Waters		<b>Spans:</b>
<b>Type of Handrail:</b>	06 - None	<u>Span No.:</u>	<u>Length</u>
<b>Roadway Surface:</b>	02 - Asphalt	<u>Span No.:</u>	<u>Length</u>

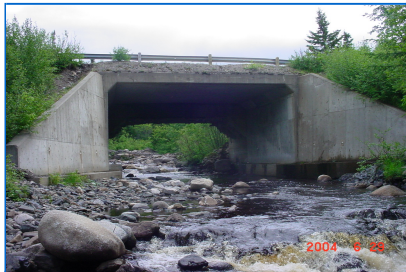
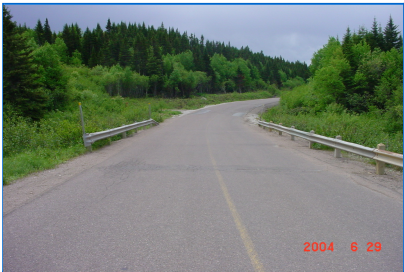
<b>SUBSTRUCTURE</b>			
<b>Condition:</b>	P3 - Poor	<b>Bearings:</b>	I - Inapplicable
		<b>Bearing Seat:</b>	I - Inapplicable
<b>Comments:</b>	Scour under the upstream footing. Masonry rock wall missing significant part on upstream side. Could present a falling hazard in the future.		
<b>SUPERSTRUCTURE</b>			
<b>Condition:</b>	F2 - Fair	<b>Expansion Joints:</b>	I - Inapplicable
<b>Comments:</b>	Older part of bridge still has formwork in place so it cannot be inspected. Deck is leaking between the old and new sections.		
<b>DECK</b>			
<b>Condition:</b>	F2 - Fair	<b>Curbs:</b>	I - Inapplicable
