GOVERNMENT OF NEWFOUNDLAND AND LABRADOR Department of Transportation and Infrastructure	<b>BRIDGE INSPECTION REPORT</b> <b>B01142021-1</b>	
<b>Date:</b> 5/7/2020	<b>Inspected By:</b> Terrance Coates	<b>Category:</b> Eng. - Engineering	
<b>BRIDGE INFORMATION</b>			
<b>Site:</b>	4-146 - SEAL BROOK BRIDGE		
<b>Route:</b>		<b>Overall Length:</b>	47.2 m
<b>Year Built:</b>	1978	<b>Est:</b> No	<b>Overall Width:</b> 10.9 m
<b>Year Last Rehab.:</b>		<b>Est:</b> No	<b>Roadway Width:</b> 10.5 m
<b>Region:</b>	WEST COAST/NORTHERN		<b>Sidewalk Width:</b> 0 m
<b>Jurisdiction:</b>	Provincial		<b>Clearance to R.D. or N.W.L.:</b> 4.5 m
<b>Type of Structure:</b>	01 - AASH to Girder		<b>Max Depth of N.W.L.:</b> 0.5 m
<b>Purpose of Structure:</b>	03 - Over Navigable Waters		<b>Spans:</b>
<b>Type of Handrail:</b>	01 - Aluminum Rail		<u>Span No.:</u> <u>Length</u> <u>Span No.:</u> <u>Length</u>
<b>Roadway Surface:</b>	01 - Concrete		1            31.3    4            0

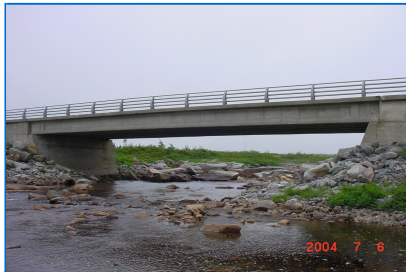
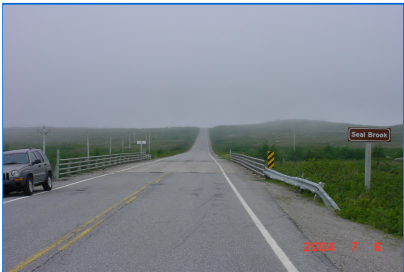
<b>SUBSTRUCTURE</b>			
<b>Condition:</b>	G - Good	<b>Bearings:</b>	G - Good
		<b>Bearing Seat:</b>	G - Good
<b>Comments:</b>	Rehab done in 2018.		
<b>SUPERSTRUCTURE</b>			
<b>Condition:</b>	G - Good	<b>Expansion Joints:</b>	U - Uninspectable
<b>Comments:</b>	No visible mechanical joints.		
<b>DECK</b>			
<b>Condition:</b>	G - Good	<b>Curbs:</b>	G - Good
<b>Hand Rail:</b>	G - Good	<b>Roadway Condition:</b>	G - Good

<b>Approach Rail:</b>	G - Good		
<b>Comments:</b>	Asphalt on deck deteriorating.		
<b>HYDROLOGY</b>			
<b>Water Velocity:</b>	0 m/s	<b>Ice Problem:</b>	K - Known Problem
<b>Water Depth:</b>	0 m	<b>Scour Problem:</b>	P - Possible Problem
<b>Waterway:</b>	01 - Adequate	<b>Debris Problem:</b>	N - No Problem
<b>Comments:</b>			
<b>REPLACEMENT/REHABILITATION</b>			
<b>Next Rehab. Date:</b>	2021	<b>Replacement Year:</b>	2021
<b>Antic. Rehab. Cost:</b>	\$0	<b>Replacement Cost:</b>	\$0
<b>Recommendations:</b>	Remove winter sand build-up along curbs. Repair 1 hazard marker. Repair deteriorated asphalt on deck.		
<b>OBSERVATIONS</b>			
<b>Overall Condition:</b>	G - Good	<b>Requires Further Inspection:</b>	No
<b>Additional Observations:</b>			
<b>LEGEND:</b>			
<b>Condition Definitions:</b>			
1 - *Good - [discontinued code].	F2 - Fair.	C - Unsafe (Closed to Public).	<b>Problem Definitions:</b>
2 - *Fair - [discontinued code].	F1 - Fair.	U - Uninspectable.	N - No Problem.
