# TECHNICAL MEMO

Prepared By: Water Resources Management Division (WRMD)Date: March 2022Re: Animal Burrows on Earthen Dams

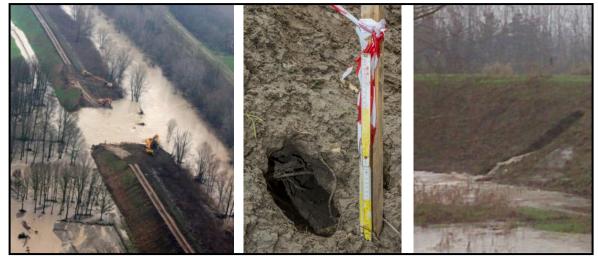
Figure 3 – Left: Significant breach on the Panaro riverbank (Italy) in 2014. The area was known to have significant animal burrows. Middle: Badger footprints and a burrow entrance were observed in 2010 and 2012 at the same area as the breach (left). Right: On the same day as the breach (left), internal erosion caused a smaller breach in an area downstream, which also had animal burrows. Images retrieved from Taccari, 2015, pg. 25 & 134.

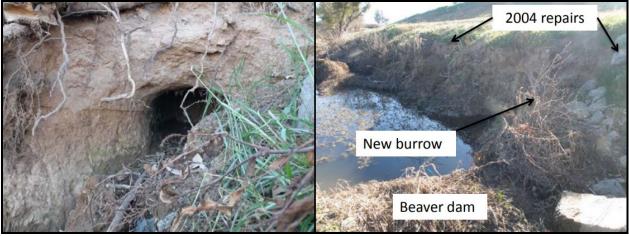
These methods are generally less intrusive on ecosystems, and do not specifically impact nontarget wildlife. In some cases, it may be too expensive or impractical to implement ongoing nonlethal control. Additionally, there is no guarantee that the measures undertaken will be effective, Figure 6 shows the reoccurrence of a beaver dam in an area which had previously had nonlethal removal and structural repair.

Figure 6 – Left: Entrance to a beaver burrow coincides with tree root (bottom of image), other exposed roots also visible. Right: Reoccurrence of intrusion after a previous repair was completed. Image retrieved from Roa et al, 2014, pg. 41.
