**Exploration Programme, Summer 2008
Archaeological Survey**

**NEW MILLENNIUM
CAPITAL CORP.**

DIRECT-SHIPPING ORE PROJECT

November 2008

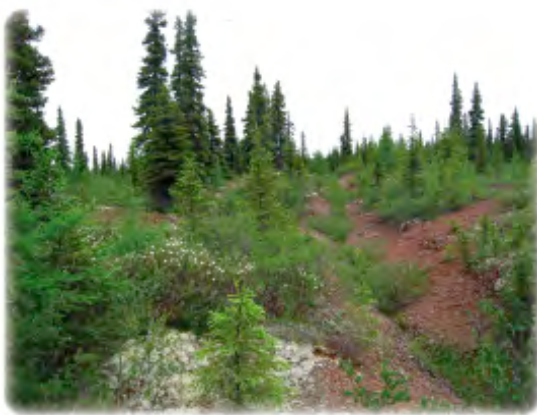
Photo 1 - Overview of the Star Creek 2 area illustrating a trench - View towards the north-east (SCHEFF-08-N1-96)

The overall area shows obvious signs of major humanly-induced disturbances that have significantly altered the integrity of the surface deposits. Long scars (trenches) as deep as 2 m (Photo 1) were observed. These trenches seem to have been dug several decades ago, most likely in the context of a mining operation. Overall, Star Creek 2 presents an irregular microtopography that generally slopes steeply towards the shore of Star Lake (Photo 2). Generally thick, the vegetation is composed mainly of spruce and alder. The drainage is deficient in some places, especially in the southeast part of the area.

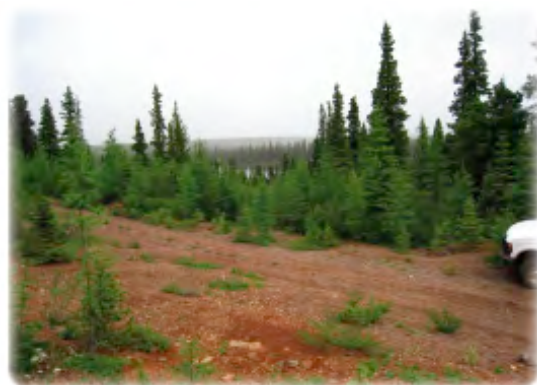
Photo 2 - Overview of the Star Creek 2 area with Star Lake in the center of the photo - View towards the north-east (SCHEFF-08-N1-99)

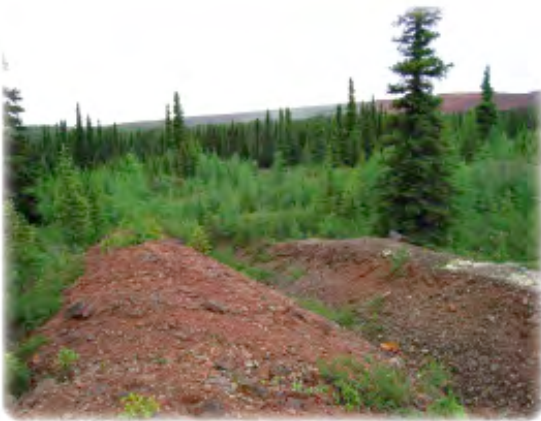
Photo 3 - Overview of the Ferriman 4 area illustrating trenches associated with mining operations - View towards the south-east (SCHEFF-08-N1-93)

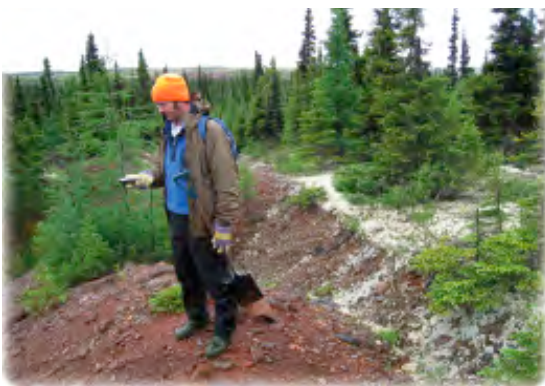
Photo 4 - Overview of the Ferriman 4 area with evidence of old trenching associated with mining operations - View towards the south-west (SCHEFF-08-N1-95)

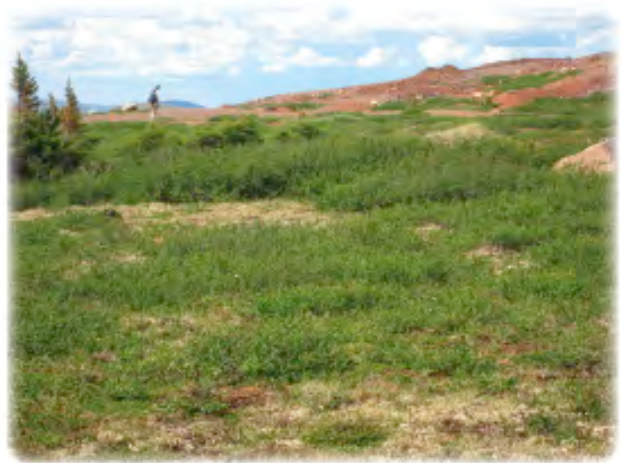
The Fleming 7N area (Figure 3) runs alongside the southwest side of a hill that shows signs of disturbance from former mining operations (Photo 5). In fact, the entire Fleming 7N area seems to have been seriously disturbed by such activities. The underdeveloped plant cover consists exclusively of moss, sphagnum and some small shrubs. No mature trees were observed. The topography is generally flat while the microtopography is hummocky as a result of previous mining operations. The bedrock is exposed throughout the area. Blocks measuring approximately one metre can also be seen in some places.

Photo 5 - Overview of the Fleming 7N area with hill on top right - View towards the north (SCHEFF-08-N1-24)

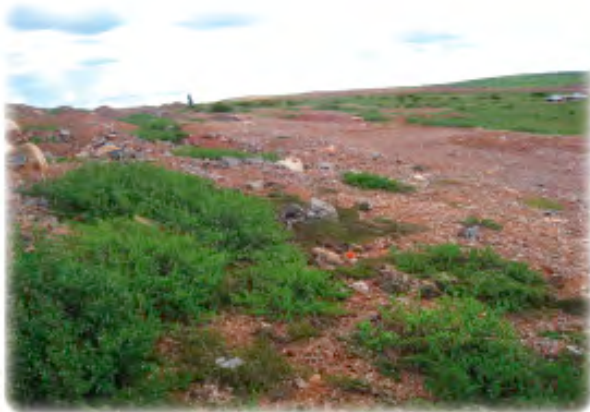
Photo 6 - Overview of the Fleming 7N area with a trench in the foreground - View towards the south (SCHEFF-08-N1-28)

The area that was surveyed measured approximately 750 m (on a north-west/south-east axis) by 100 m (on a north-east/south-west axis). Numerous trenches, generally shallow (less than one meter), criss-cross the surface (Photo 6). Test-pitting was deemed unnecessary, but the entire area was subjected to a systematic visual inspection. No evidence associated with former human occupation was noted.

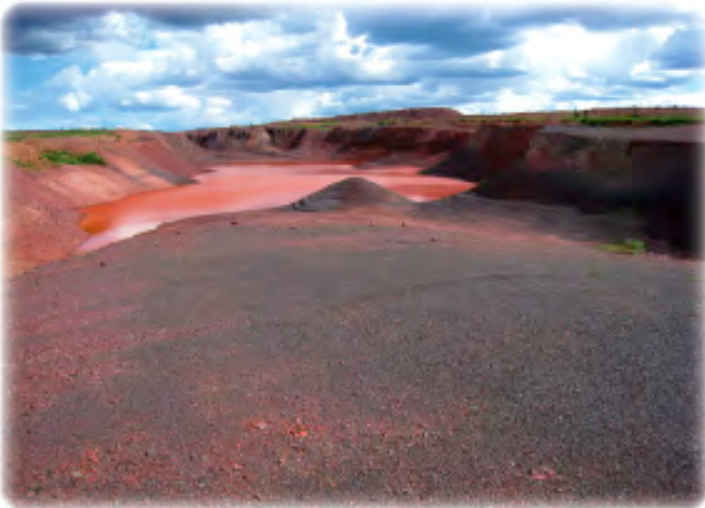
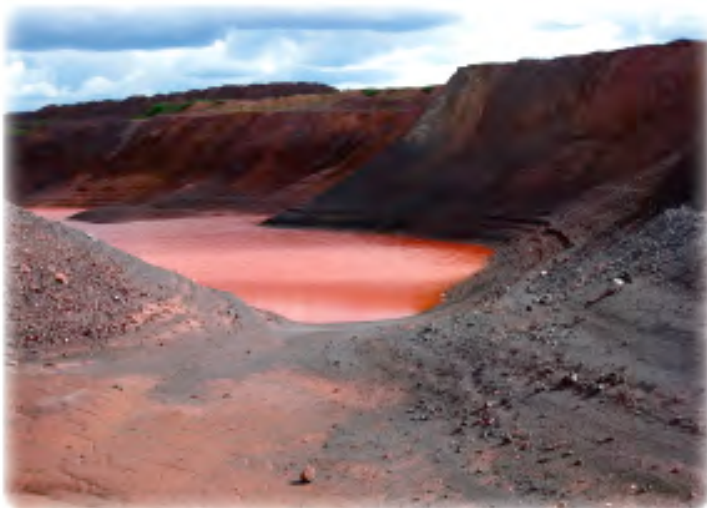
The Timmins 3N area (Figure 3) corresponds to a mine pit that is filled with water and bordered on each side by piles of waste rock originating from the pit (Photos 7 and 8). No vegetation was observed on the surface, and a quick visual inspection was deemed sufficient. No evidence of former human activities was observed within the limits of this area, which measured approximately 750 m x 100 m.

Photo 7 - Overview of the Timmins 3N area - View towards the south (SCHEFF-08-N1-29)

Photo 8 - Overview of the Timmins 3N area - View towards the south (SCHEFF-08-N1-32)

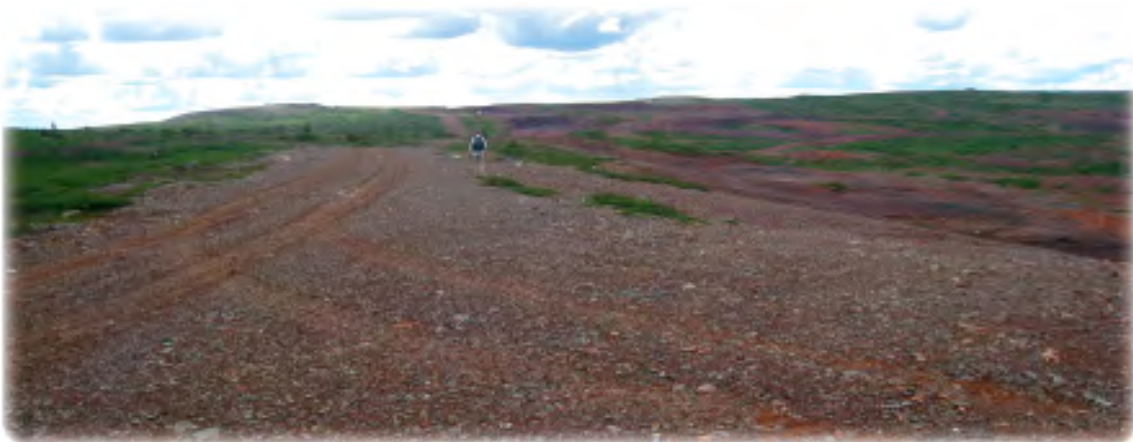
Photo 9 - Overview of the Timmins 7 area - View towards the south-east (SCHEFF-08-N1-10)

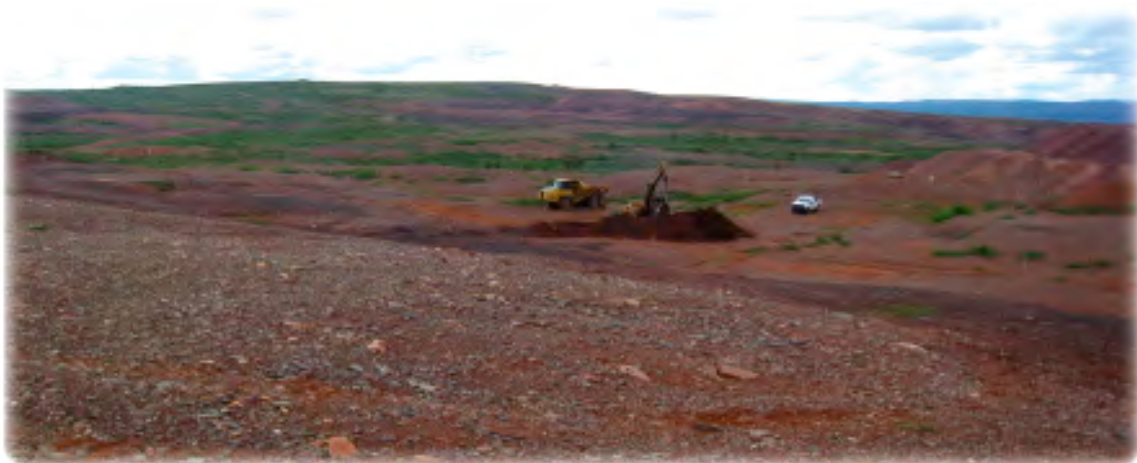
Photo 10 - Overview of the Timmins 7 area with a shovel taking a sample - View towards the south (SCHEFF-08-N1-11)

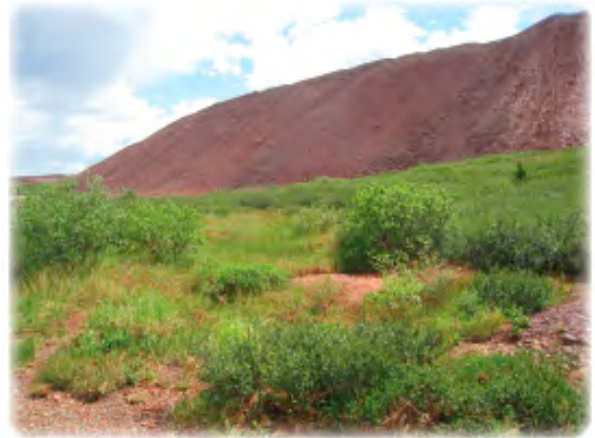
The Timmins 8 area is small, measuring about 180 m (on a north-west/south-east axis) by 75 m (on an east-west axis) (Figure 3). Once again, the environment was completely disturbed by mining activities that took place in the early 1980s (Photo 11). A thin layer of vegetation has grown back (sphagnum and small shrubs) on a soil consisting almost entirely of small stones and blocks measuring roughly 10 cm. The area is adjacent to a huge pile of waste rock (Photo 11). Numerous wide trenches, generally oriented north-west/south-east, were observed (Photo 12).

Photo 11 - Overview of the Timmins 8 area with a huge pile of fill - View towards the south-west (SCHEFF-08-N1-19)

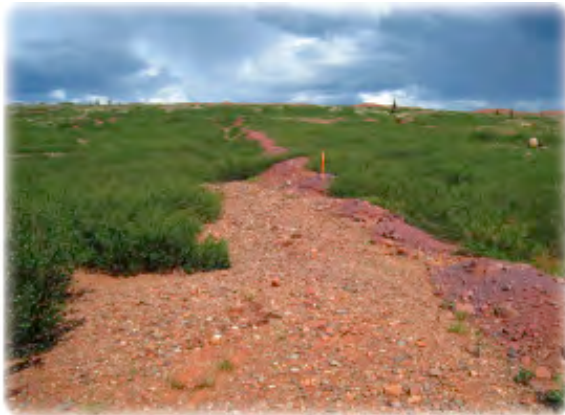
Photo 12 - Overview of the Timmins 8 area with a trench (old operation and stake) - View towards the east (SCHEFF-08-N1-16)

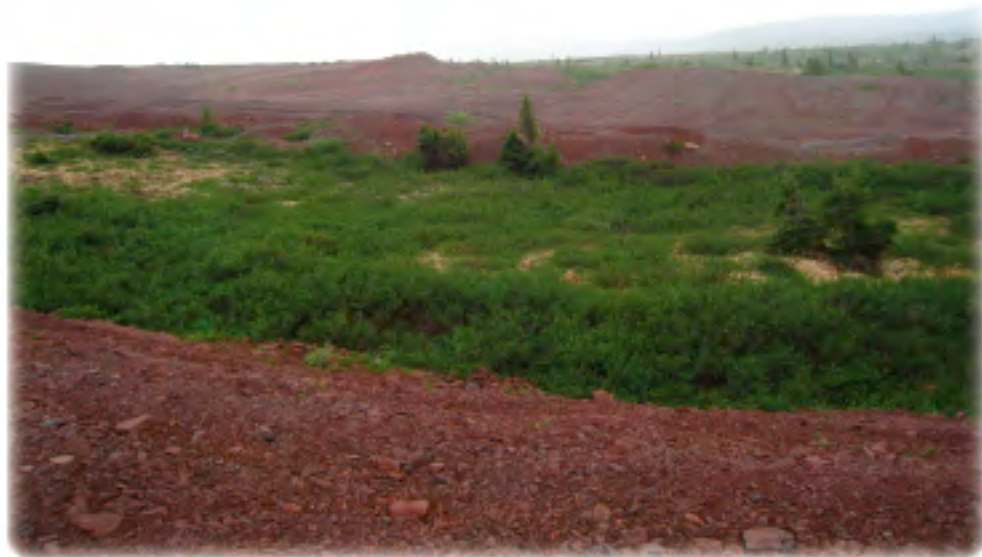
The Timmins 4 area is rather large, covering 800 m (on a north-west/south-east axis) by 175 m (on an east/west axis) (Figure 4). As in the case of Timmins 8, this large area presents an environment completely disturbed by mining activities that most likely took place in the 1980s (Photo 13). These activities are still underway, since machinery was observed close to the access road. The underdeveloped vegetation consists of a thin layer of sphagnum with scattered shrubs. The soil is almost entirely gravel, and practically no humus layer has developed on the rock surfaces exposed by mining. Clearly influenced by mining operations, the topography observed is flat, and the microtopography is hummocky.

Photo 13 - Overview of the Timmins 4 area - View towards the south-west (SCHEFF-08-N1-92)

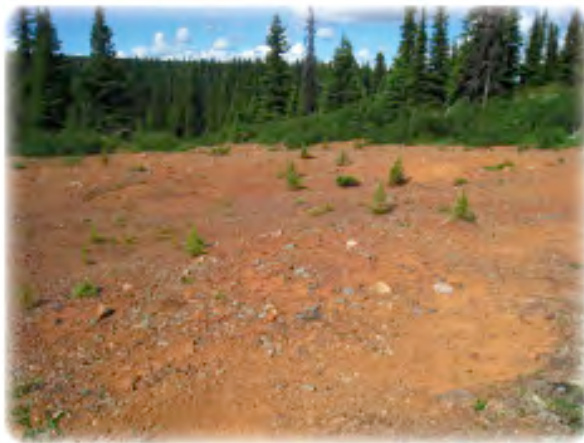
The Barney 2 area measures approximately 260 m (on a north-west/south-east axis) by 100 m (on an east-west axis) (Figure 4). Generally, the vegetation has re-grown very little on a surface that was obviously completely disturbed by mining operations in the 1980s (Photo 14). Large areas free of vegetation showed that the soil consists of pebbles mixed with red sand. Many long, mechanically excavated trenches were also observed (Photo 15). It is to be noted that the area is located on the eastern slope of a densely wooded small valley where, according to the geologist of New Millennium, chert outcrops are visible on the surface.

Photo 14 - Overview of the Barney 2 area, exposed part - View towards the west (SCHEFF-08-N1-03)

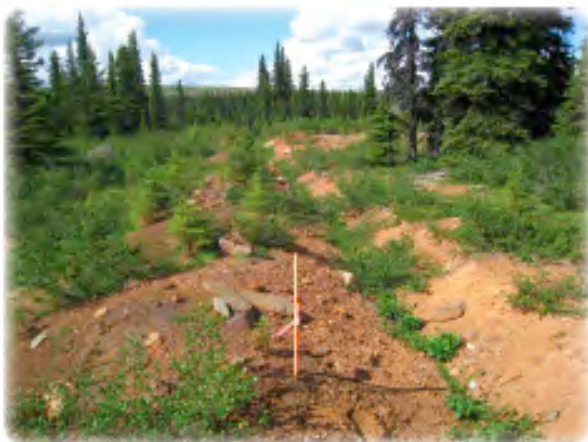
Photo 15 - Overview of the Barney 2 area, end of the area with a trench and stakes H and I - View towards the west (SCHEFF-08-N1-04)

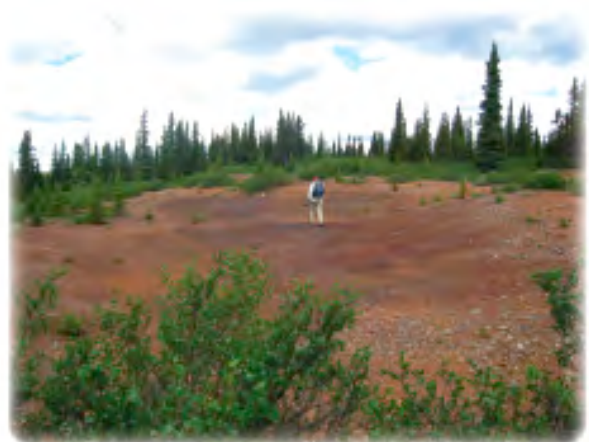
Test pits (N = 8) measuring 50 cm x 50 cm were dug in certain areas that appeared less disturbed. The stratigraphy observed revealed a sequence of a surface layer of peat 5 to 8 cm thick, followed by a very poorly developed layer of Ah humus (1 to 2 cm), which rested upon an orange sand mixed with pebbles. Generally, the depth reached was about thirty centimetres. The results of these test pits, combined with a systematic visual inspection (Photo 16), showed no evidence associated with former human occupation.

Photo 16 - Overview of the Barney 2 area - View towards the north (SCHEFF-08-N1-06)

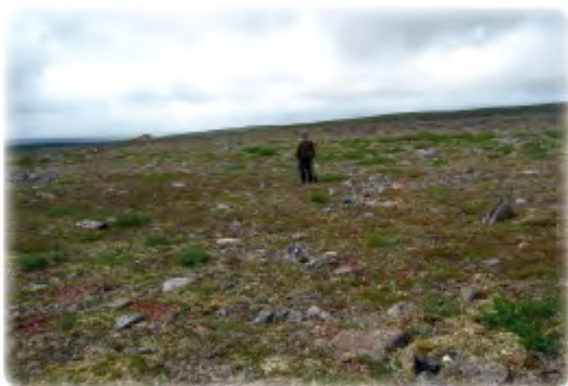
Photo 17 - Overview of the Sunny 1 area - View towards the south-west (SCHEFF-08-N1-68)

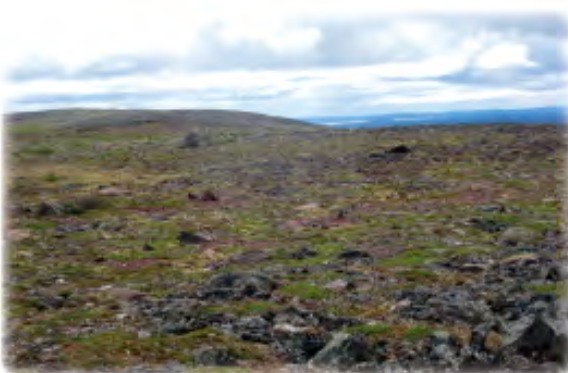
Photo 18 - Overview of the Sunny 1 area - View towards the north-east (SCHEFF-08-N1-71)

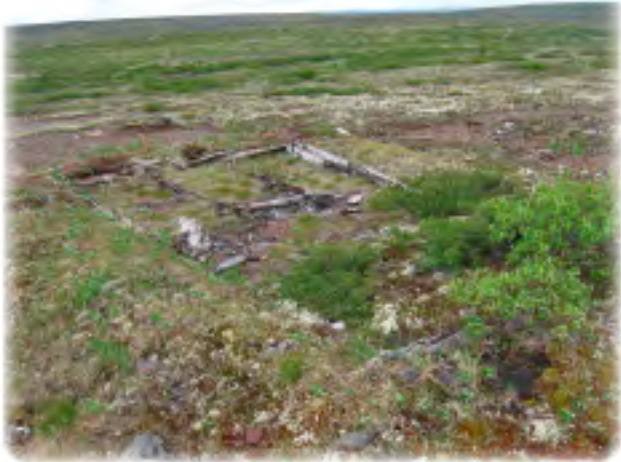
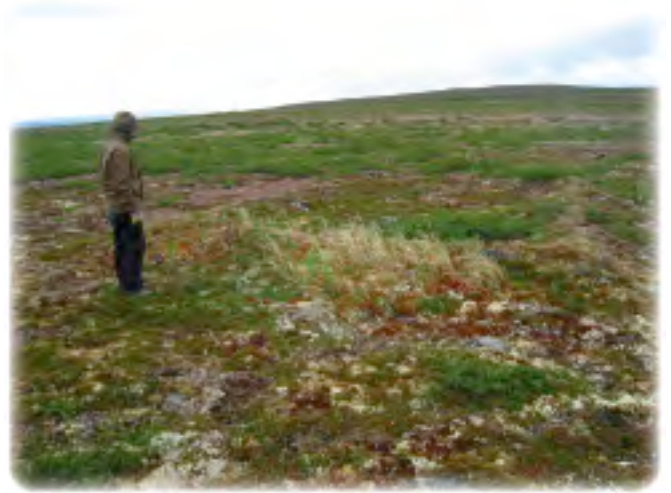
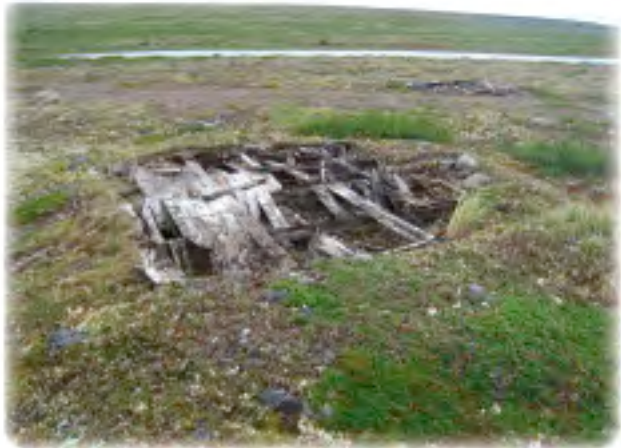
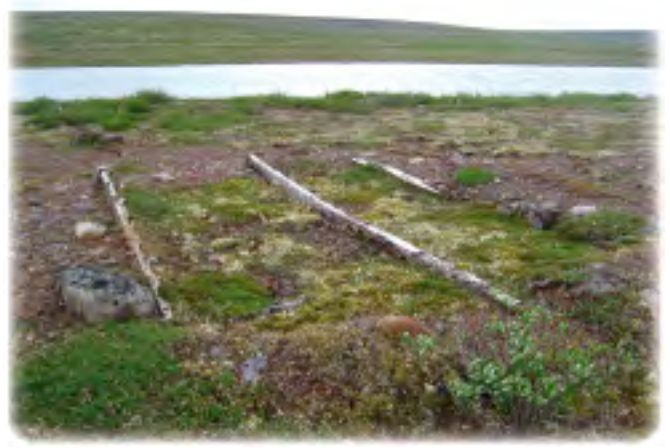
No test-pitting was deemed necessary, since the accumulation of soil is practically nil. The visual inspection revealed a small *inuksuk* made of three flat stones. No other traces of former anthropogenic activities were observed within the limits of this zone. However, the presence of a former mining camp must be mentioned; it consisted of approximately twenty tent structures spread out along either side of the secondary access road (Figure 5). Since it was located outside the limits of Sunny 1, no plan was drawn. The remains are what is left of a camp probably dating from the 1940s or 1950s (Photos 19 to 22). Generally, it shows evidence of the foundations of tent structures with

wooden floors resting on logs. The walls were probably made of white canvas. In most cases, earth bunds of approximately 7 m x 5 m delineated the shape of the tents. Many construction items were observed, including spiral nails, fragments of stove pipes, fragments of various metals, etc.

Photos 19, 20, 21 and 22 - Sunny 1 area - Old drilling camp, Foggy Lake (SCHEFF-08-N1-83, SCHEFF-08-N1-77, SCHEFF-08-N1-85 and SCHEFF-08-N1-75)

An abandoned former mining camp dating from the 1940s or the 1950s was found near the Sunny 1 area. While it is located outside of the limits of this area, it is desirable that its integrity not be disturbed by future field work. In addition, we recommend that an historical and photographic study be undertaken to record the history of this site for future generations.

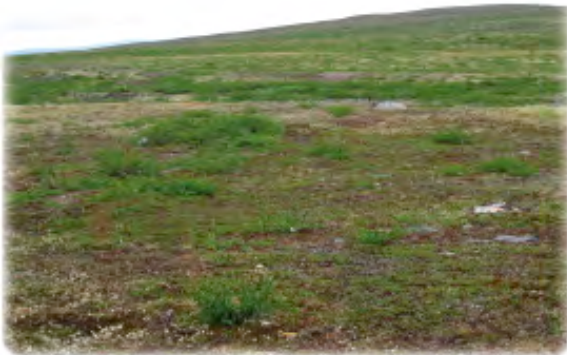
The Kivivik 3N/3S area measures approximately 900 m (on its north-west/south-east axis) by approximately 150 m (on its east-west axis) (Figure 5). Characterised by a topography varying from flat to hummocky (Photo 23), this area does not appear to have been disturbed in the past. It is bordered to the west by a valley, and to the east by a secondary access road (Photo 24). The southern half of the area is badly drained, which creates a rather marshy zone. The northern part is well drained. Shrub vegetation is completely absent, while the sparse plant cover is made of sphagnum and caribou moss.

Photo 23 - Overview of the Kivivik 3N/3S area with survey stake - View towards the south-west (SCHEFF-08-N1-62)

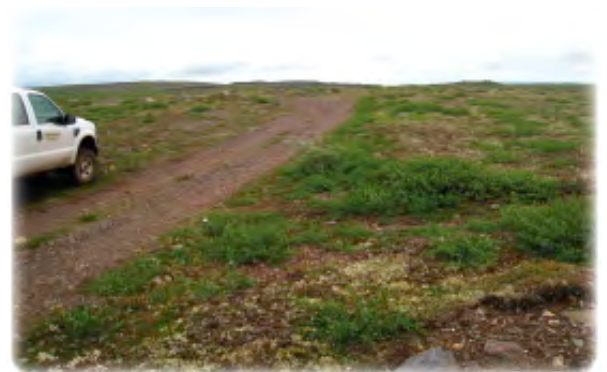
Photo 24 - Overview of the Kivivik 3N/3S area with a truck and access road - View towards the south (SCHEFF-08-N1-64)

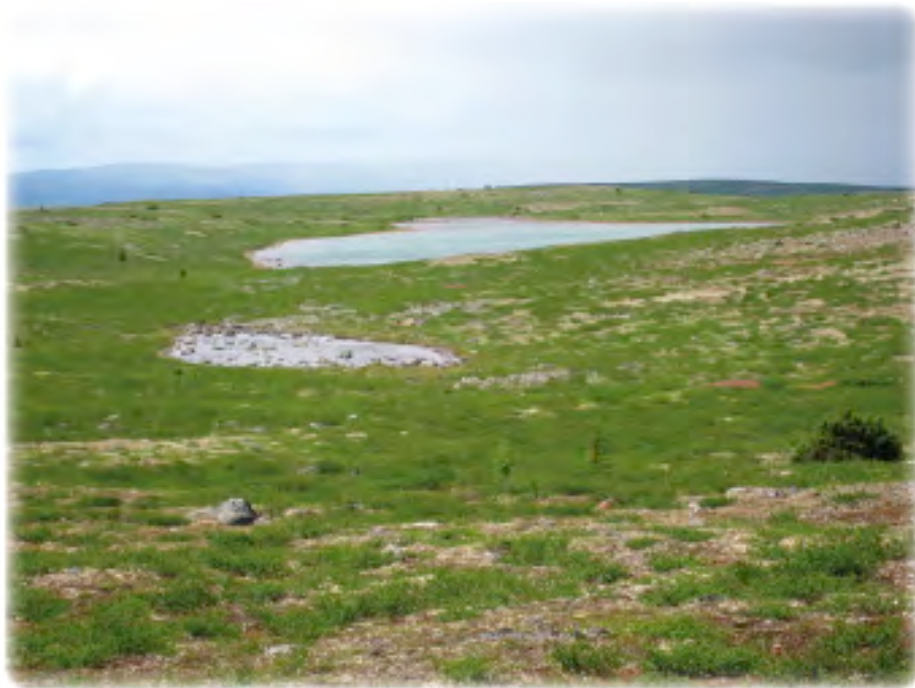
The limits of the Kivivik 4 area extend a little over one kilometre (on a north-west/south-east axis) by approximately 175 m (on an east/west axis) (Figure 5). The area is characterised by the presence of an unnamed lake in its northern part and a small pond in its southern part (Photo 25). The remaining of the area is rather poorly drained. Overall, the topography observed slopes gently towards the lake shore. The microtopography is hummocky with a few benches. Erratic blocks are visible everywhere, and some fields of boulders were also observed. The surface plant cover is very sparse, and a few small shrubs are present. No evidence of anthropogenic disturbance related to mining operations was observed. Some caribou bones as well as a trail that these animals have used for generations were noted.

Photo 25 - Overview of the Kivivik 4 area - View towards the north-east (SCHEFF-08-N1-88)

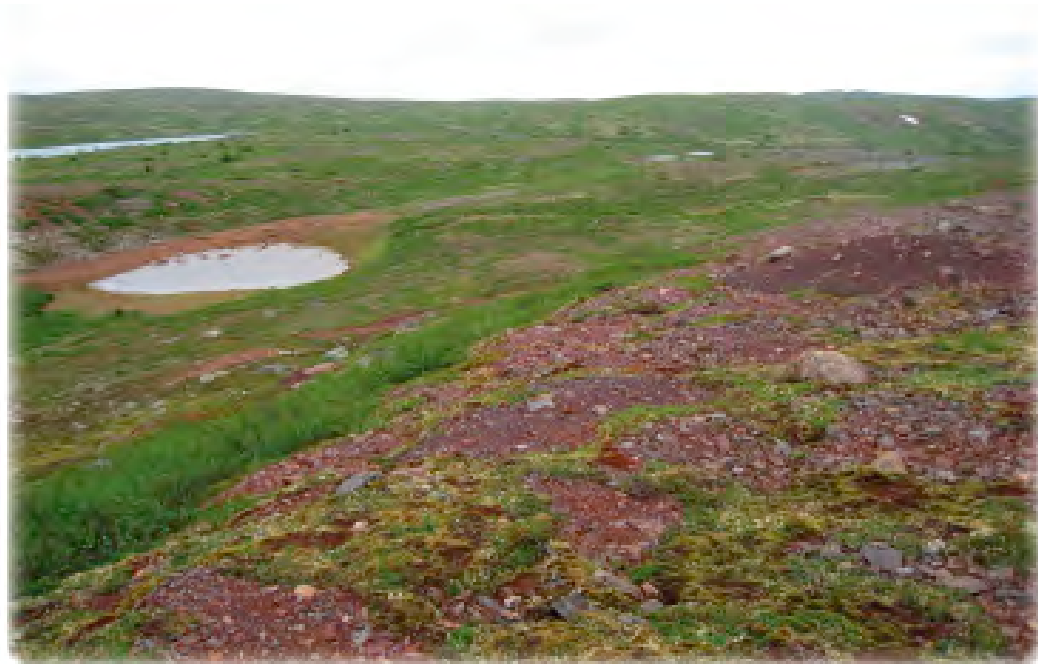
Photo 26 - Overview of the Kivivik 5 area - View towards the south-west (SCHEFF-08-N1-58)

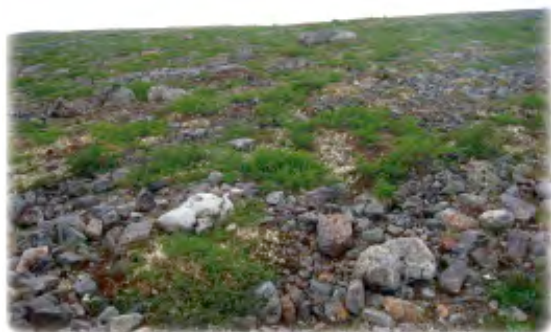
Photo 27 - Overview of the Kivivik 2 area, northern part - View towards the north-west (SCHEFF-08-N1-49)

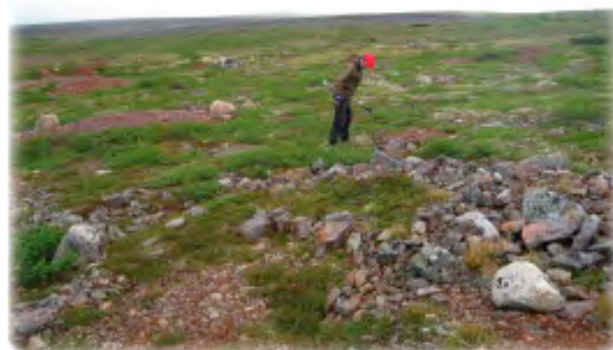
Borehole trenches and piles of waste rock were the main evidence of humanly-induced disturbance, which probably occurred in the early 1980s (Photo 28). No test-pitting was deemed necessary in such an environment, and the systematic visual inspection revealed no evidence of former human occupation.

Photo 28 - Overview of the Kivivik 2 area, northern part - View towards the south-west (SCHEFF-08-N1-51)

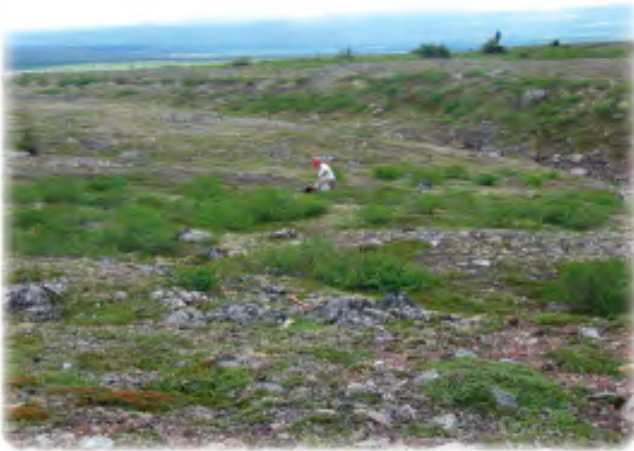
Photo 29 - Overview of the Goodwood area, northern part, west side of the road - View towards the south-west (SCHEFF-08-N1-33)

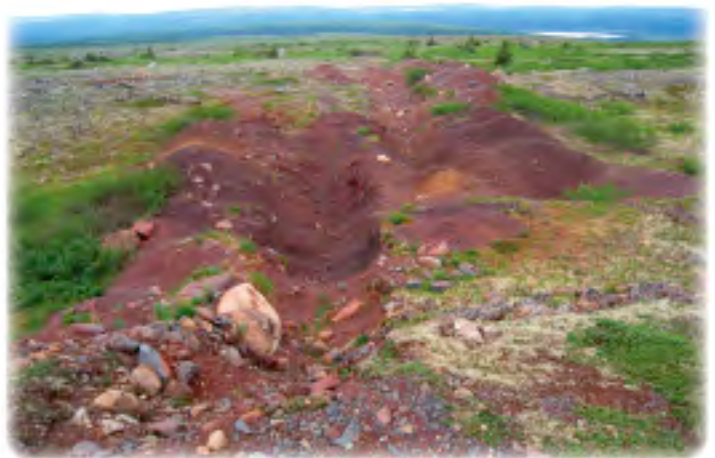
Numerous traces of anthropogenic disturbance related to mining activities were noted (Photo 30). Indeed, trenches, test pits and piles of waste rock were visible almost everywhere. No test-pitting was deemed necessary. The visual inspection showed no indications of the former occupation of this area. Many chert nodules of various colours (black, grey, red, green) were observed. None of them showed traces of human use.

Photo 30 - Overview of the Goodwood area, northern part, west side of the road with trench and stake H - View towards the south-west (SCHEFF-08-N1-40)
