## **COMPLETION REPORT**

Grading, Compaction, and Interim Cover of Former Upper Trinity South Waste Disposal Site New Harbour, NL

March 2012

AMEC Project No. TF1112732

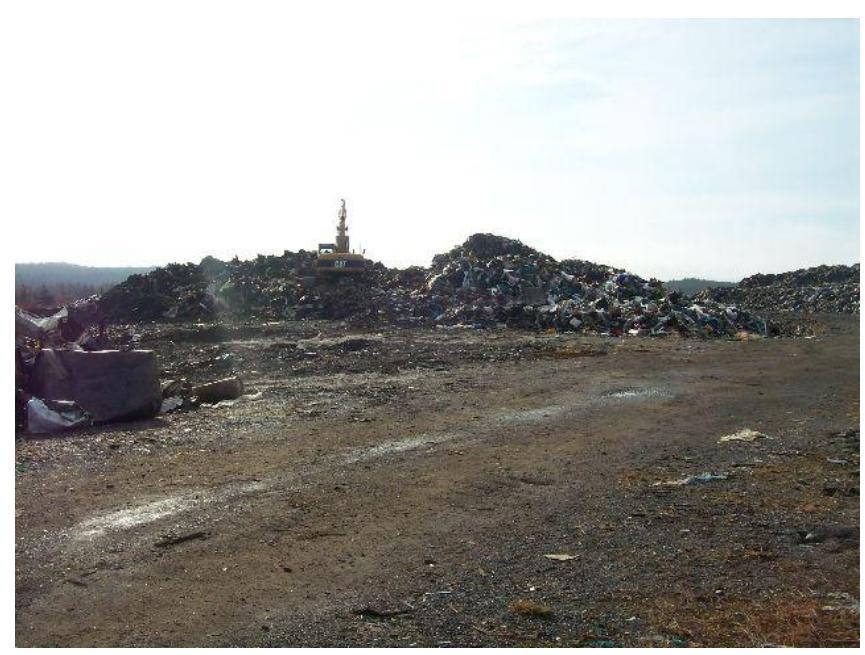
Photo 1 – West waste stockpile (Nov 14)

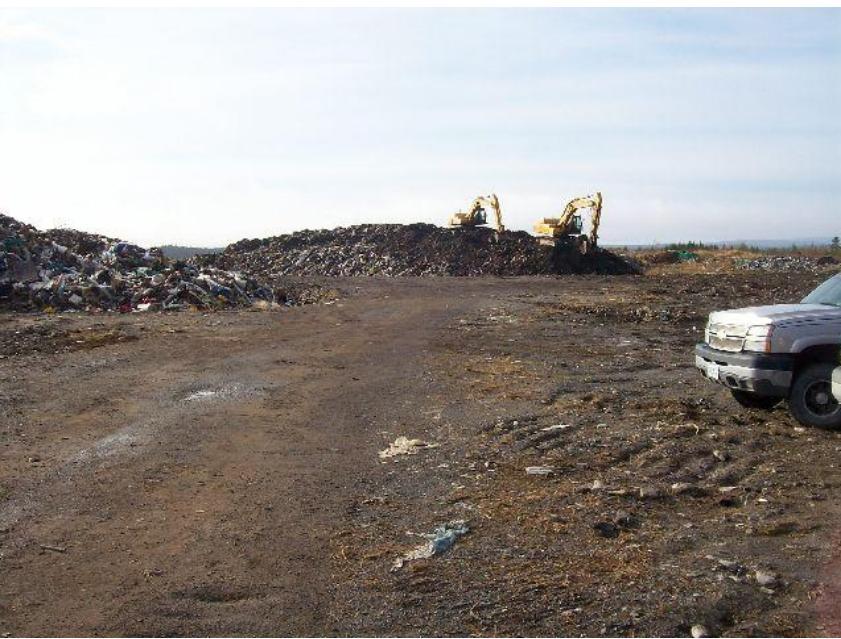
Photo 2 – East waste stockpile (Nov 14)

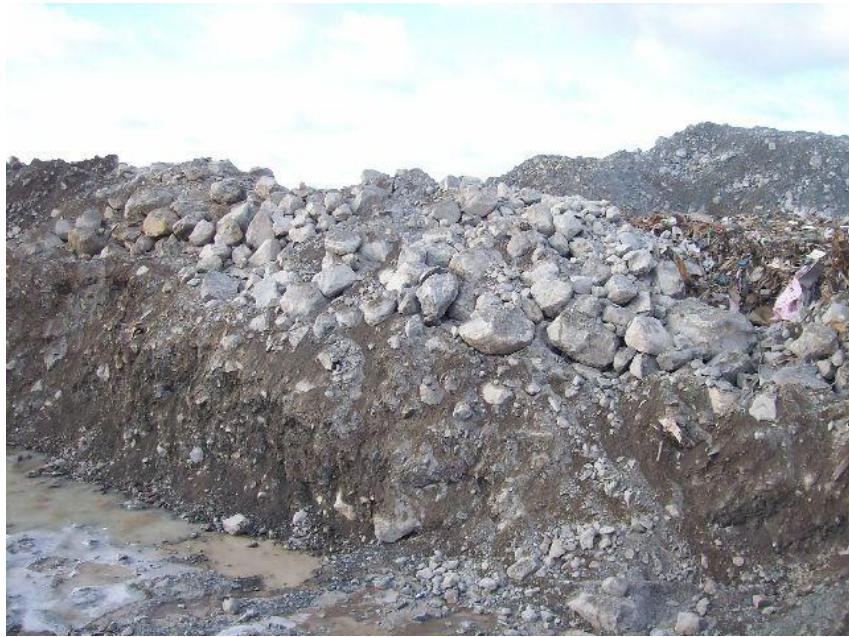
Numerous boulders (some as large as 2 m<sup>3</sup>) were encountered throughout the borrow areas. These boulders had not been previously identified and were not addressed in the tender. Care was exercised during excavation and placement to ensure that no boulders larger than 0.5 m in diameter were placed within the cover. The oversize boulders were temporarily stockpiled throughout the site and subsequently disposed of in the base of the secondary borrow source, adjacent to the access road, and covered with soil.

Photo 14 – Typical boulders encountered during trench excavation (Nov 22)

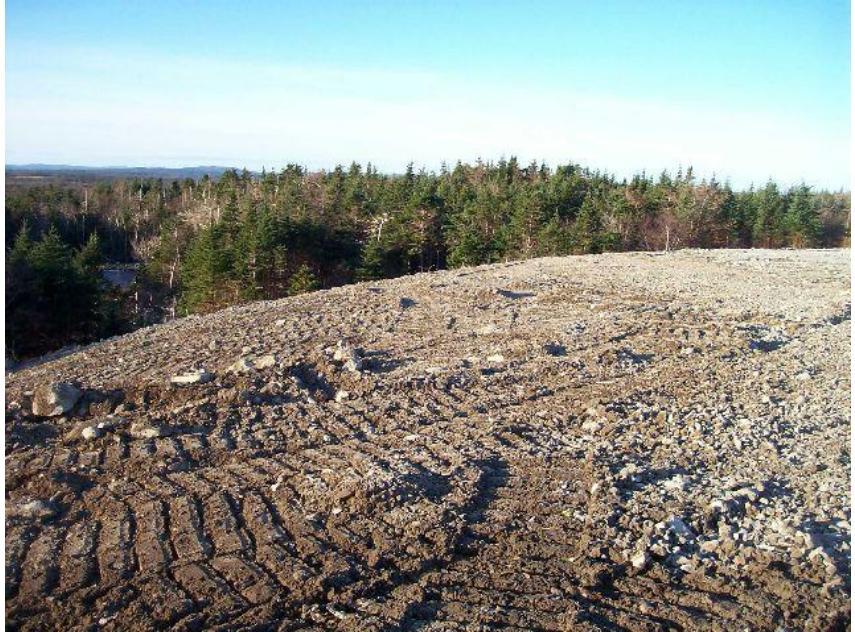
Photo 18 – South slope covered and compacted (Nov 23)

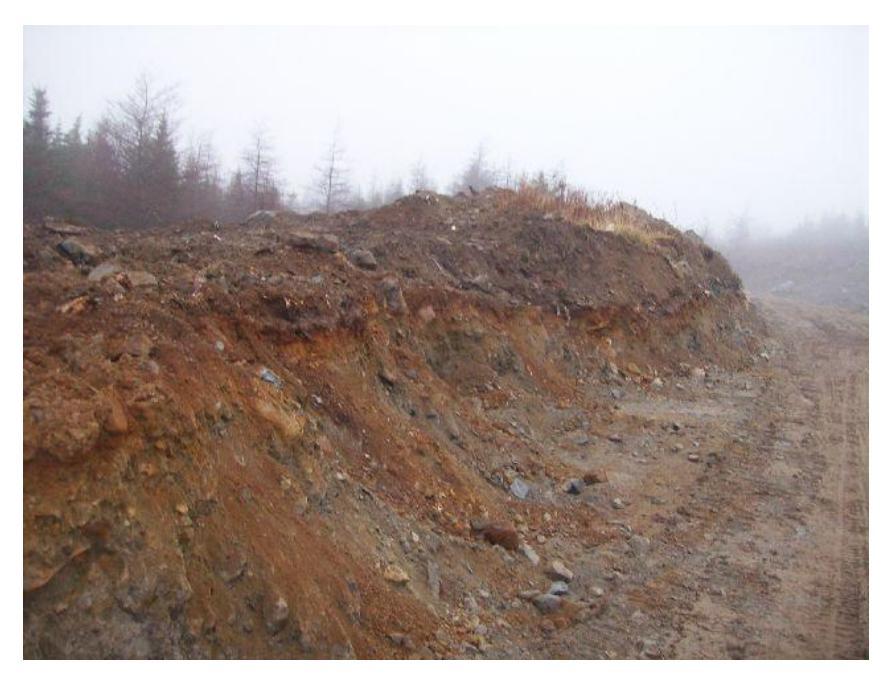
Photo 24 - Excavated site access road showing thing layer of waste (Dec 6)

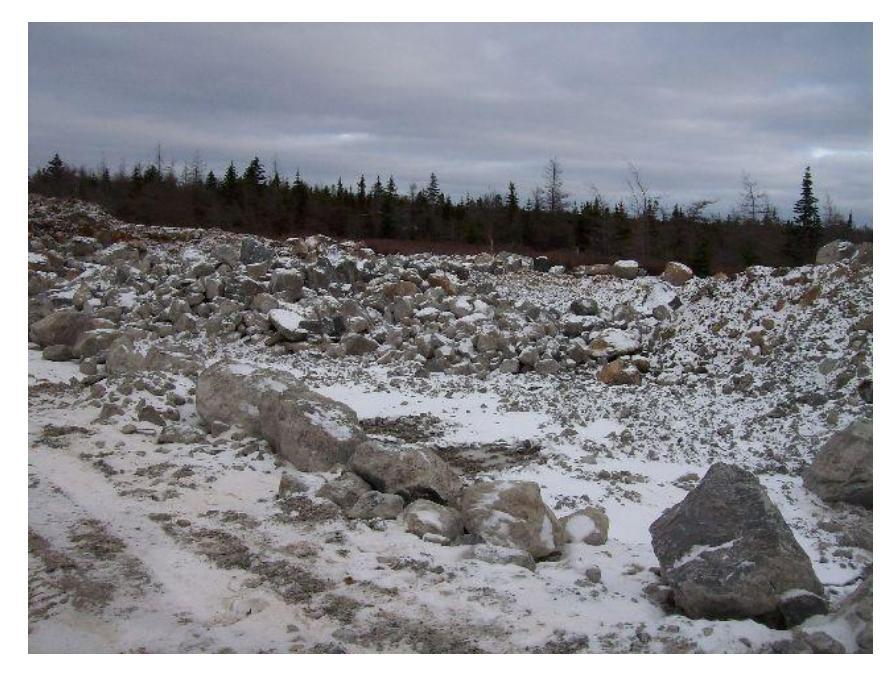
Photo 27 – Typical boulders encountered in main borrow source (Dec 14)

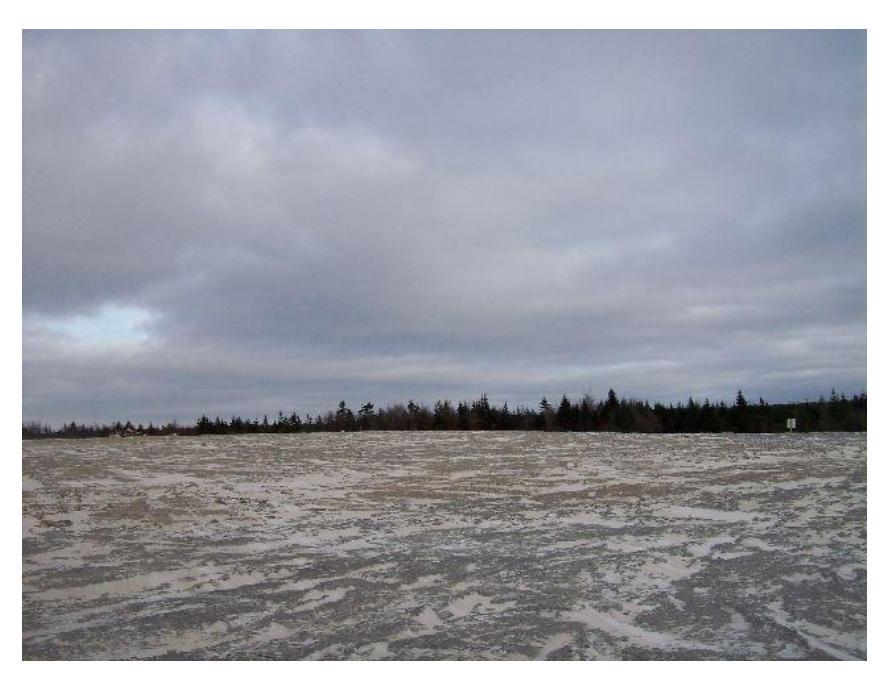
Photo 28 – Covered trench (Dec 14)

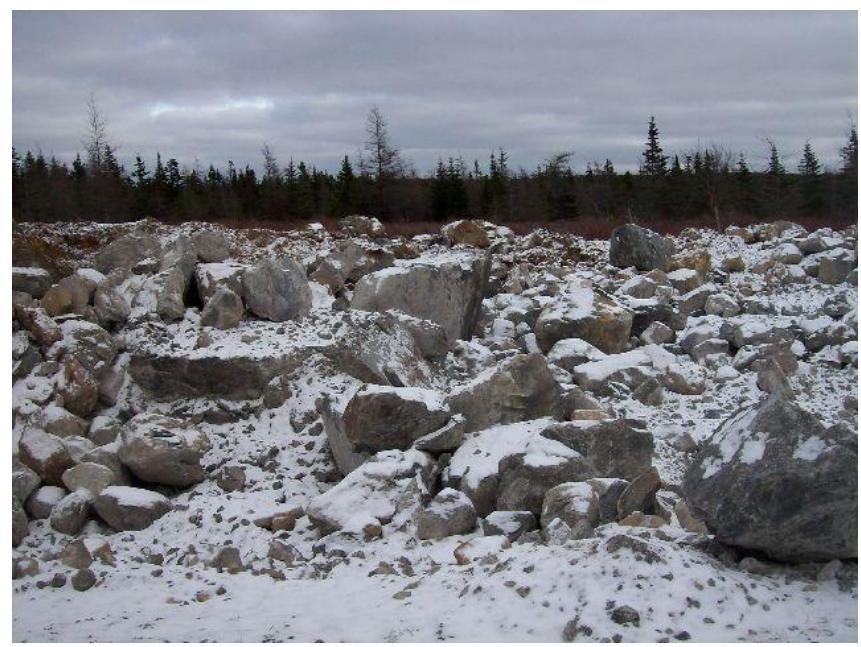
Photo 29 – Large boulders in main borrow source (Dec 14)

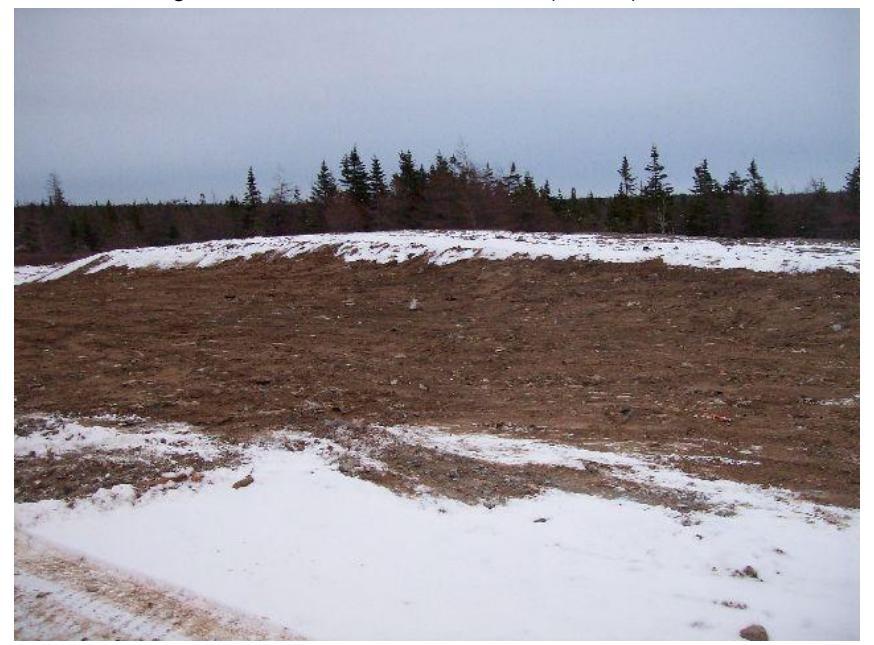
Photo 30 – Covered boulders (Dec 20)

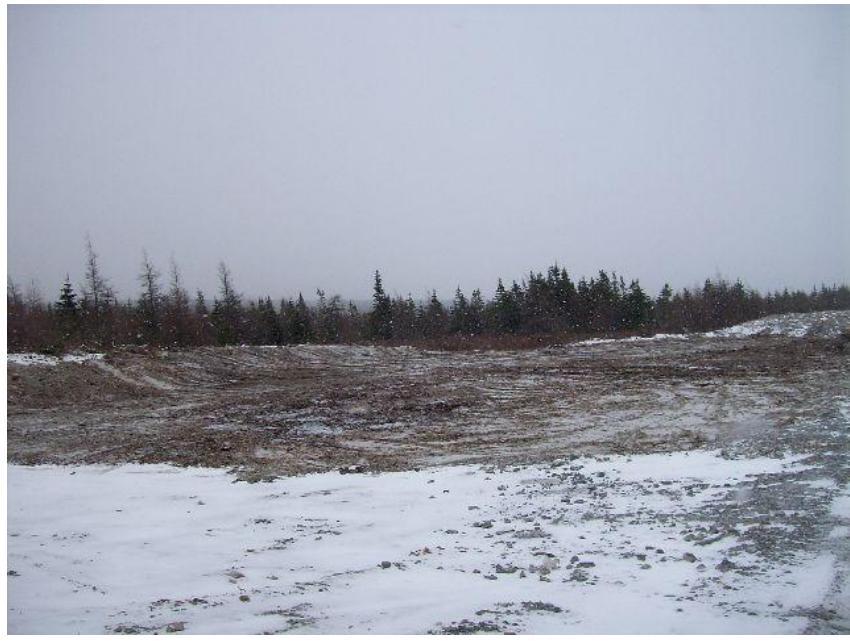
Photo 31 – Covered boulders (Dec 22)
