Groundwater Under Direct Influence of Surface Water (GUDI) – an Evaluation for Public Water Supplies in Newfoundland and Labrador

Government of Newfoundland and Labrador, Department of Environment and Conservation, Water Resources Management Division

Prepared by: AECOM 1701 Hollis Street SH400 (PO Box 576 CRO) Halifax, NS, Canada B3J 3M8 www.aecom.com

Date: June, 2013

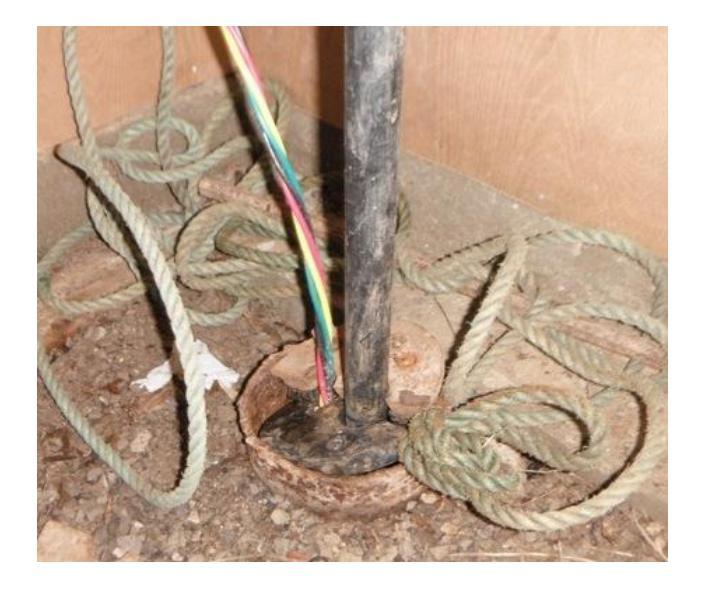
**Photo 3** – Well #1 in Holyrood may be unsanitary due to penetrations in the well cap and the insufficient well casing height (< 30 cm).

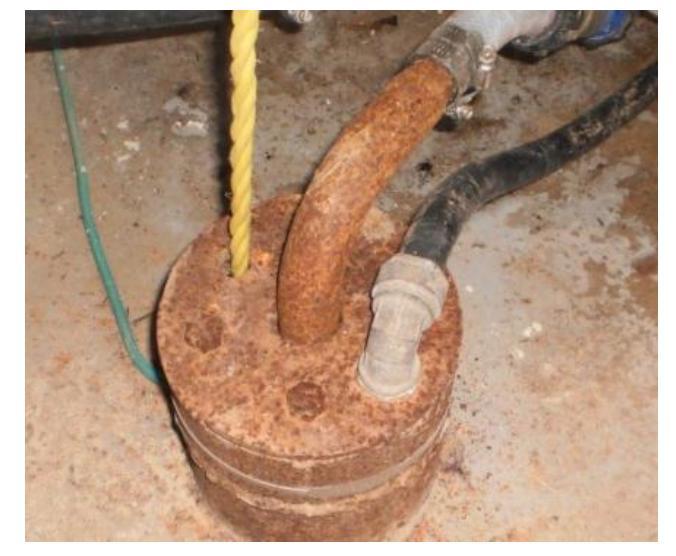
**Photo 4** – Well # 2 in Bunyan's Cove is unsanitary due to inadequate well seal (holes in well cap, rope coming through well cap), and insufficient well casing height (< 30 cm).

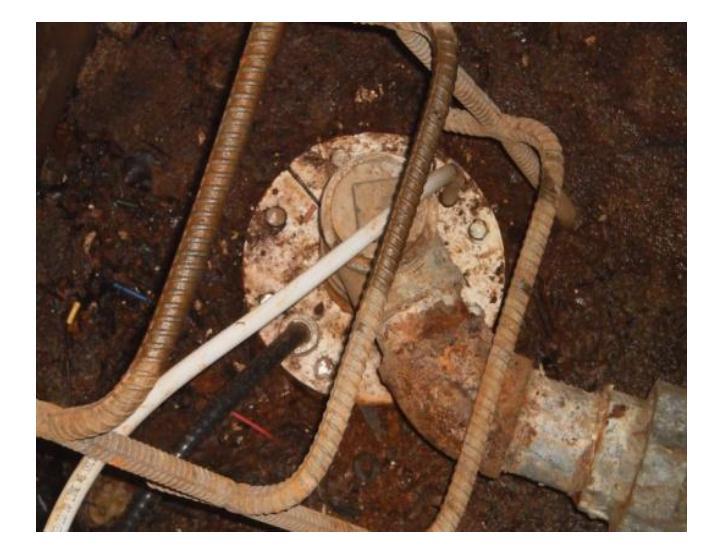
**Photo 5** – Well pit, Holyrood Well No. 3 is unsanitary due to penetrations in the well cap, well casing does not extend >30 cm above ground surface, and the well is constructed in a manner where surface water can enter around the wellhead.

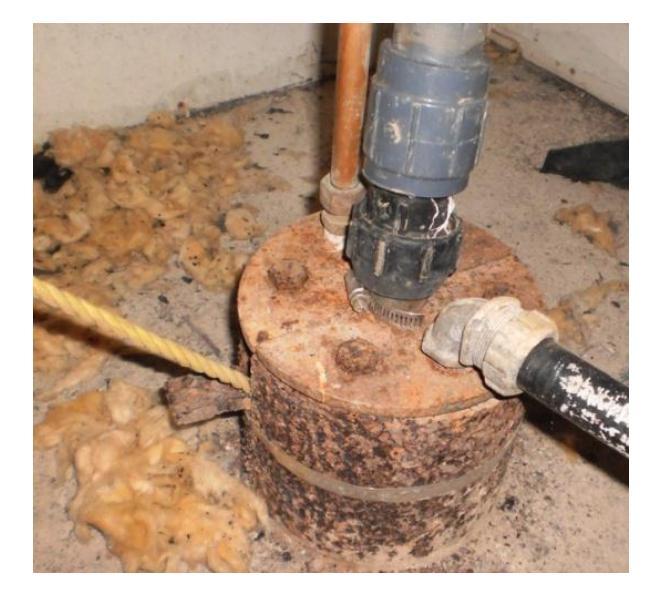
**Photo 7** – Gilbert Hill Well in Hopeall is unsanitary due to hole in casing (improper well seal), insufficient well casing height (< 30 cm), untidy housekeeping in well house (evidence of rodents). Pump seems to be supported on well seal using a gear clamp, which is inappropriate.

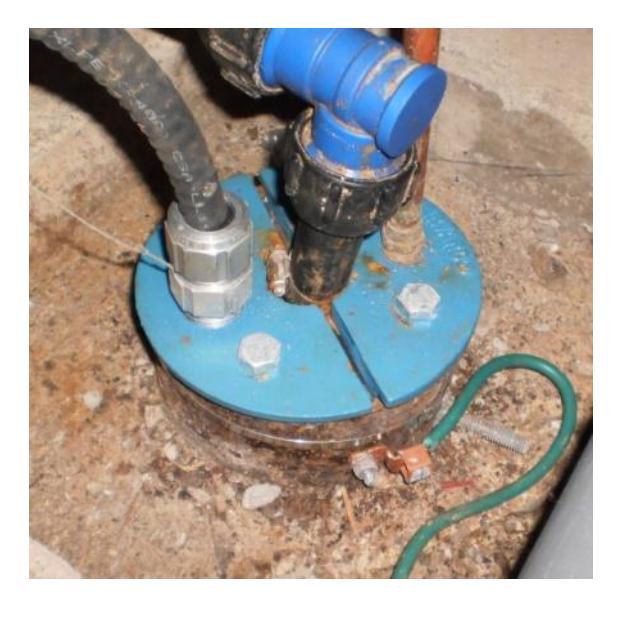
**Photo 8** – Champney's Arm well in Port Rexton is unsanitary due to improper well cap (not vermin proof or properly vented), and insufficient well casing height (< 30 cm). Pump seems to be supported on well seal using a gear clamp, which is inappropriate.

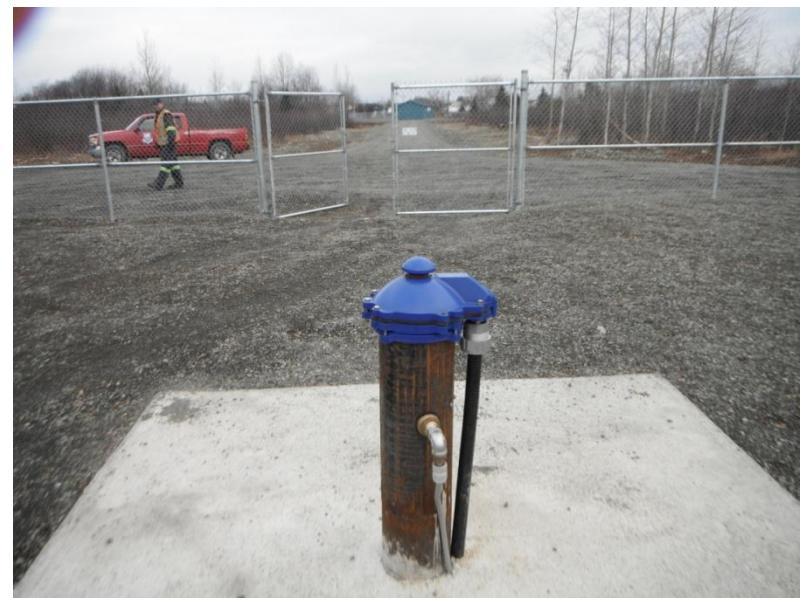
Photo 9 – Drilled well in Badger, NL as an example of a sanitary well head.

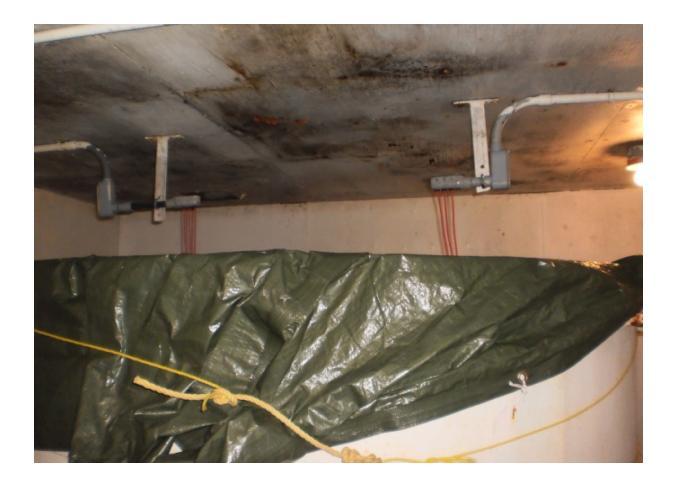
Mould and water damage above water storage

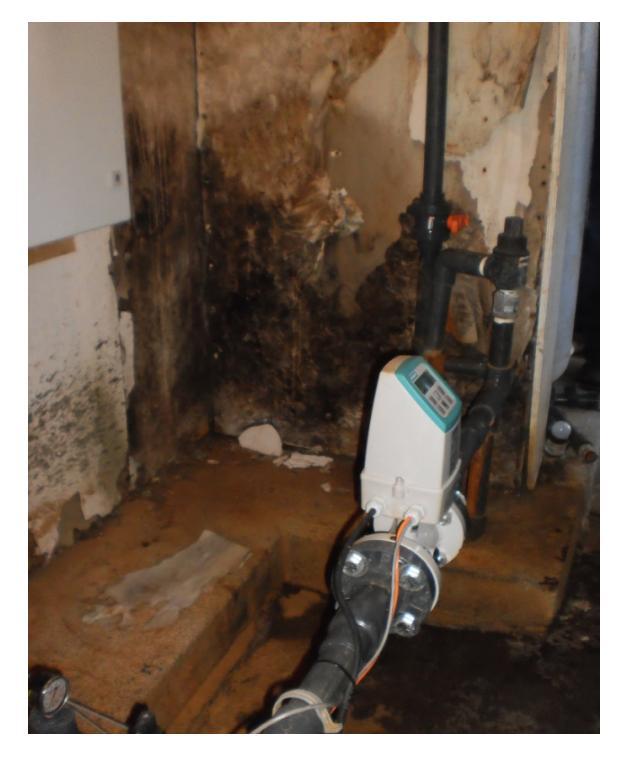
Interior of pumphouse - unsanitary conditions

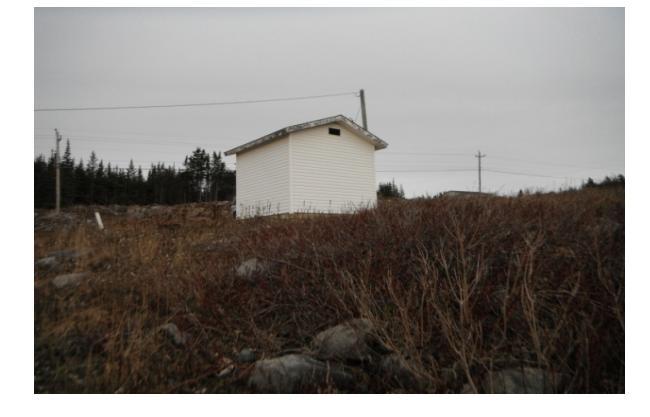
Metal debris near pumphouse
