Real Time Water Quality Monthly Report **Lower Humber River at Humber Village Bridge** **September – December 2007**

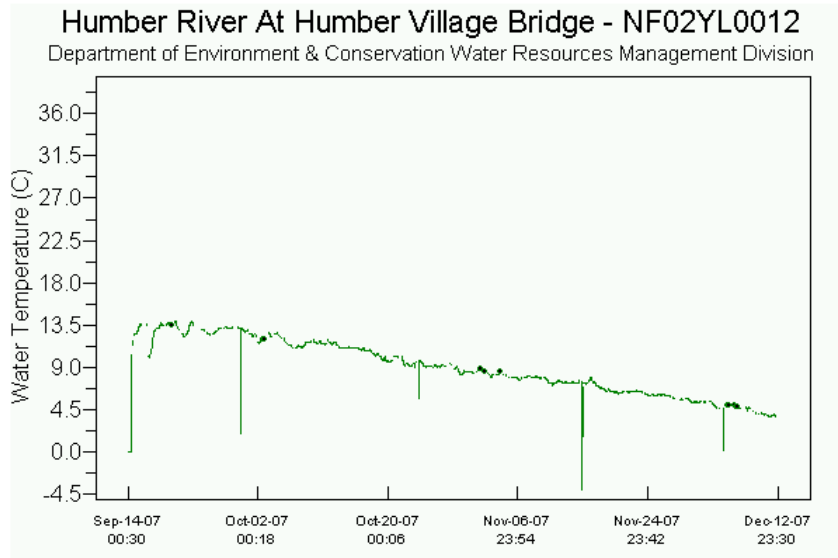
Figure 1

- During the deployment period of September 14th to December 5th, 2007 the water quality remained relatively stable for all parameters.
- The water temperature (**Figure 1**) showed a decrease over the deployment period. This is typical for this time of the year with a temperature range of 13.9°C to 4.6°C.

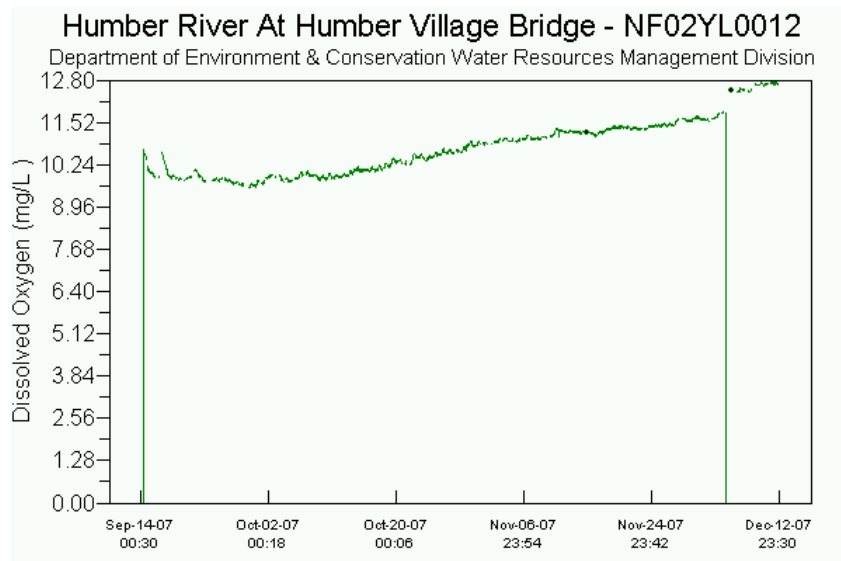
Figure 2

- The dissolved oxygen (**Figure 2**) increased over the deployment period and corresponds to the decrease seen in temperature. The DO values ranged from 9.53mg/L to 11.83mg/L.

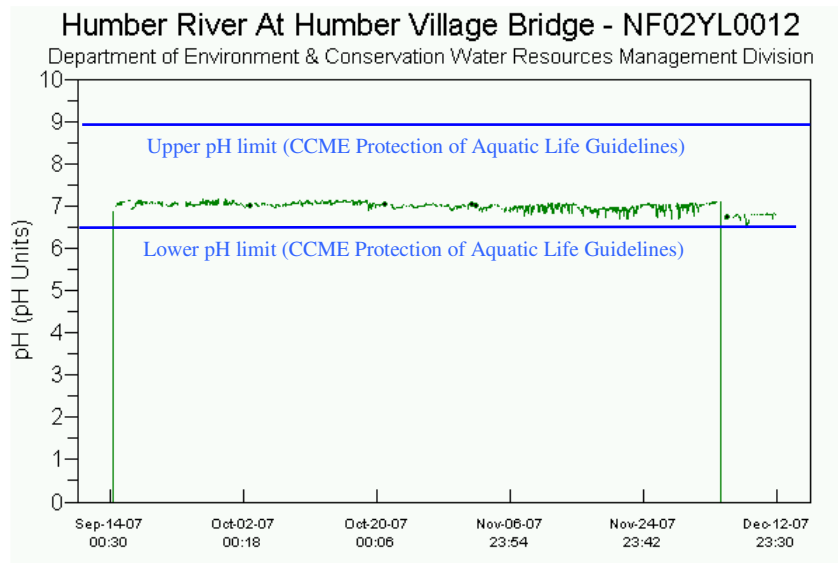
Figure 3

- pH values (**Figure 3**) remained relatively stable throughout the deployment period. The range for pH was 6.68 – 7.16 with all values falling within the recommended range (6.5 – 9.0) for the CCME Protection of Aquatic Life guidelines.

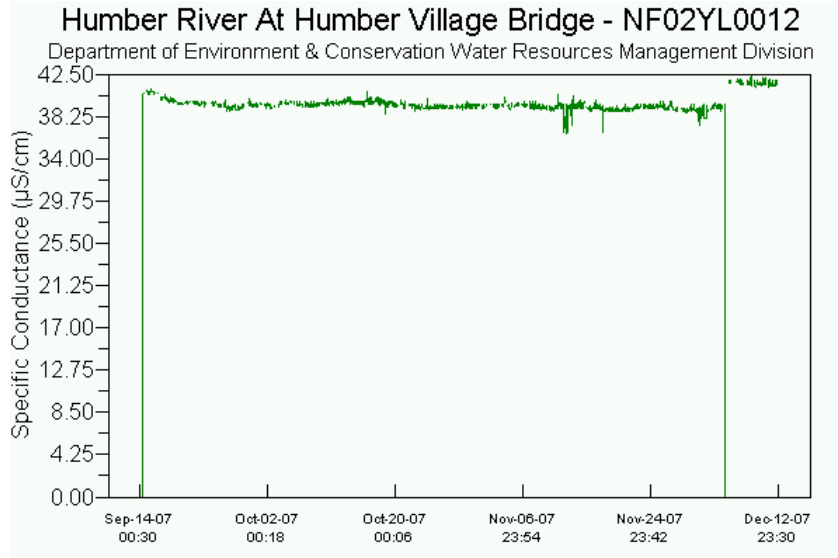
Figure 4

- Conductivity (**Figures 4**) remained consistent at background levels throughout the deployment period. The conductivity values ranged from 36.5 μ S/cm to 41.0 μ S/cm.

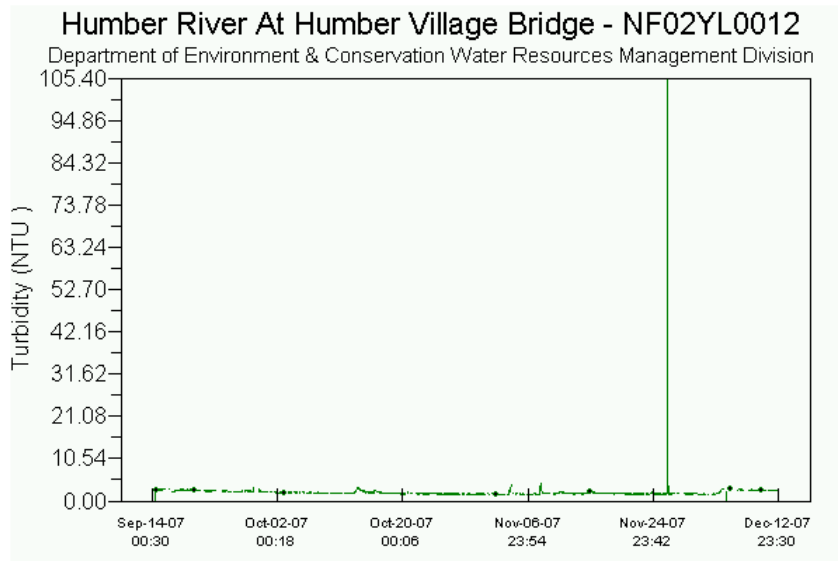
Figure 5

- The turbidity values (**Figure 5**) remained consistent throughout the deployment period with all values with the exception of one remaining below 5 NTU. The one spike seen on November 26th (105.4 NTU) occurred over a one-hour period and is not a water quality incident. This spike was likely due to a disturbance near the instrument such as organic matter going past the turbidity sensor.
