# Public Draw for Crown Land Recreational Cottage Lots Salmonier Cottage Area

Septic Site Evaluation Lots 11 & 12

# **MAE PROJECT NO 2008.0163**

# PROPOSED SALMONIER COTTAGE DEVELOPMENT - 20 LOTS

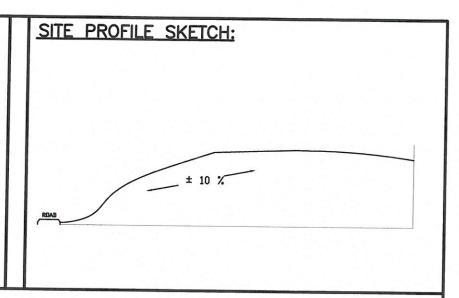
DRAWING	NO.
LOT	11

PERCOLATION PIT	TIME TO FALL 25mm (T)		
			CONDUCTED BY:	MAE DESIGN LIMITED
1		N/A	DATE:	NOV. 27, 2008
1	2	N/A	REGISTRATION NO:	AD-2000-101320
ŀ			TELEPHONE NO.	834-1554
		N/A

TEST PIT/PERCOLATION DATA SALMONIER LINE COTTAGE DEVELOPMENT

LOT #11

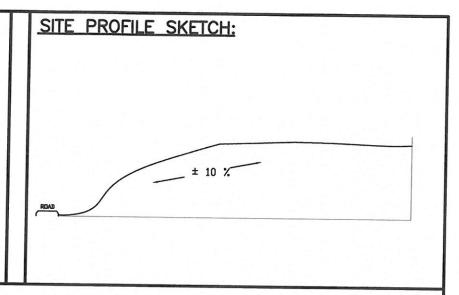
DRAWING	NO.
LOT #	12

# ROAD ROAD TP/PP TP/PP TP/PP TP/PP TP - TEST PIT PP - PERCOLATION PIT

PERCOLATION PIT	TIME TO FALL 25mm (T)		
		CONDUCTED BY:	MAE DESIGN LIMITED
1	4.75	DATE:	NOV. 27, 2008
2	4.75	REGISTRATION NO:	AD-2000-101320
		TELEPHONE NO.	834-1554
	4.75 MIN.

TEST PIT/PERCOLATION DATA SALMONIER LINE COTTAGE DEVELOPMENT LOT #12

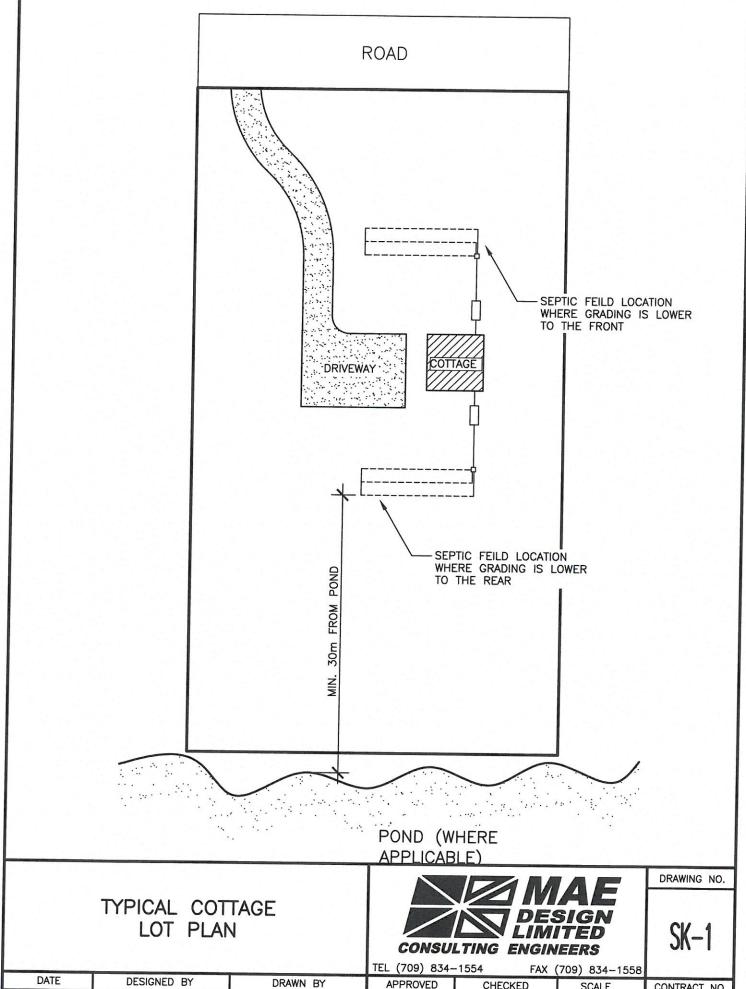
**Recommendation Sketches**

Individual septic system designs must be completed for each individual lot. The suitability
of the specific soil types encountered, the design elevation of the septic disposal pipe and the
specific septic system location for each lot will be left to the septic system designer. These
individual assessments will be more specific and provide greater detail as to the site
requirements. A typical lot development sketch is provided in Appendix D, drawing Sk-1.
