**Public Draw for Crown Land
Recreational Cottage Lots
Salmonier Cottage Area**

**Septic Site Evaluation
Lots 74 -131**

**ENGINEERING REPORT FOR
SALMONIER COTTAGE INITIATIVE COTTAGE DEVELOPMENT SEPTIC SYSTEM SITE
EVALUATIONS**

MAE PROJECT NO. 2013.093

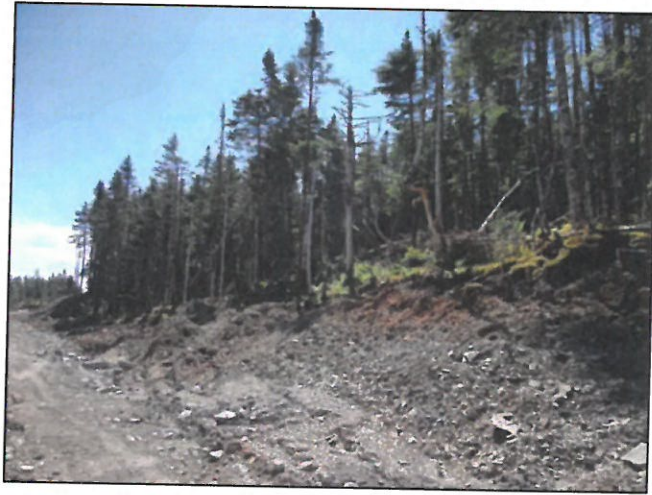
LOT#74

PERCOLATION PIT	TIME TO FALL 25mm (T)	CONDUCTED BY: CHRIS FIFIELD/MAE DESIGN LTD. SUPERVISED BY: STEPHEN POWER P.ENG./MAE DESIGN LTD. DATE: JULY 25, 2013 REGISTRATION NO: AD-2009-105692 TELEPHONE NO. 834-1554
1	1 MIN. 49 SEC.

0.30M	GRUBBING
1.07M	REDDISH BROWN SILTY MATERIAL
1.98M	DARK GREY SILTY GRAVEL WITH COBBLES
1.98M	BOTTOM OF TESTPIT
<p>COMMENTS: NO ROCK ENCOUNTERED NO GROUNDWATER ENCOUNTERED</p>

- Bedrock was observed in the test pits on lots 73 and 74. The septic field distribution pipe is required to be installed a minimum of 1.15 meters above the bedrock elevation.
- Recommendation Sketch SK-3 should be followed for lots 72-74,76, and 100-105.

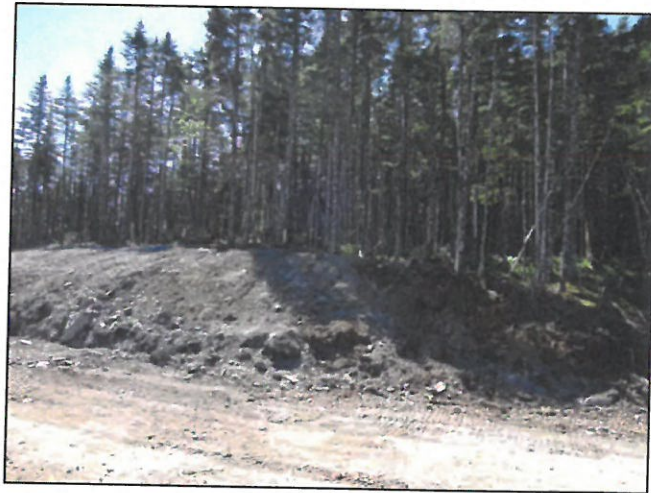
LOT #76

PERCOLATION PIT	TIME TO FALL 25mm (T)	CONDUCTED BY: CHRIS FIFIELD/MAE DESIGN LTD. SUPERVISED BY: STEPHEN POWER P.ENG./MAE DESIGN LTD. DATE: JULY 25, 2013 REGISTRATION NO: AD-2009-105692 TELEPHONE NO. 834-1554
1	4 MIN. 12 SEC.

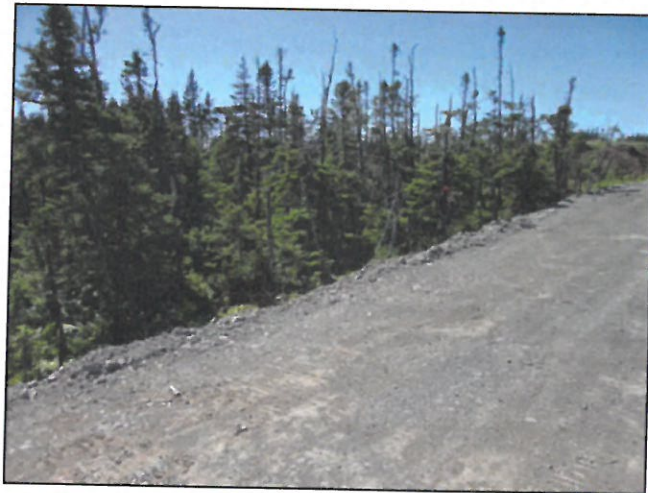
LOT#92

PERCOLATION PIT	TIME TO FALL 25mm (T)	CONDUCTED BY: CHRIS FIFIELD/MAE DESIGN LTD. SUPERVISED BY: STEPHEN POWER P.ENG./MAE DESIGN LTD. DATE: JULY 26, 2013 REGISTRATION NO: AD-2009-105692 TELEPHONE NO. 834-1554
1	1 MIN. 03 SEC.

- Recommendation Sketch SK-2 should be followed for lots 88,92-99,106-107, and 111-114.

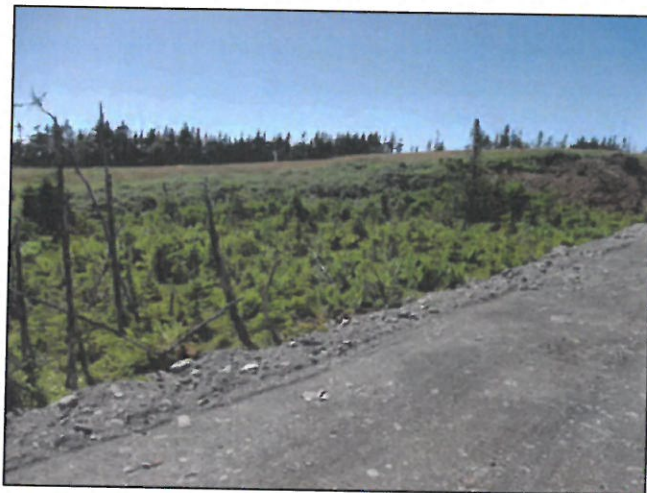
LOT#93

PERCOLATION PIT	TIME TO FALL 25mm (T)	CONDUCTED BY: CHRIS FIFIELD/MAE DESIGN LTD. SUPERVISED BY: STEPHEN POWER P.ENG./MAE DESIGN LTD. DATE: JULY 26, 2013 REGISTRATION NO: AD-2009-105692 TELEPHONE NO. 834-1554
1	3 MIN. 44 SEC.

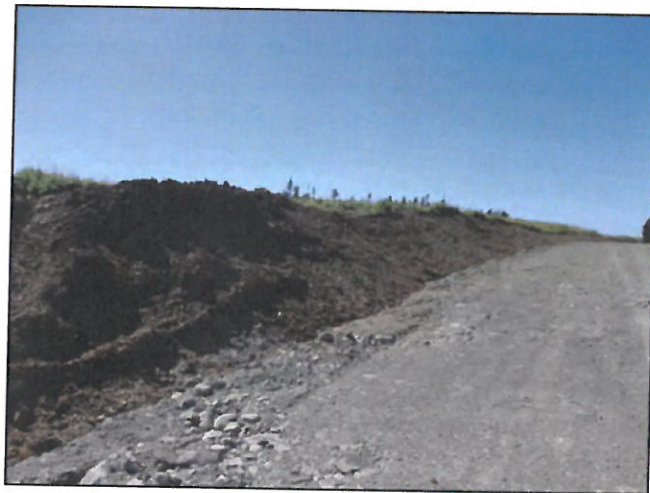
LOT#94

PERCOLATION PIT	TIME TO FALL 25mm (T)	CONDUCTED BY: CHRIS FIFIELD/MAE DESIGN LTD. SUPERVISED BY: STEPHEN POWER P.ENG./MAE DESIGN LTD. DATE: JULY 26, 2013 REGISTRATION NO: AD-2009-105692 TELEPHONE NO. 834-1554
1	5 MIN. 57 SEC.

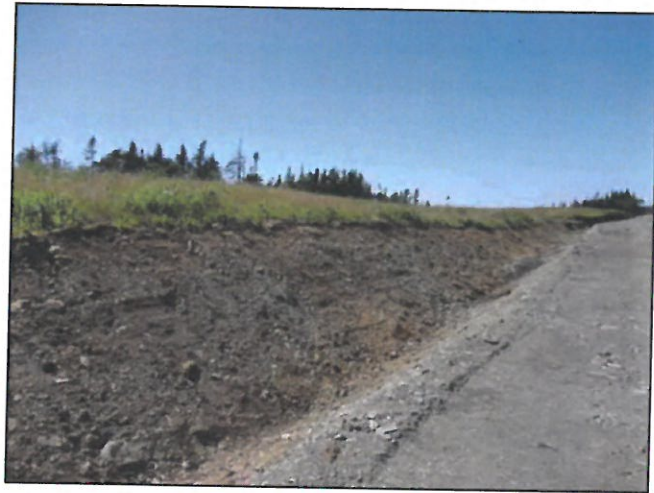
LOT#95

PERCOLATION PIT	TIME TO FALL 25mm (T)	CONDUCTED BY: CHRIS FIFIELD/MAE DESIGN LTD. SUPERVISED BY: STEPHEN POWER P.ENG./MAE DESIGN LTD. DATE: JULY 26, 2013 REGISTRATION NO: AD-2009-105692 TELEPHONE NO. 834-1554
1	2 MIN. 03 SEC.

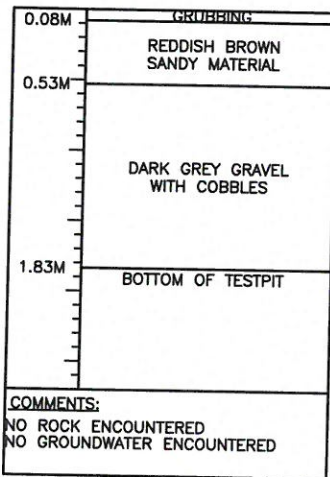
TEST PIT #1:

COMMENTS:
 NO ROCK ENCOUNTERED
 NO GROUNDWATER ENCOUNTERED

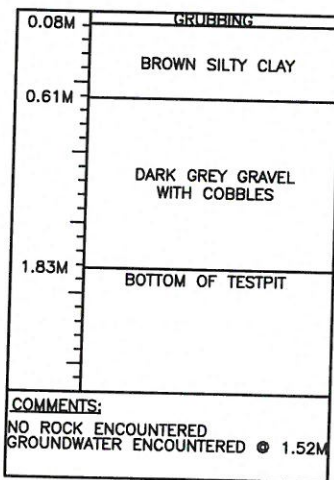
TEST PIT #1:

NO ROCK ENCOUNTERED
GROUNDWATER ENCOUNTERED @ 1.52M

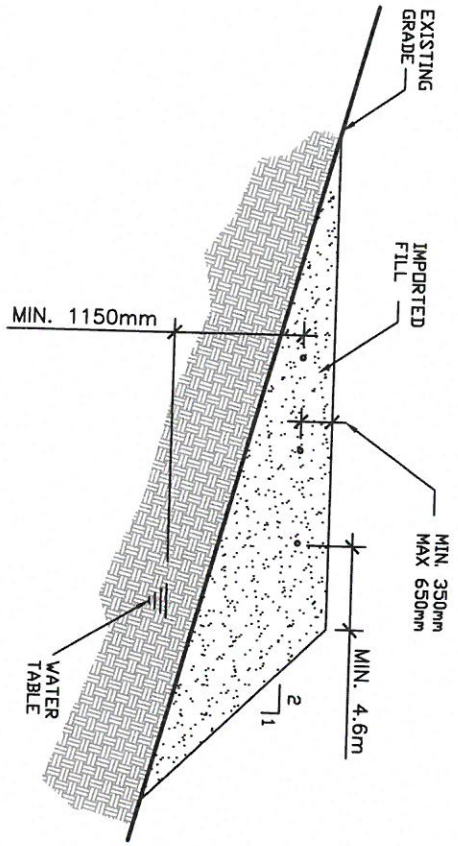
TYPICAL SECTION THROUGH SEPTIC FIELD WHEN INSTALLED IN IMPORTED FILL.

- Due to a poor percolation rates these lots require the material in the septic field area to be removed (± 450 m³) and replaced with a suitable fill material with a percolation rate between 5-10 minutes. The fill area should encompass the septic field area and extend 4.5 meters on all sides before sloping. A standard septic field including the 4.5

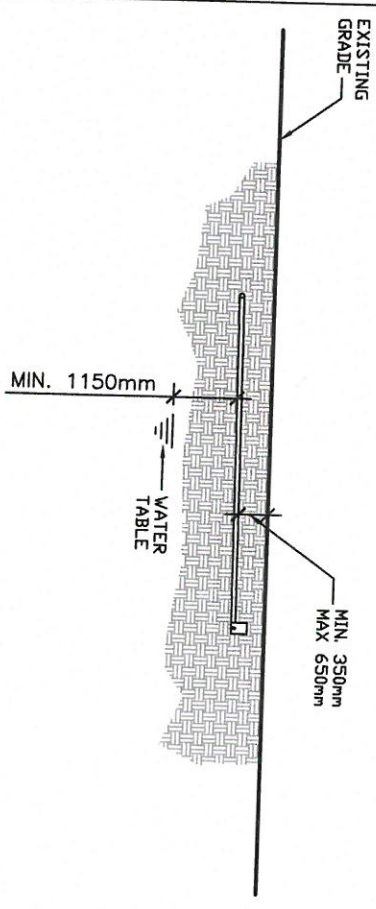
TYPICAL SECTION THROUGH SEPTIC FIELD WHEN INSTALLED IN EXISTING GRADE.
