## **Real-Time Water Quality Report**

# Grieg NL Nurseries Ltd Monitoring Well

Annual Deployment Period: November 23, 2022 to December 12, 2023

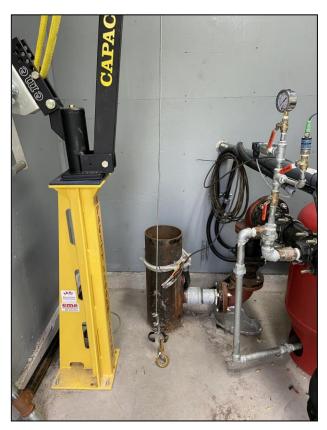
Figure 4: Well Casing in the hut

Grieg Seafood has two wells: a main production well that provides new water to the facility as needed; and a monitoring/backup well that houses the WRMD monitoring equipment. Both wells are functioning in good condition. In the event of a catastrophic failure of the main well, the monitoring well can serve as a backup.

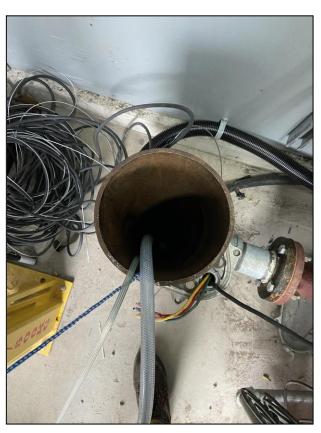
Figure 5: View looking into well

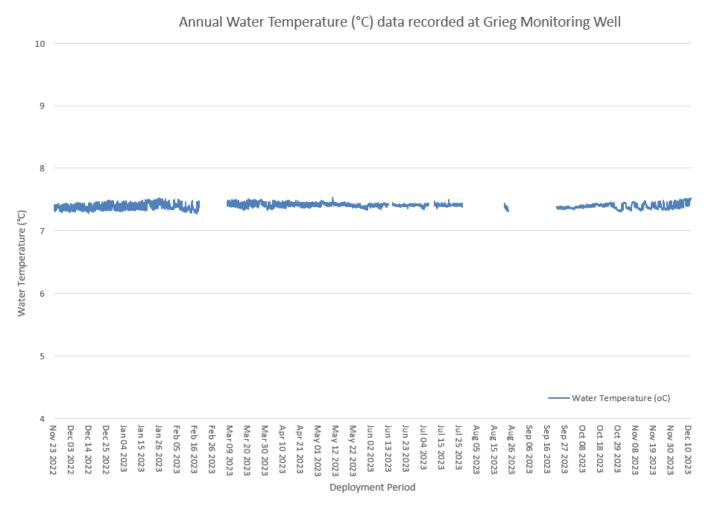
Figure 6: Water temperature (°C) values

Between November 23, 2022, and December 12, 2023, the water temperature fluctuated within the range of 7.28°C to 7.54°C throughout the deployment period, as illustrated in Figure 6. The annual average water temperature was recorded at 7.40°C.

The water temperatures remain consistent throughout the year of data. Due to the depth of the instrument in the well, there is very little influence from air temperatures on the water, therefore there is minimal variance between the minimum and maximum values.

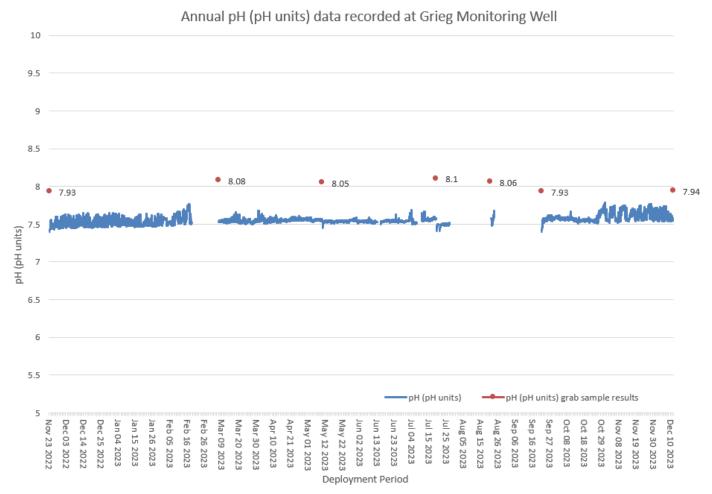
Figure 7: pH (pH units) values

Between November 23, 2022, and December 12, 2023, pH values exhibited a range from 7.40 pH units to 7.78 pH units. Throughout the deployment year, pH remained reasonably consistent, with an average of 7.56 pH units.

A pH sensor measures the acidity or alkalinity of a water body and is a measure of the concentration of hydrogen ions ( $H^+$ ) in a solution. Minor pH fluctuations were likely a consequence of aquifer pumping activities. The well's refilling process and subsequent level adjustments led to temporary variations in pH levels, as depicted in Figure 7.

The red points on the graph denote pH values derived from grab samples, offering complementary insights to the in-situ monitoring conducted by the water quality instrument (refer to Table 1). It is anticipated that there may be slight disparities between the pH values obtained from grab samples and the water quality instrument. Variations in the data could be attributed to factors such as delayed analysis of grab samples over several days and the pumping of the well before collecting grab samples, which may disturb the water column.

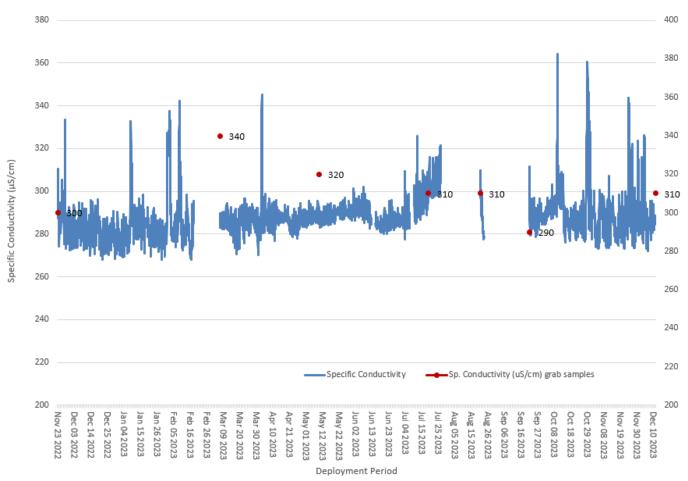
Annual Specific Conductivity (µS/cm) data recorded at Grieg Monitoring Well

Figure 8: Specific conductivity (µS/cm) values

Throughout the annual deployment season, conductivity levels were within 267.94  $\mu$ S/cm and 364.21  $\mu$ S/cm (Figure 8), with an average of 287.60  $\mu$ S/cm. The specific conductivity probe measures the presence of diluted salts and inorganic materials in a water source. In instances where there is minimal or no external influence, the conductivity in the groundwater well remains relatively stable, experiencing minimal fluctuations. Elevated spikes in conductivity are likely attributed to pumping activities and disturbances within the aquifer which can disturb the water column.

The red points on the graph represent the specific conductivity results from the grab samples collected at the beginning of a deployment (Table 1). It is expected that there would be some differences between the insitu data and the grab sample data. Variations in the data can arise due to factors such as delayed analysis of grab samples spanning several days, as well as the pumping of the well prior to collecting grab samples.

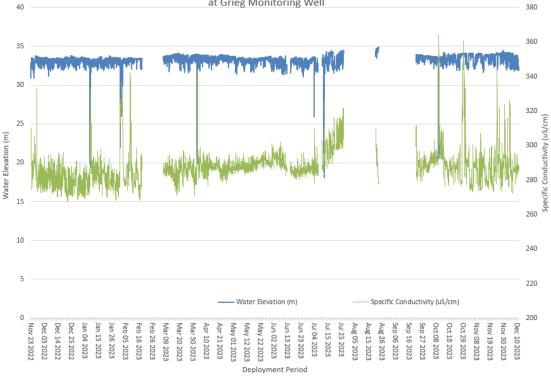
Annual Water Elevation (m) and Specific Conductivity (µS/cm) data recorded at Grieg Monitoring Well

#### Figure 9: Annual Specific Conductivity & Water Elevation

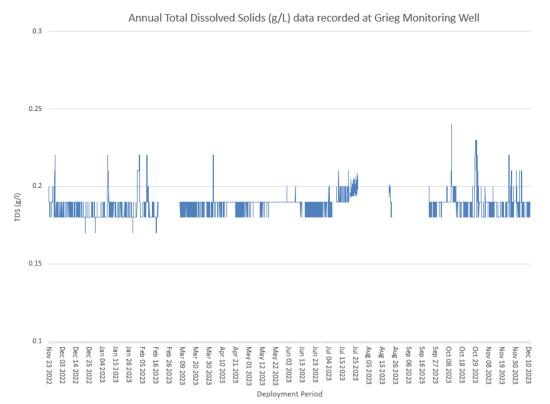
Figure 10: Total Dissolved Solids (TDS)

TDS data is derived from the specific conductivity data. The water quality instrument is programmed to calculate an estimated TDS value from a conductivity value. TDS data will mirror the movement of the specific conductivity data, however the TDS is calculated in g/L (Figure 10). For the deployment year, TDS ranged within 0.17 g/L to 0.24 g/L.

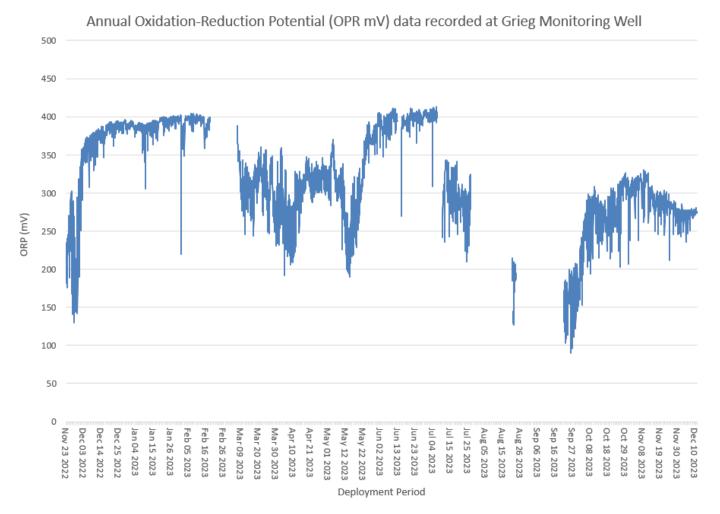
Figure 11: ORP values (mV)

ORP levels during the year of deployment ranged within 90.10 mV to 412.70 mV, with an average of 322.66 mV, an increase from the 2022 average of 288.7 mV (Table 3, Appendix I). As expected, due to periodic pumping of the well, fluctuations in ORP levels were observed, but values generally remained within typical ranges over the course of the year. The variations in ORP values throughout the deployment are visually evident in Figure 11, showcasing dips and increases. It's worth noting that ORP can take days to weeks to equilibrate in groundwater, which may explain the lower values observed at the beginning of each deployment period.

ORP, measuring the oxidizing-reduction potential of groundwater, plays a crucial role in identifying the mobility and persistence of contaminants that could impact water quality. The values can be influenced by local conditions, the presence of specific contaminants, and the geochemical characteristics of the aquifer. Natural aquifer materials may release specific chemicals, leading to concentration changes over time. ORP values are unique to each water body, and collecting background data is essential for understanding the significance of changes in the data and their potential implications.

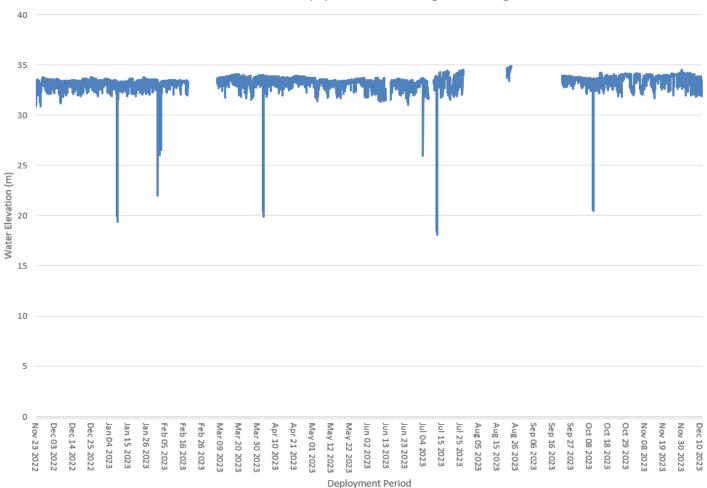
Annual Water Elevation (m) recorded at Grieg Monitoring Well

Figure 12: Water Elevation (m)

Water Elevation monitors the height of the water surface in the well measured to an assumed datum. Water Elevation at the monitoring well, ranged within 18.05 m to 34.88 m throughout the year of deployment, with an annual average of 33.19 m. Generally, the water elevation within this groundwater well remains constant. This well and its aquifer are intermittently accessed through pumping. There will be fluctuations in water elevation during deployment (Figure 12). Despite the larger dips in water elevation, the range of the elevation was reasonably consistent across deployment.
