PVC LEAK DETECTION

ST. JOHN'S
DEPARTMENT OF PUBLIC WORKS
INFRASTRUCTURE DIVISION

PVC Leak Detection – Case Study

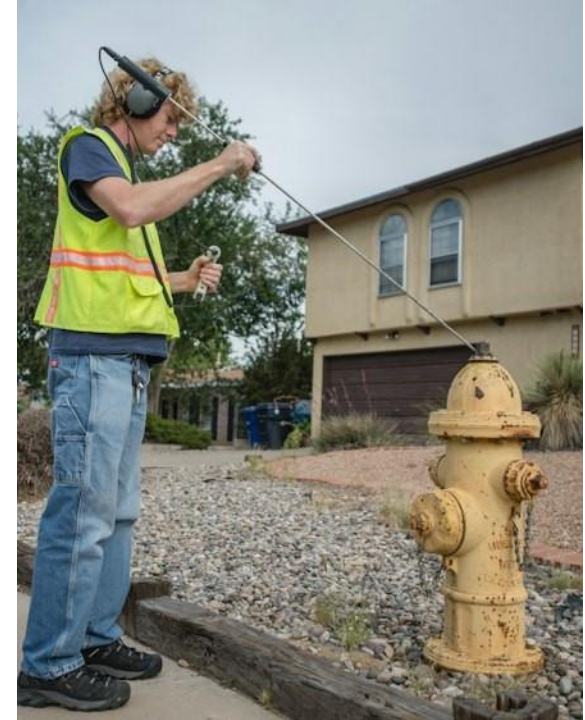
Noise Survey

- Easily accessible points within water distribution system - hydrants, valves, curb stops, etc.
- Crews listen to each hydrant / valve and record notes;
- Can be done from a list or map;
- Results are reviewed to determine a potential leak area (area of interest).

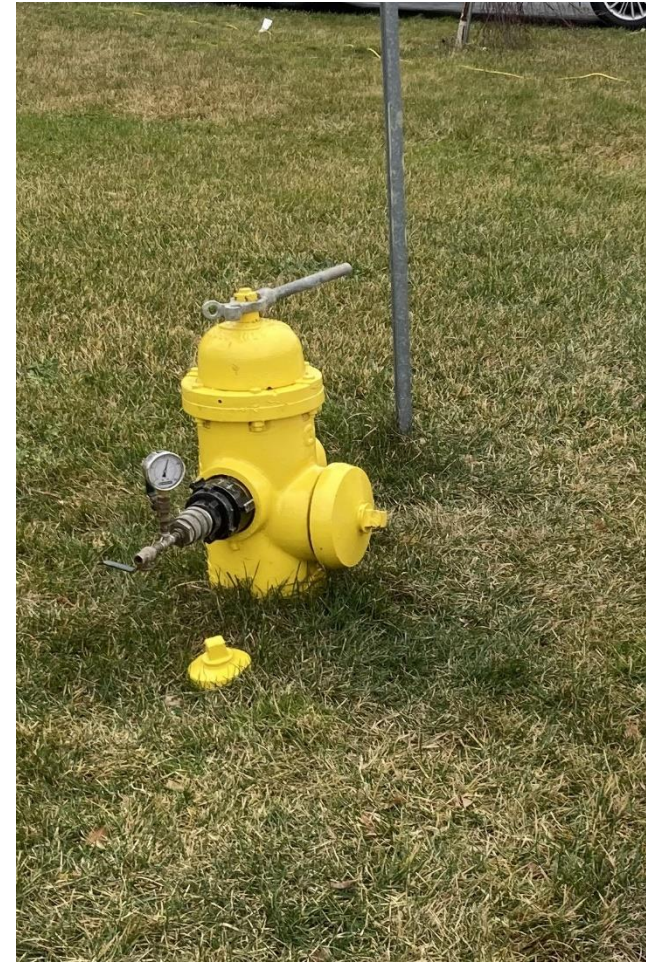
Leak Detection Toolbox – Step Testing

- Confirm boundary – ensure that there is only one supply for the area.
- Locate and close step valves, record time valves were opened and closed.
- Leave the step valves closed for 5-15 minutes.
- Record data from flow meter - initial flow, lowest flow and total drop/change
- Monitor water pressure at the high point (or critical point) to ensure that the pressure does not drop below 20 psi.
- If pressure drops quickly it may indicate a large usage or leak – reopen valves.

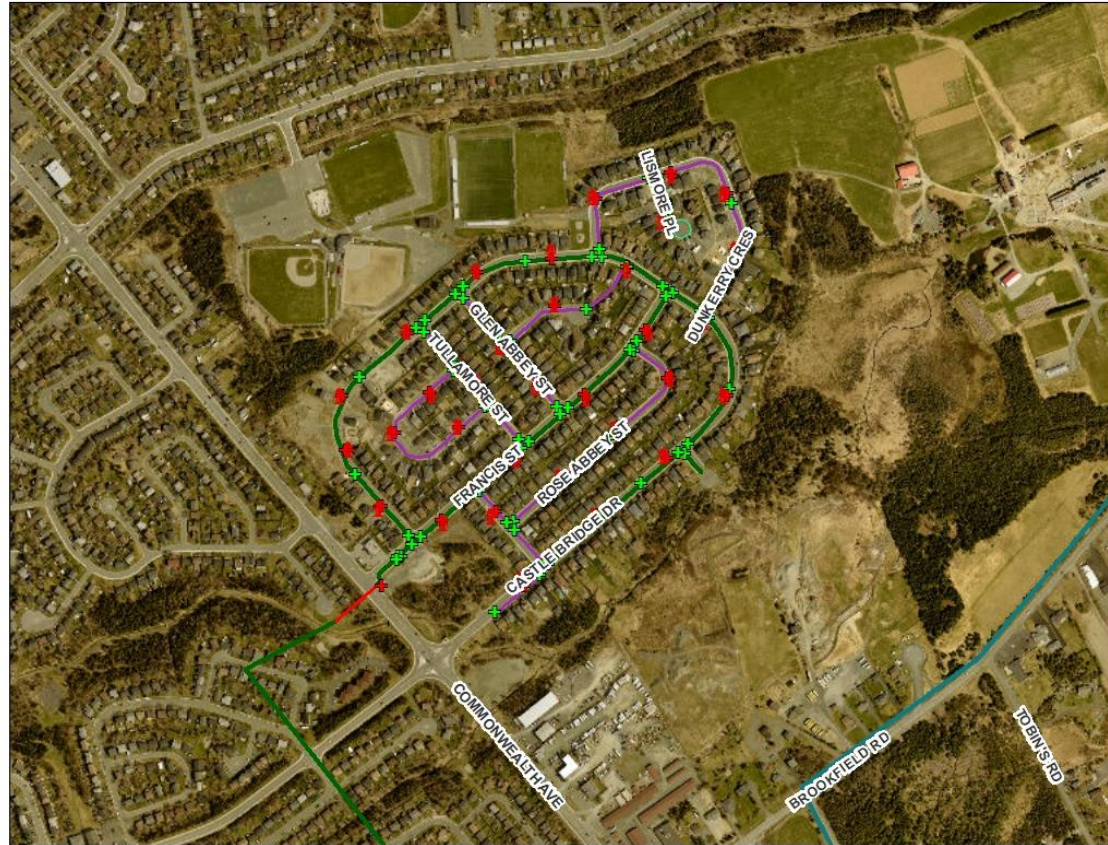
Brookfield Plains

- 411 Parcels
- 4.4 km of watermain (200mm and 300mm diameter)
- Constructed in several phases between 2008 and 2013.
- All watermains are constructed from PVC.

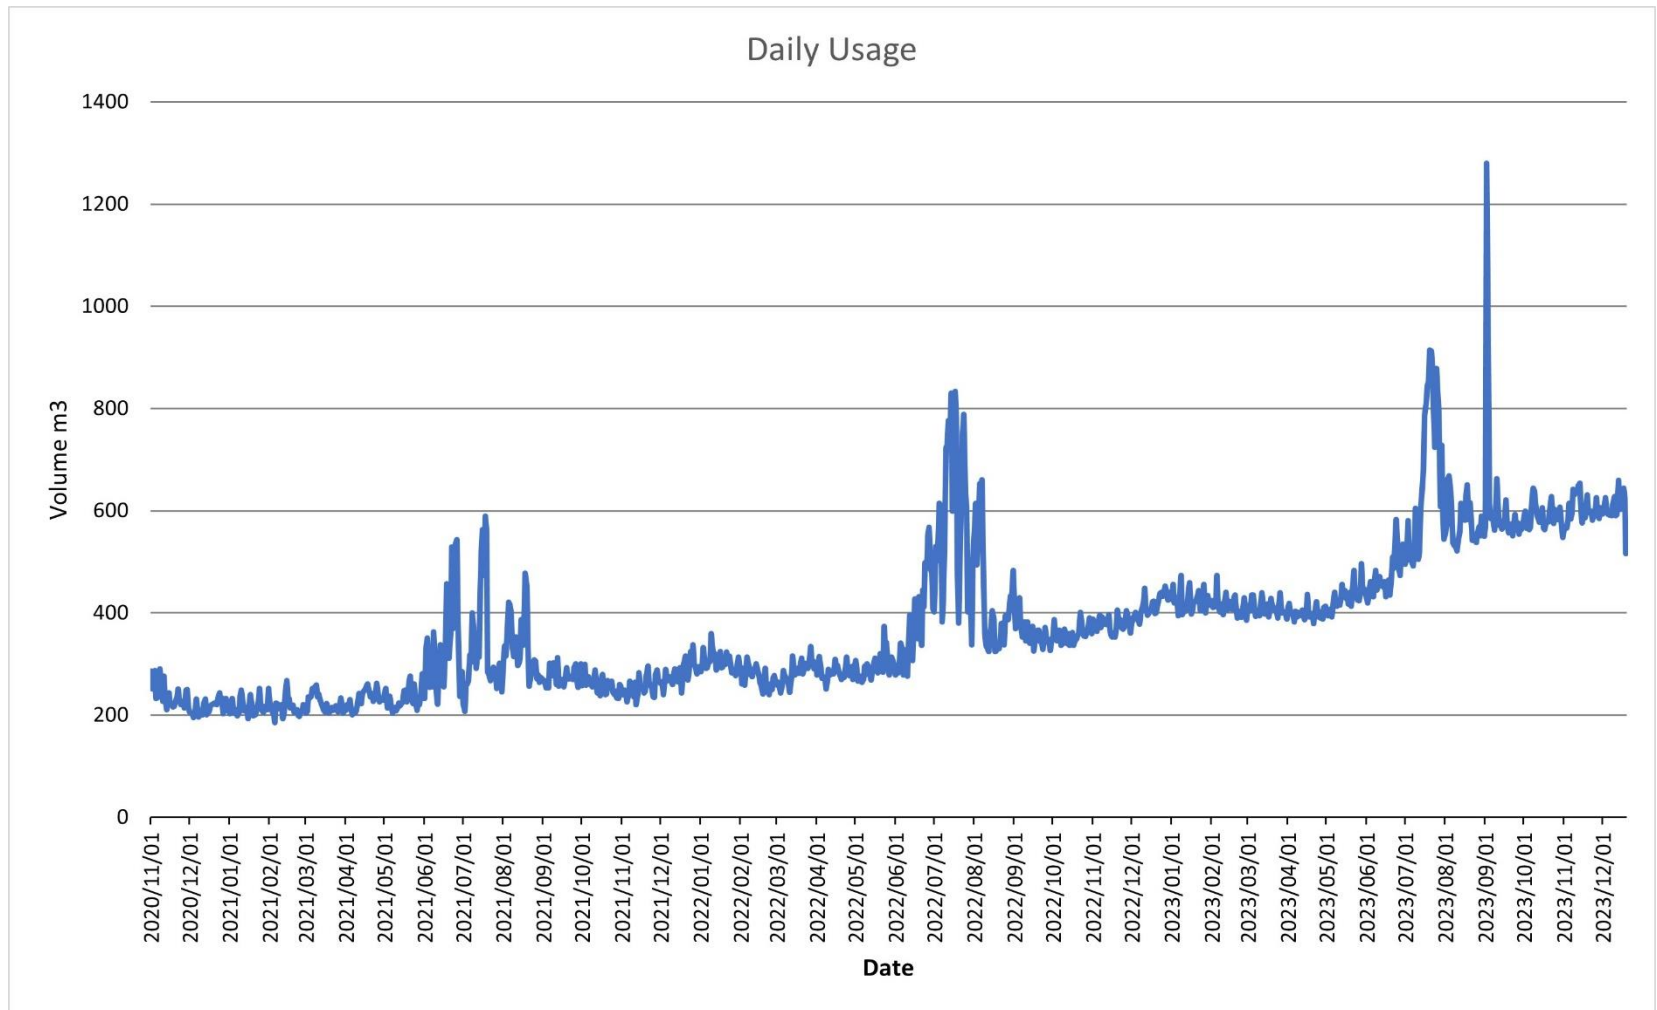
Background – Water Consumption

- Area supplied through an adjacent municipality
- Water usage is metered at municipal boundary and the billing is adjusted accordingly
- Water usage increased and night usage was high
- Increase first noticed in 2022
- Substantial increase noticed in September 2023

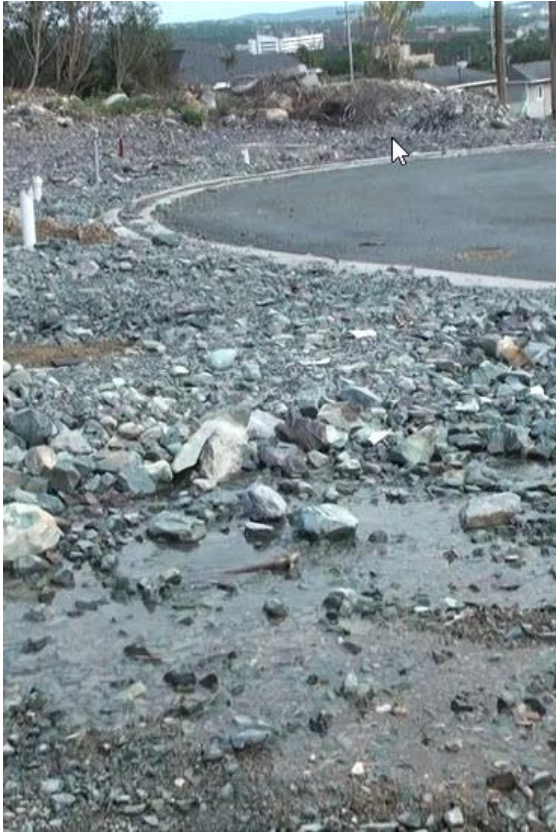
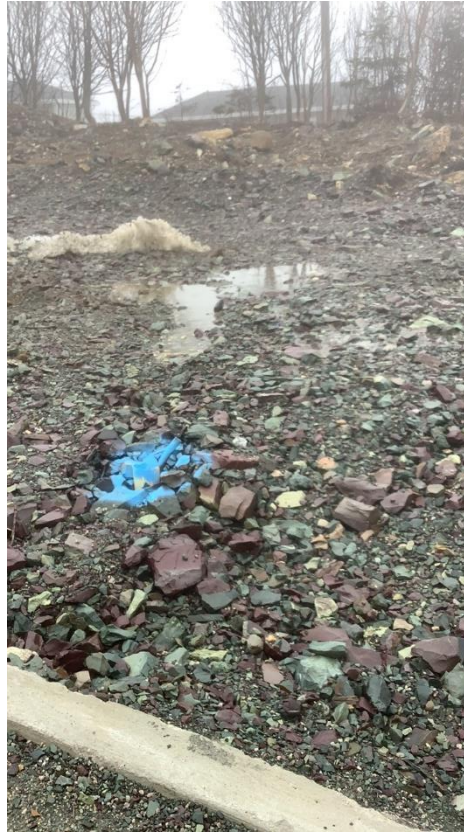
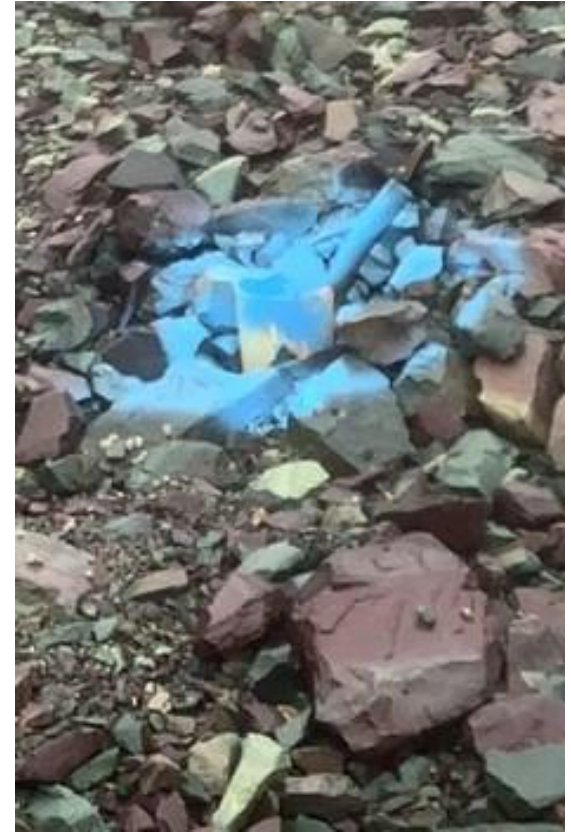
Investigation #1 – Curb Stops

Noise Survey
of vacant lots
Check to see
if curb stops
are open.

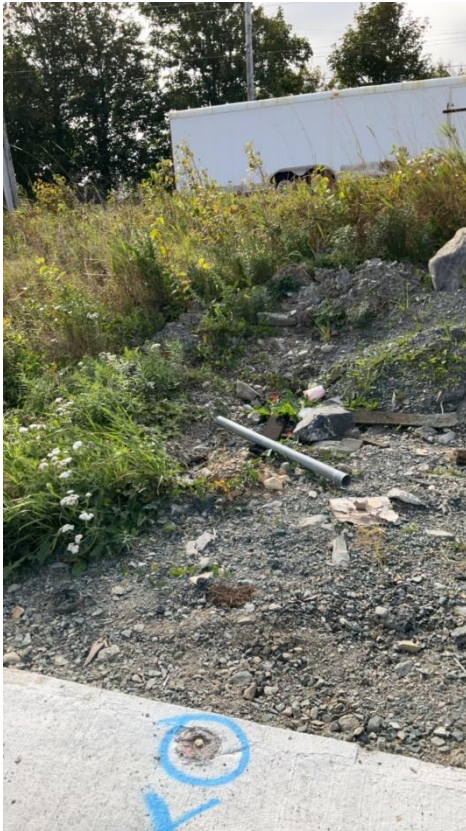
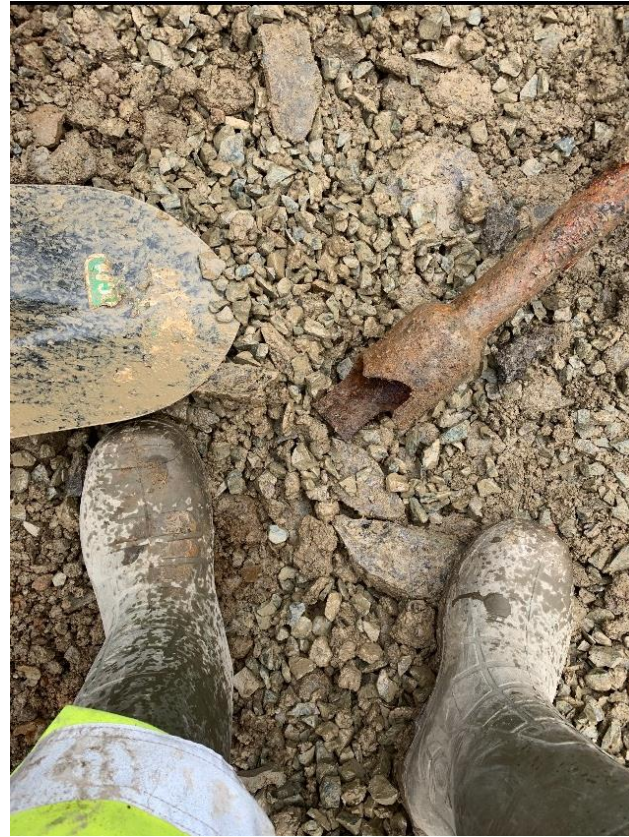
Investigation #1 - Repair

- Leak found, hole in PEX

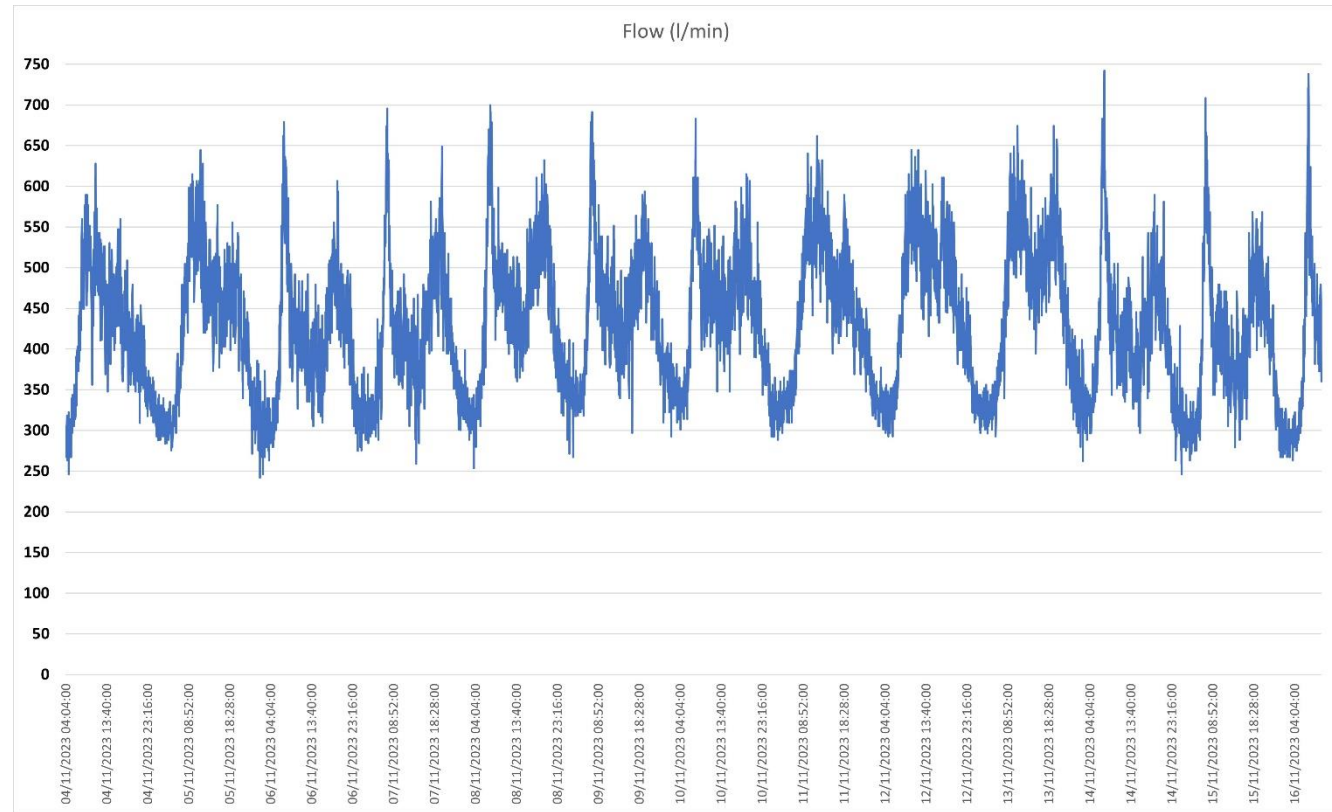
Investigation #1 - Results

- Minimal reduction in water usage

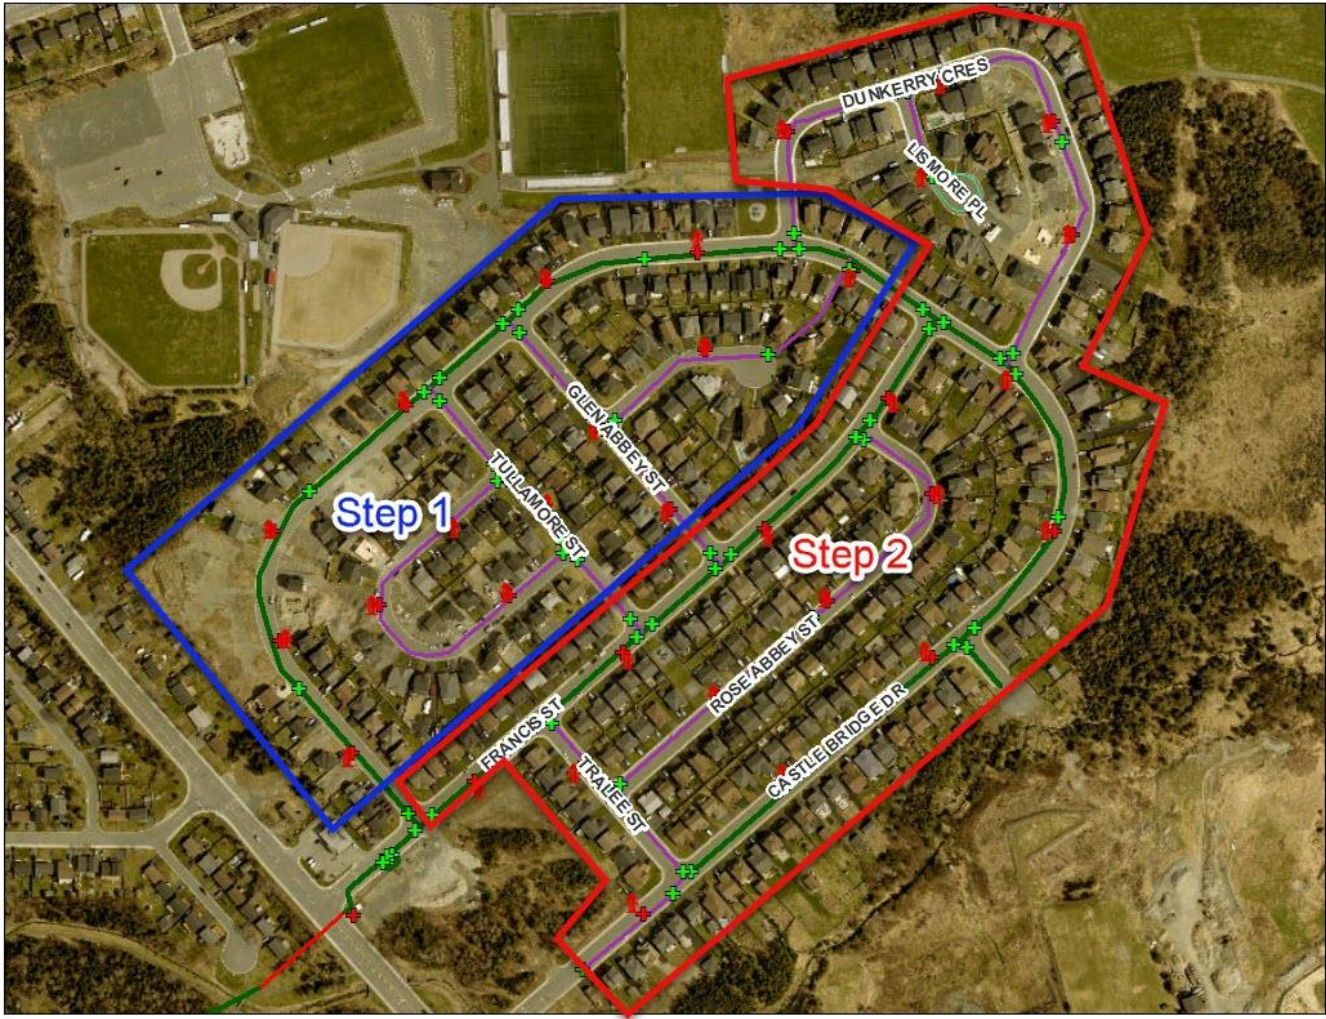
Investigation #2

Divide the area in half

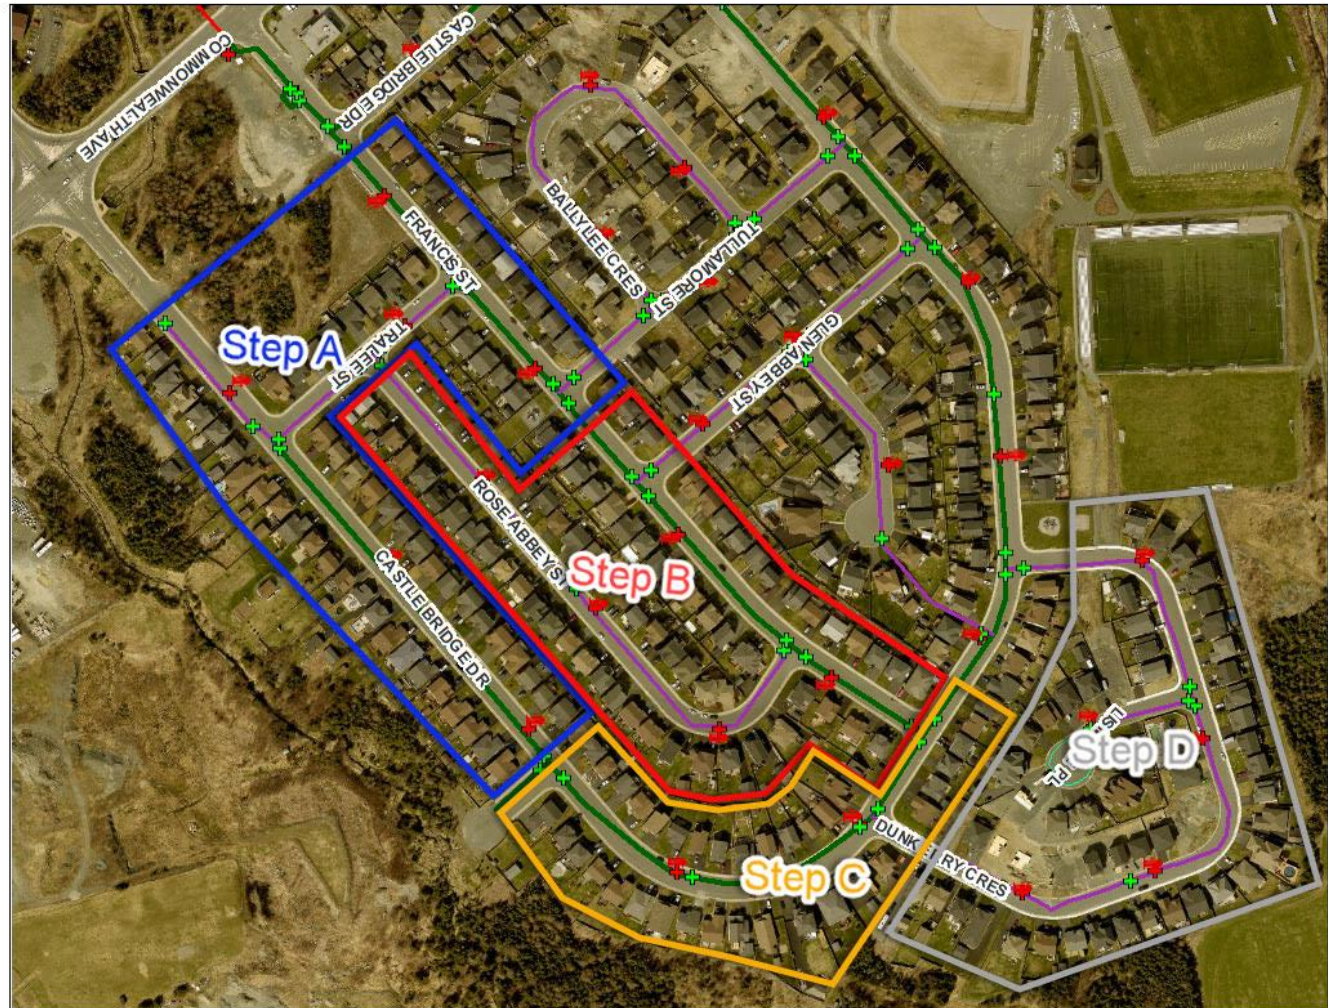
Investigation #2 – Step Testing

Divide Step Area 2 in into smaller steps

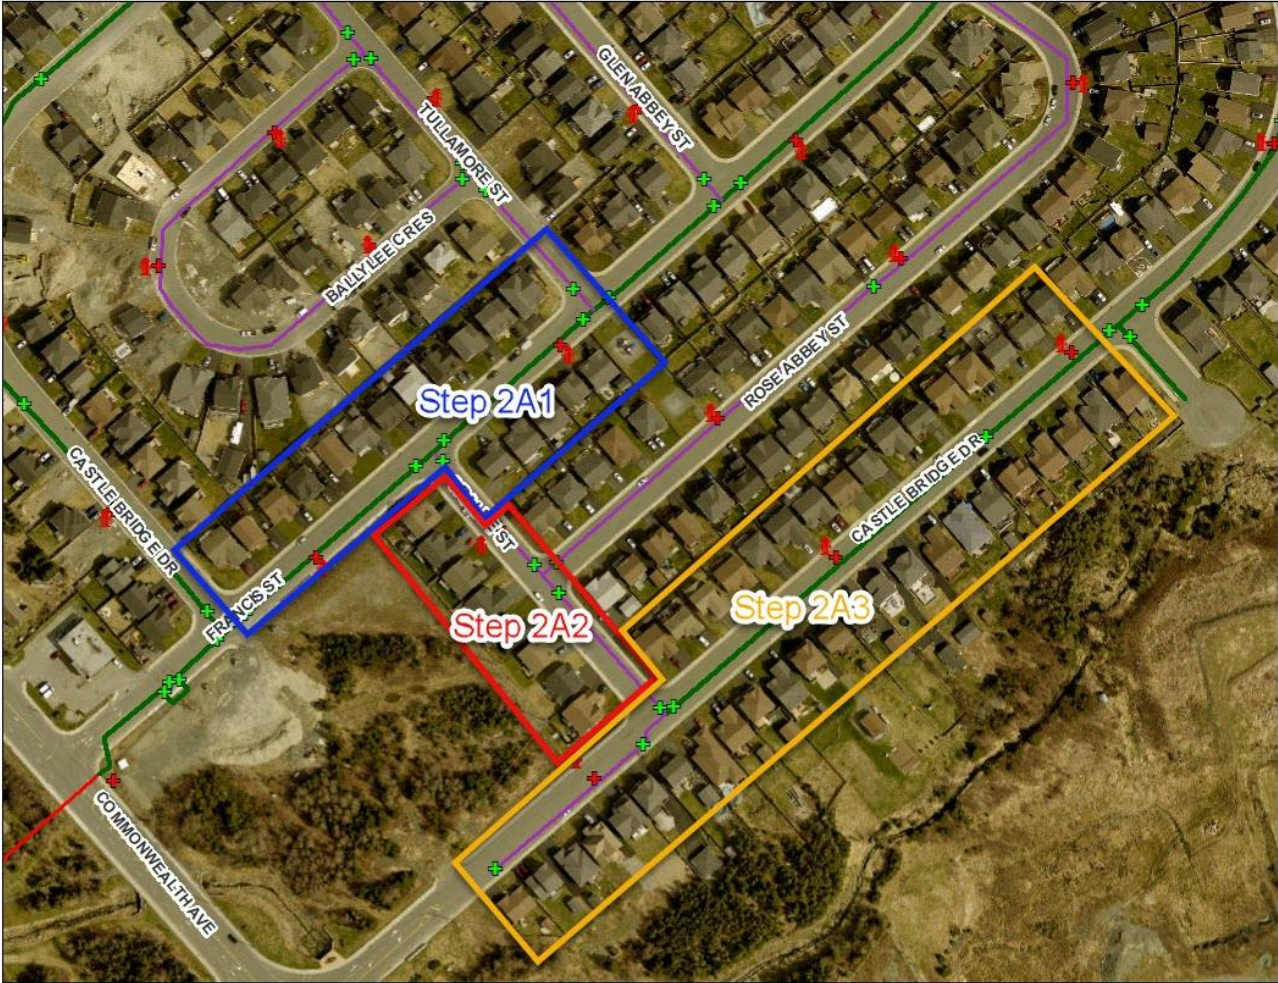
Investigation #2 – Step Testing Area 2A

Divide Step Area 2A in into smaller steps

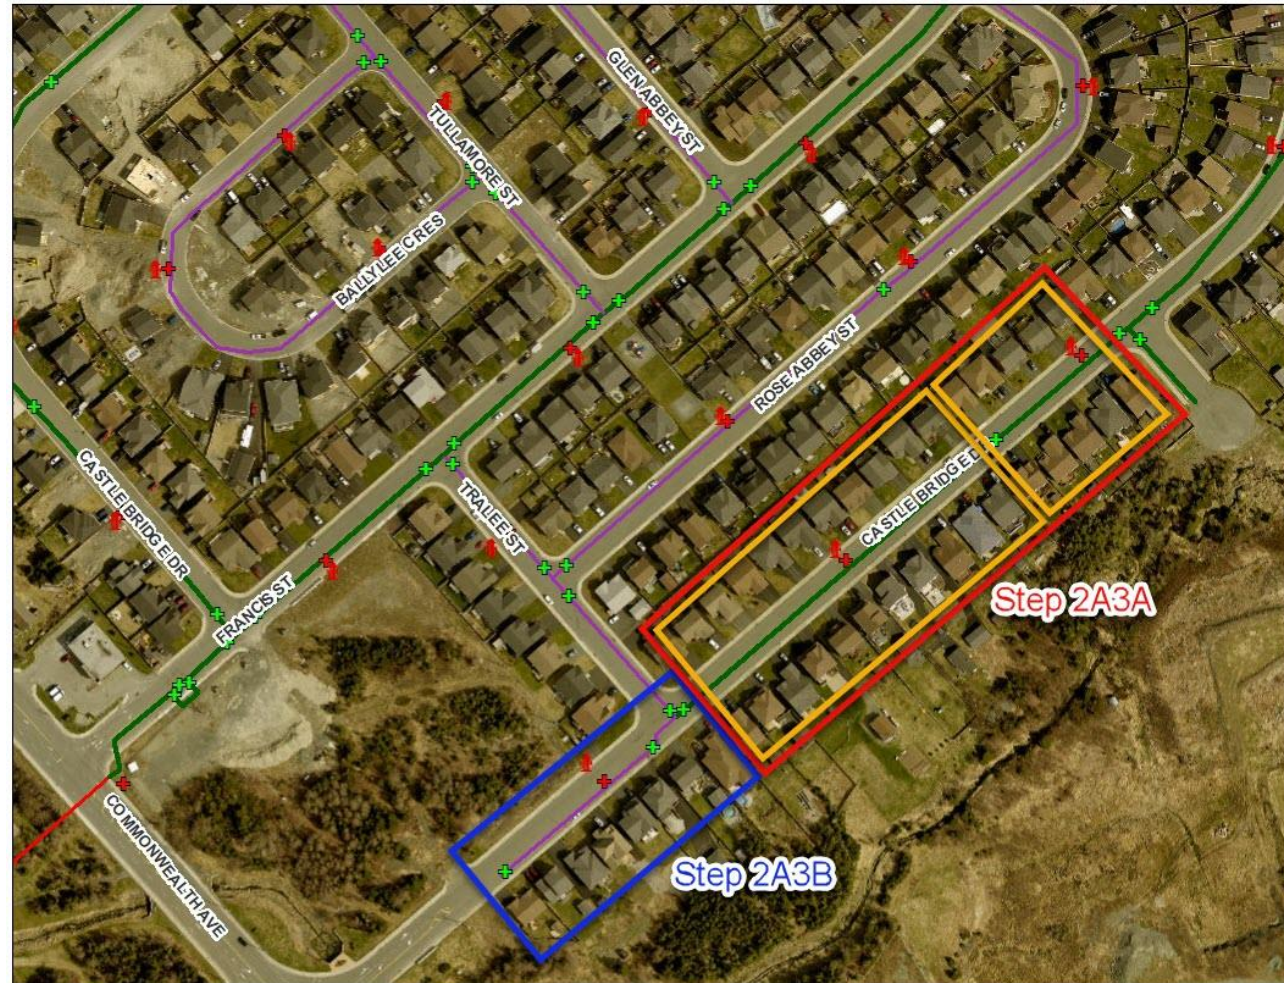
Investigation #2

Divide Step Area 2A3 in into smaller steps

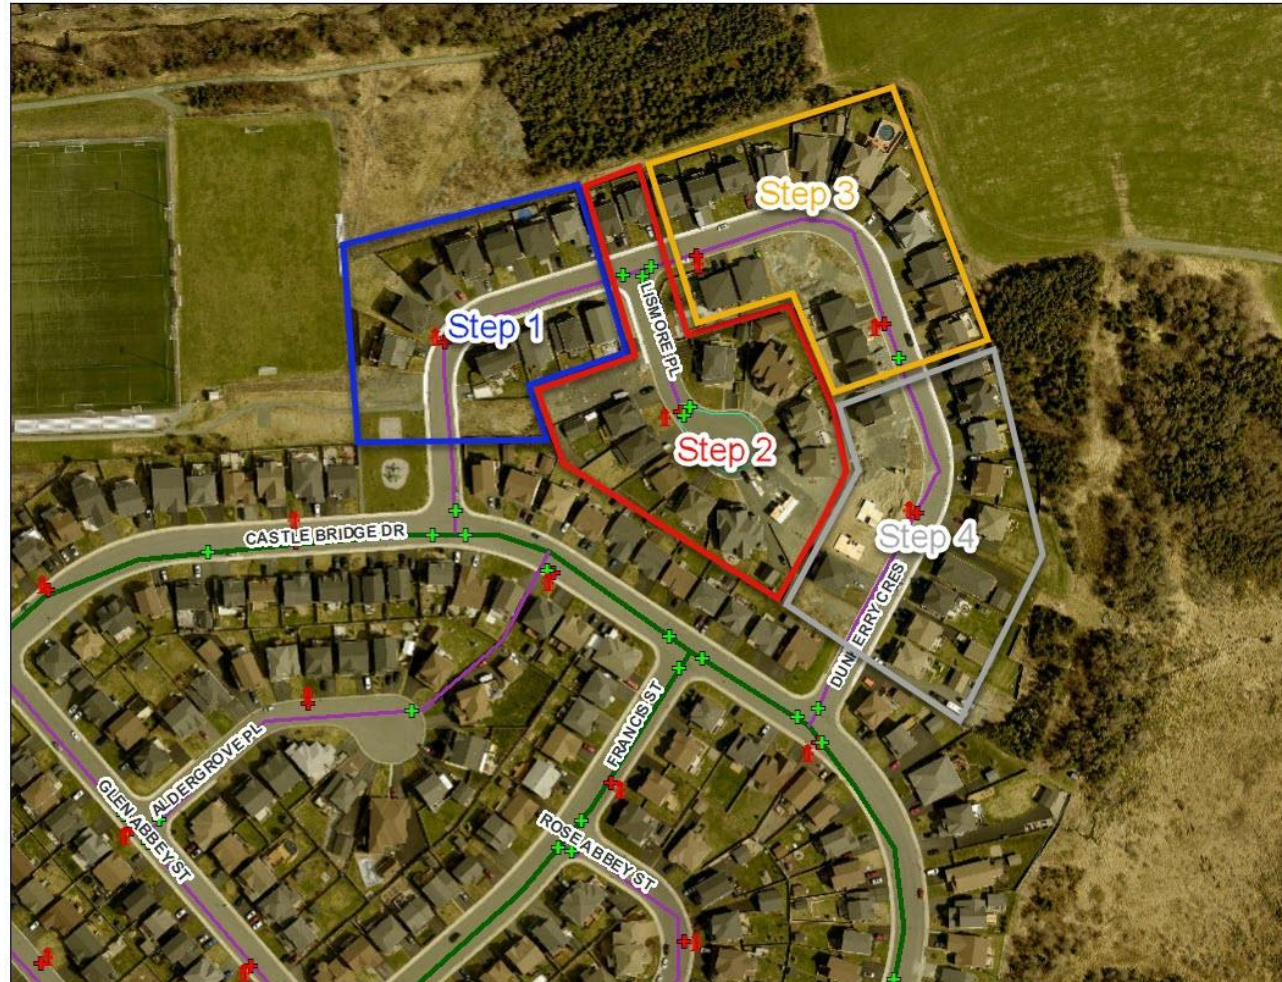
Investigation #3 – Step Testing Area 2D

Divide Step Area 2D in into smaller steps

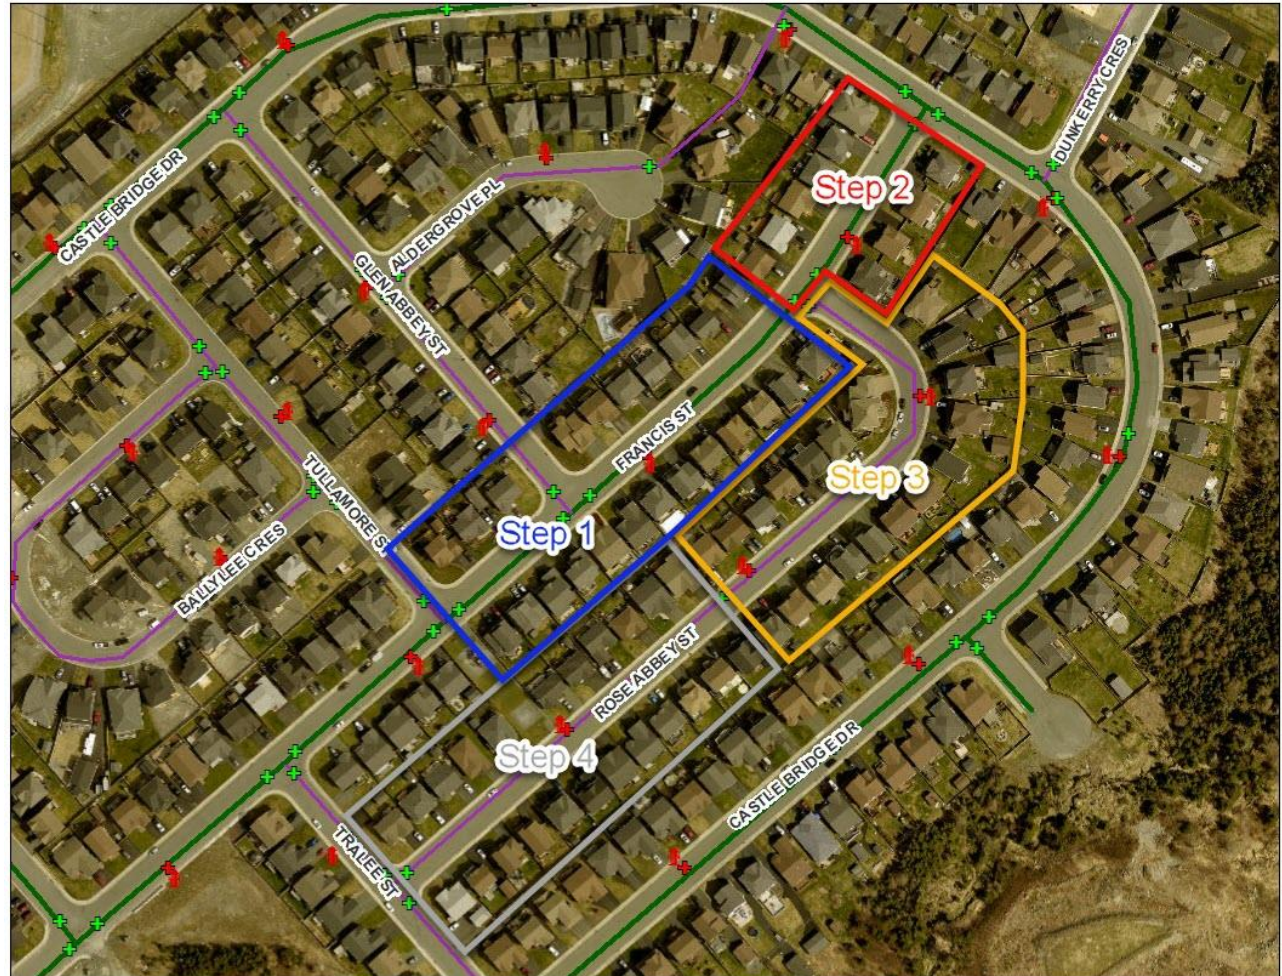
Investigation #3 – Step Testing Area 2B

Divide Step Area 2B in into smaller steps

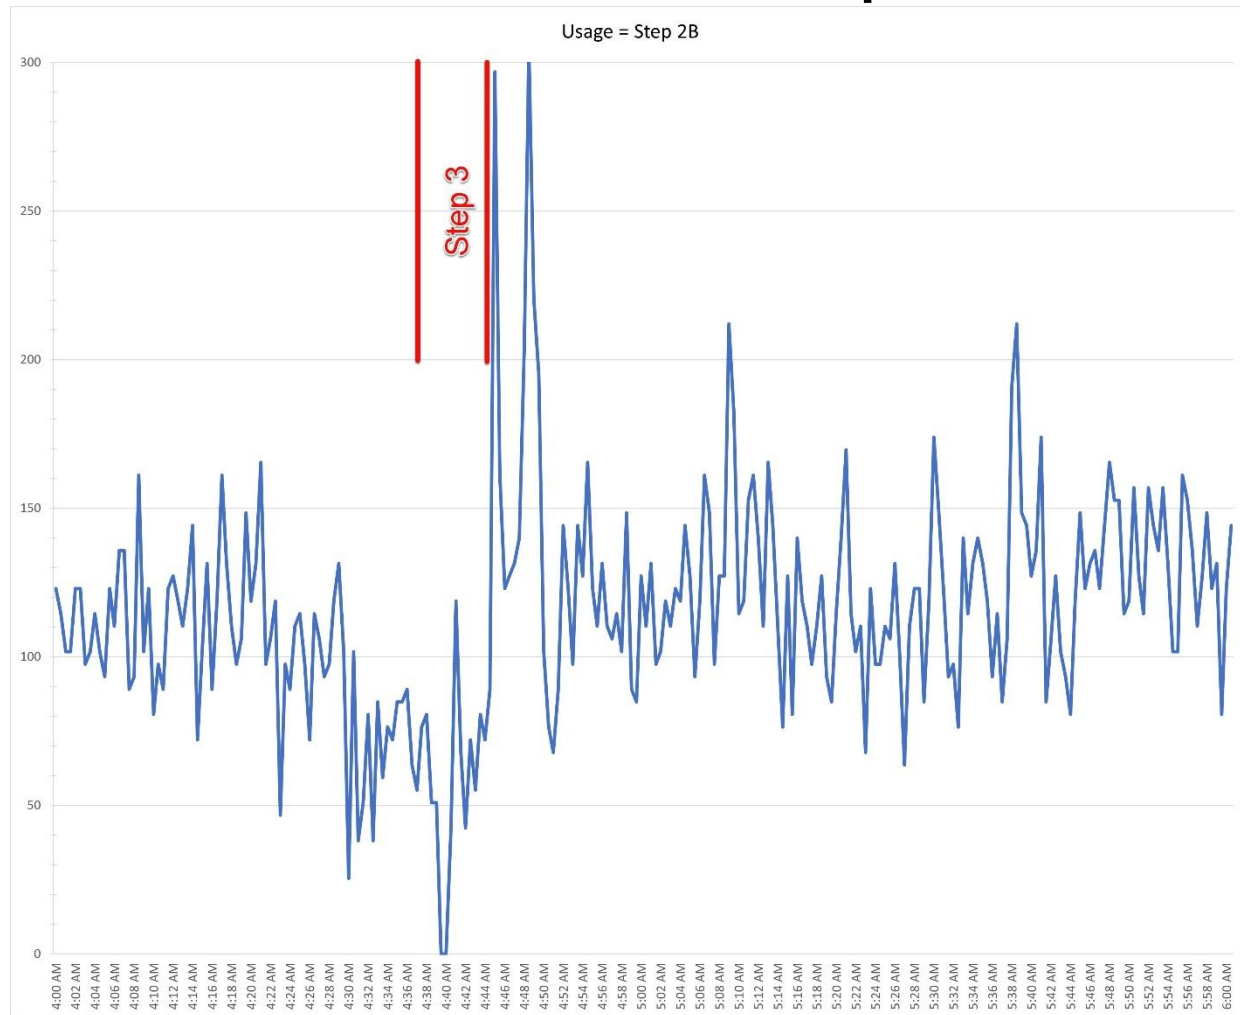
Investigation #3 – Meter Data Step 2B

- Leak Located in Step 3
