**Decline Drilling Program Support  
Factual Summary Report of  
Geotechnical Logging, Packer  
Testing and Downhole  
Geophysical Surveys  
Great Atlantic Salt Deposit  
St. George's, NL**

GEMTEC Project: 101556.003

May 15, 2023  
GEMTEC Project: 101556.003

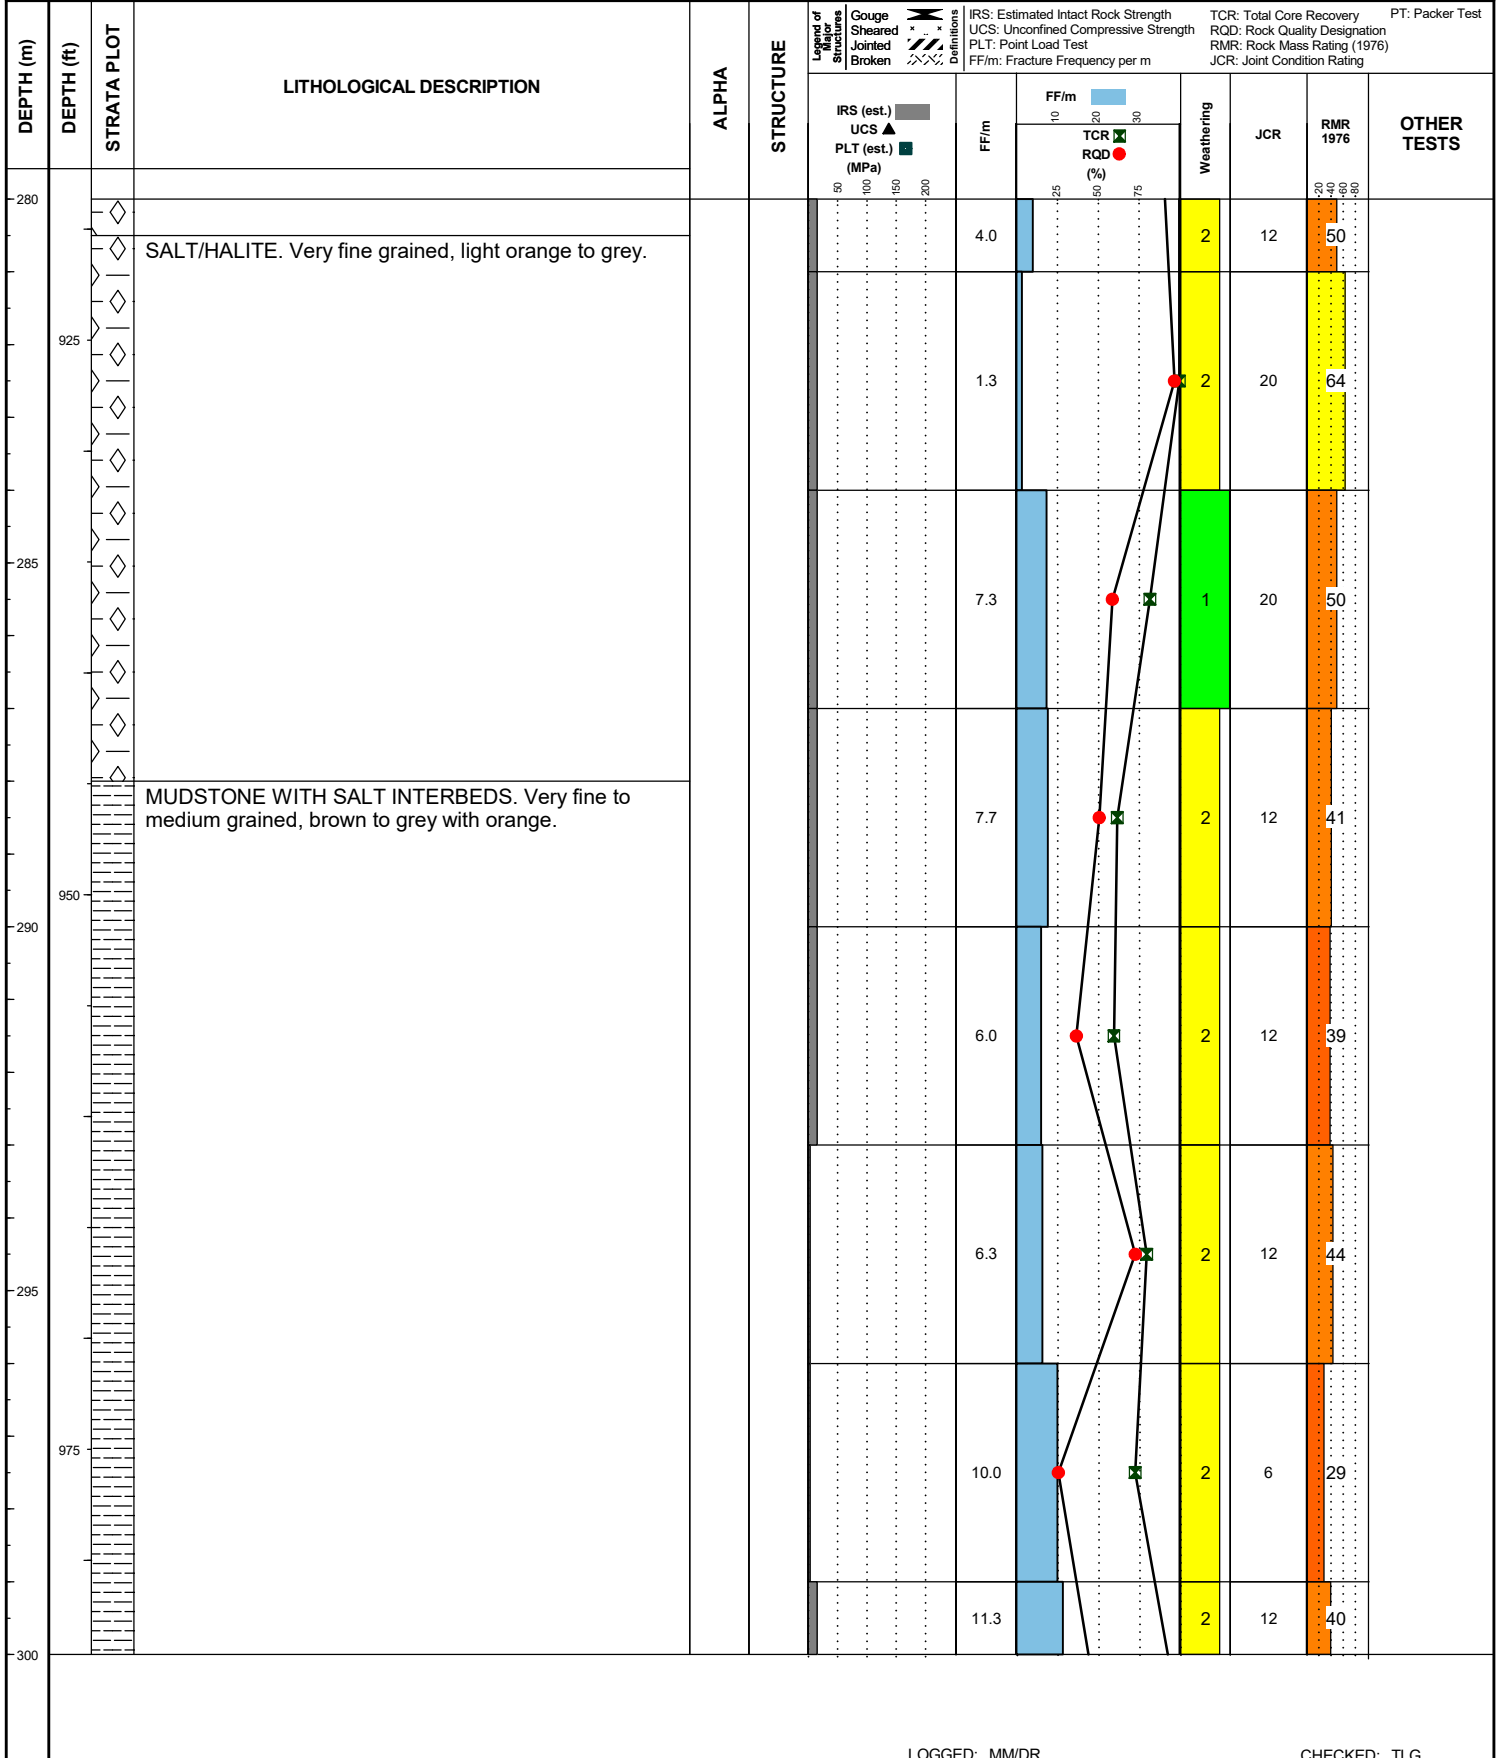
PROJECT NAME: Gemtec Atlas Salt Geotechnical Investigation

TOTAL DEPTH: 491.60 m  
N: 5363177 E: 387770  
ELEVATION: 55.00 m  
UTM ZONE: 21N

DATE STARTED: MAR 30, 2023  
DATE COMPLETED: MAR 31, 2023  
INCLINATION: N/A°  
AZIMUTH: 0°

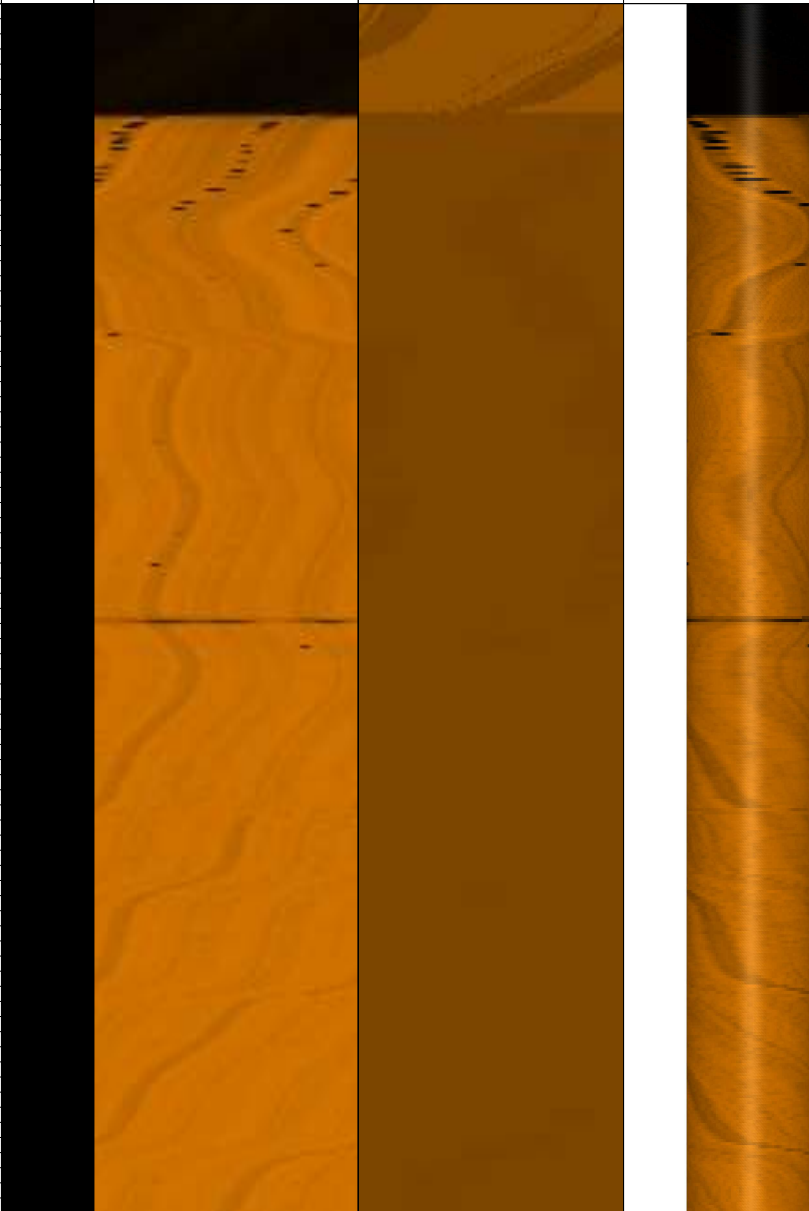
Depth	Litho	Acoustic Image			Orientation	Comments
	Litho	Amplitude-NM	TravelTime-NM	3D Log	True North	
		0 15000 0° 90° 180° 270° 0°	0 us 250 0° 90° 180° 270° 0°	-0°	0 90	
1m:10m		Structure 0° 90° 180° 270° 0°				
6.20

Unable to depth match due to ABI image only.  Water Level at 6.35 m.
6.40						
6.60						
6.80						
7.00						
7.20						
7.40						
7.60						
7.80

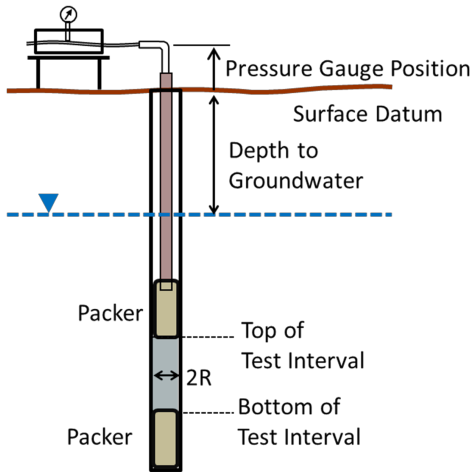
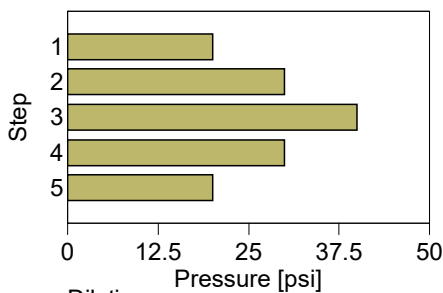
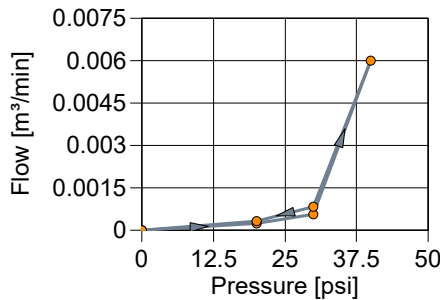
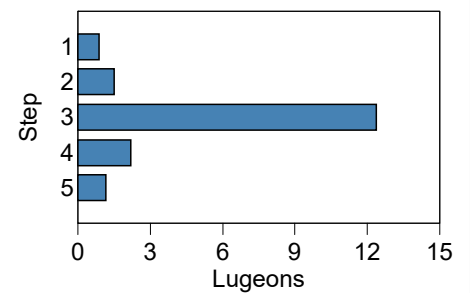
Location: St. George's, NL	Lugeon Test: PT-1	Tested bore: D-1
Test Conducted by: DR		Test Date: 4/2/2023
Analysis Performed by: CW		Analysis Date: 5/3/2023
Lithology: Mudstone

Top of Test Interval: 143.000 m  
 Bottom of Test Interval: 144.500 m  
 Length of Test Interval: 1.500 m  
 Gauge Position: 0.740 m  
 Depth to Groundwater: 4.080 m  
 Radius of Test Section: 0.050 m

Dilation  
 Lugeon: 0.874  
 Hydraulic Conductivity:  $7.74E-8$  m/s  
 Hydraulic Conductivity: 0.00668 m/d

Performed using a double packer test assembly.

Swivel leaking water observed during test, the amount lost represents on average 64% of the total injection volume; K value should be regarded with caution as the formational K may be less than reported.

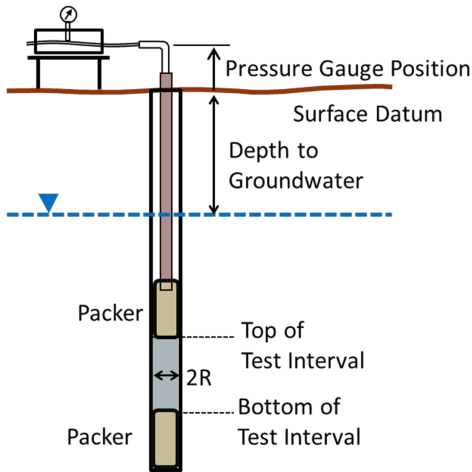
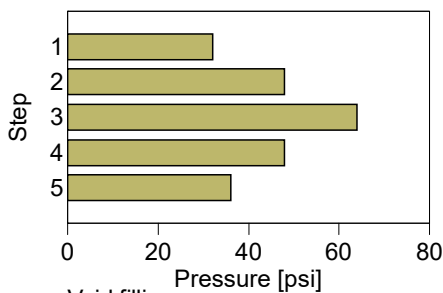
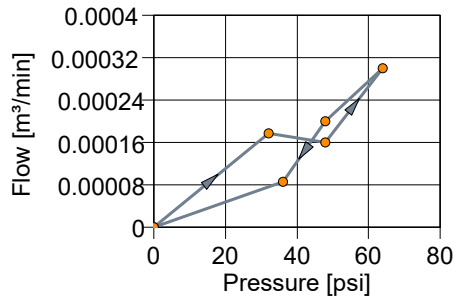
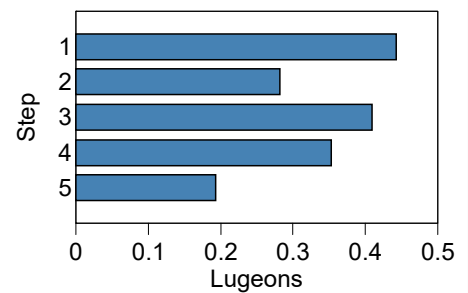
Location: St. George's, NL	Lugeon Test: PT-3	Tested bore: D-1
Test Conducted by: DR		Test Date: 4/2/2023
Analysis Performed by: CW		Analysis Date: 5/3/2023
Lithology: Conglomerate

Top of Test Interval: 63.500 m  
Bottom of Test Interval: 65.000 m  
Length of Test Interval: 1.500 m  
Gauge Position: 0.740 m  
Depth to Groundwater: 4.080 m  
Radius of Test Section: 0.050 m

Void filling  
Lugeon: 0.193  
Hydraulic Conductivity:  $1.71E-8$  m/s  
Hydraulic Conductivity: 0.00148 m/d

Performed using a double packer test assembly.

Swivel leaking water observed during test, the amount lost represents on average 62% of the total injection volume; K value should be regarded with caution as the formational K may be less than reported.

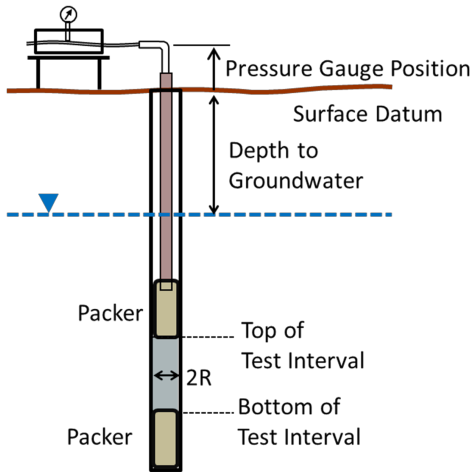
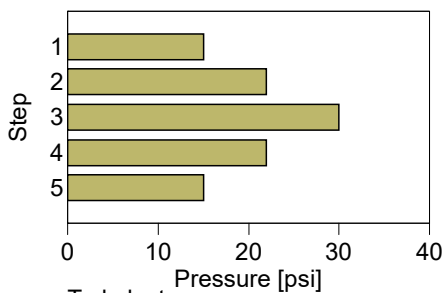
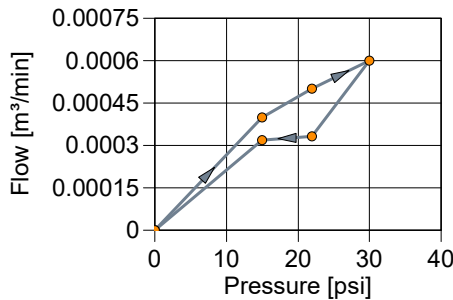
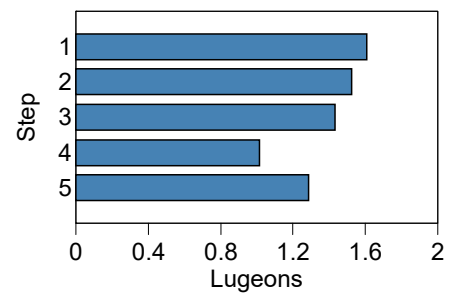
Location: St. George's, NL	Lugeon Test: PT-5	Tested bore: D-1
Test Conducted by: DR		Test Date: 4/4/2023
Analysis Performed by: CW		Analysis Date: 5/3/2023
Lithology: Conglomerate

Top of Test Interval: 117.500 m  
Bottom of Test Interval: 119.150 m  
Length of Test Interval: 1.650 m  
Gauge Position: 0.740 m  
Depth to Groundwater: 4.080 m  
Radius of Test Section: 0.050 m

Turbulent  
Lugeon: 1.523  
Hydraulic Conductivity:  $1.39E-7$  m/s  
Hydraulic Conductivity: 0.01197 m/d

Performed using a double packer test assembly.  
Swivel leaking water observed during test, the amount lost represents on average 89% of the total injection volume; K value should be regarded with caution as the formational K may be less than reported.  
Hydraulic conductivity value for test interval derived based on flow classification: Turbulent (Step 2).

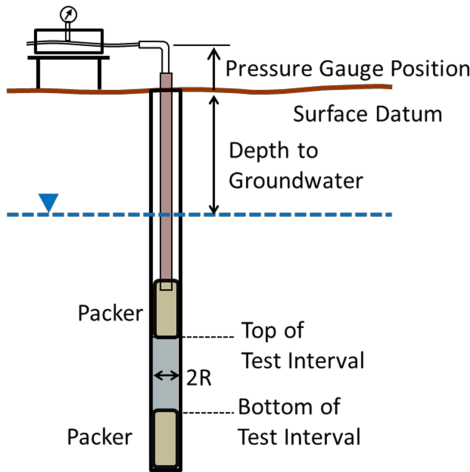
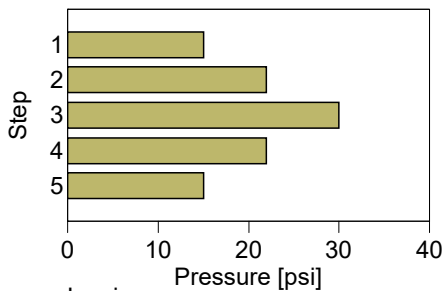
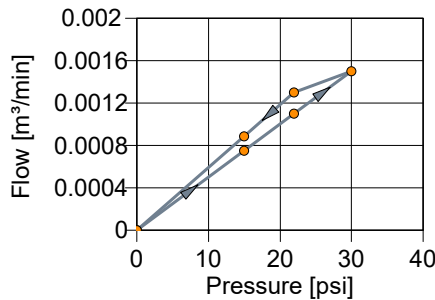
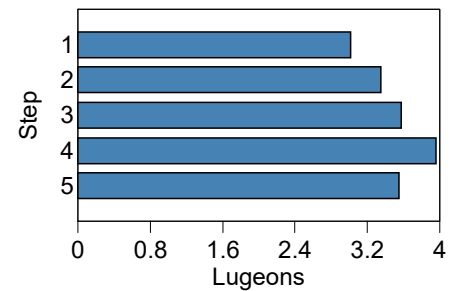
Location: St. George's, NL	Lugeon Test: PT-6	Tested bore: D-1
Test Conducted by: DR		Test Date: 4/4/2023
Analysis Performed by: CW		Analysis Date: 5/3/2023
Lithology: Sandstone

Top of Test Interval: 120.500 m  
 Bottom of Test Interval: 122.150 m  
 Length of Test Interval: 1.650 m  
 Gauge Position: 0.740 m  
 Depth to Groundwater: 4.080 m  
 Radius of Test Section: 0.050 m

Laminar  
 Lugeon: 4.468  
 Hydraulic Conductivity:  $4.06E-7$  m/s  
 Hydraulic Conductivity: 0.03512 m/d

Performed using a double packer test assembly.

Swivel leaking water observed during test, the amount lost represents on average 79% of the total injection volume; K value should be regarded with caution as the formational K may be less than reported.

PT-6	120.5	122.15	1.65	Sandstone	4.06E-07	Water swivel leakage observed during test; the amount lost represented on average 82% of the total injection volume. Calculated K value should be regarded with caution and formational K is expected to be less than that reported.
PT-1	143	144.5	1.5	Mudstone	7.74E-08	Water swivel leakage observed during test; the amount lost represented on average 64% of the total injection volume. Calculated K value should be regarded with caution and formational K is expected to be less than that reported.
