**MEMORANDUM OF AGREEMENT
FOR
WATER QUANTITY SURVEYS**

**REPORT FOR FISCAL YEAR
2021-2022**

| Appendix D Hydrometric Infrastructure and Construction in Atlantic Canada Project Summary Report 2021 – 2022..... | 24 |

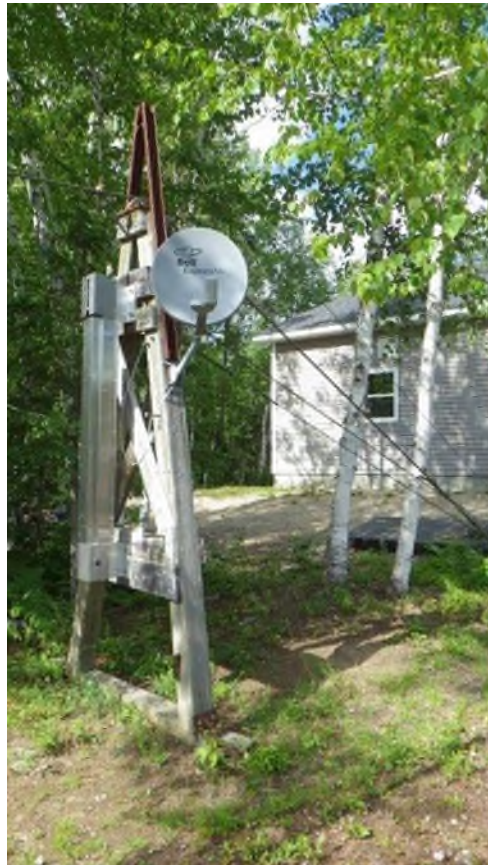
Figure 1 shows the former cableway at 01BQ001 Northwest Miramichi River at Trout Brook that was in poor condition and was no longer required. Therefore, the cableway was decommissioned on August 26, 2021 (Figure 2).

Figure 1. Left bank of former cableway at 01BQ001 Northwest Miramichi River at Trout Brook (Photograph taken on July 4, 2016).

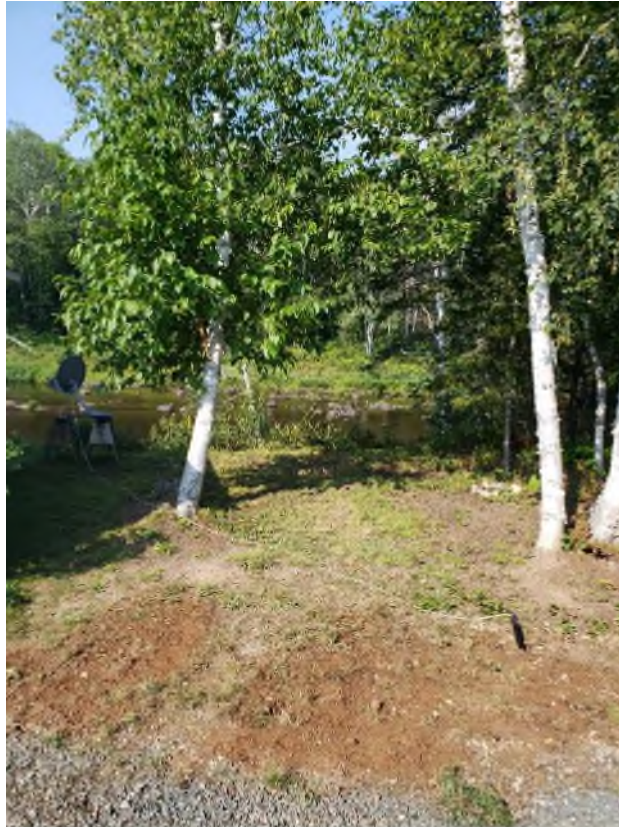
Figure 2. Post construction site at 01BQ001 Northwest Miramichi River at Trout Brook (Photograph August 26, 2021).

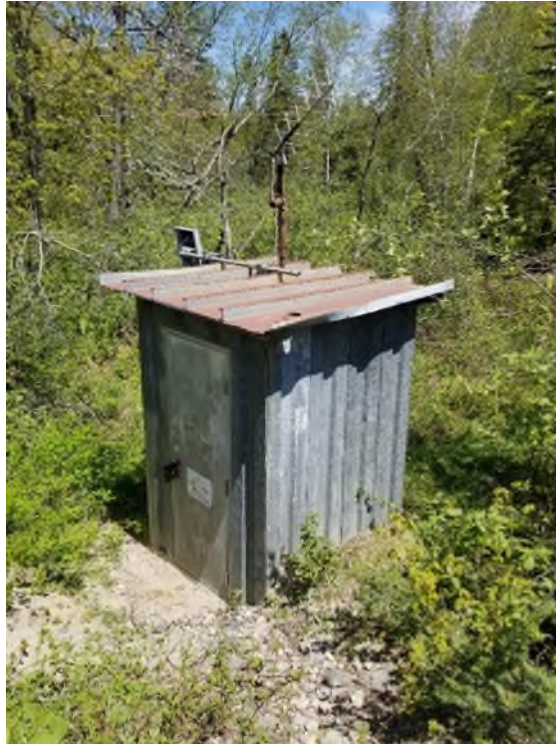
The stilling well at 01BP002 Catamaran Brook at Repap Road Bridge was in poor condition and posed an OHS risk (Figure 3). The well was no longer required as it had been converted to a pressure water level system (Figure 4), therefore, the well was decommissioned October 19, 2021. During the site reconnaissance visit in July the presence of an unidentified hydrocarbon product present as free phase in the well was encountered.

Figure 3. Gauge house and stilling well at 01BP002 Catamaran Brook at Repap Road Bridge (Photograph taken June 6, 2020).

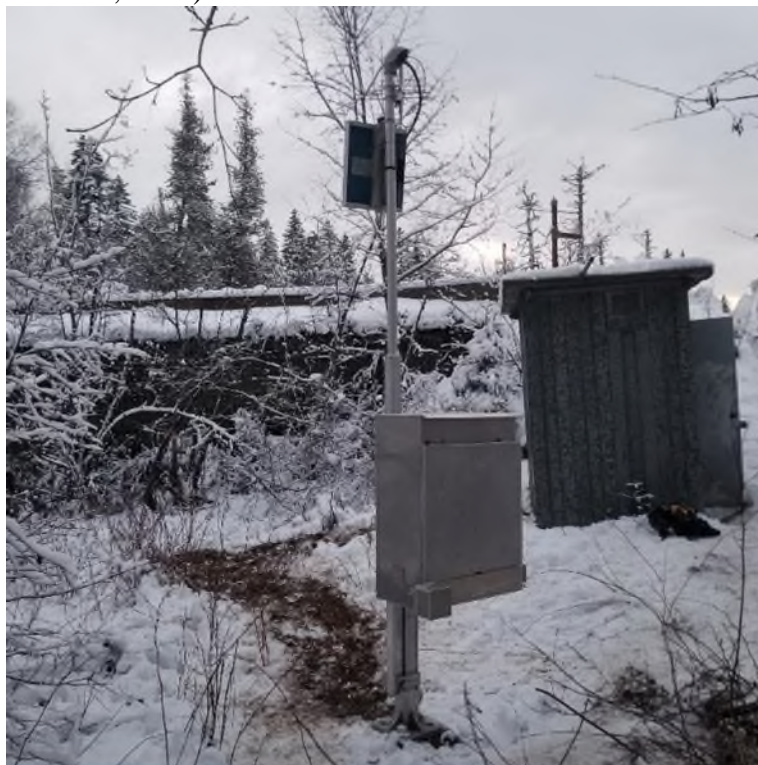
Figure 4. New tilting mast and cabinet at 01BP002 Catamaran Brook at Repap Road Bridge (Photograph taken December 7, 2020).

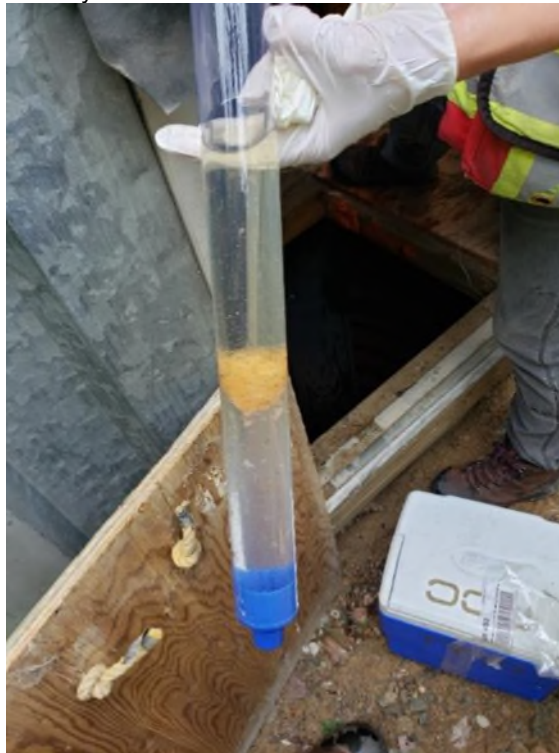
Environmental consultants were retained through PSPC as a result of encountering potential TPH contamination to conduct a preliminary environmental site assessment (Figure 5). This work was conducted with a batch of seven other stilling wells in the Maritimes. The results from this testing indicated the presence of free product in the frost tube which exceeded the applicable guidelines for the Maritimes. Other samples included groundwater, soil, and sediment which were all within the acceptable limits of the applicable guidelines.

Figure 5. Well water in the stilling well at 01BP002 showing free phase layer (photograph taken July 9, 2020).

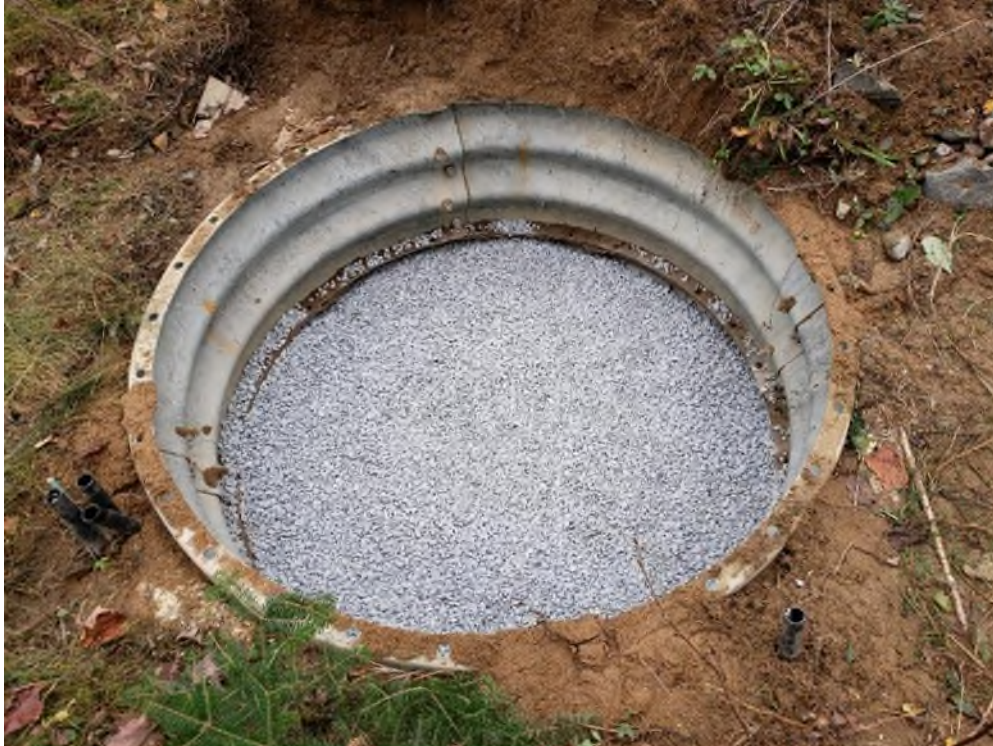
Figure 6. Well filled in with layers of sand and bentonite at 01BP002 (photograph taken October 19, 2021).

The decommissioning of the well was done in accordance with the recommendations from the report provided from the environmental assessments conducted through the PSPC. Figure 6 shows the well filled in after the water and sediment had been pumped out to be properly disposed. The site of the old well was restored using top soil and seeded to encourage new growth (Figure 7). It should be noted that there is no need for any further work at this site.

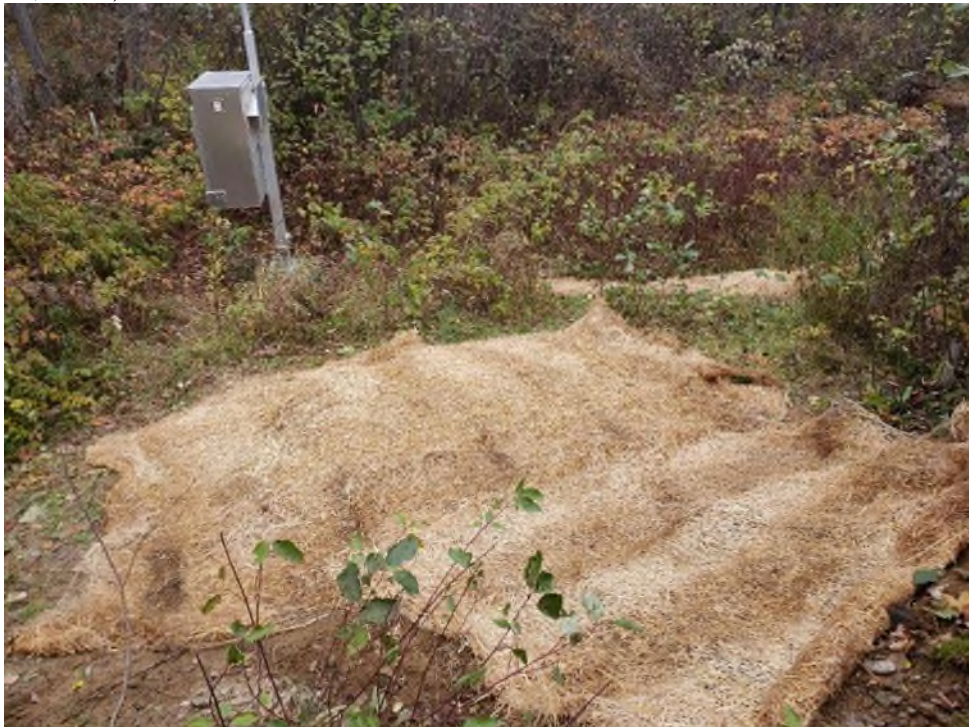
Figure 7. View looking at the site post-decommissioning and soil remediation (photograph taken October 19, 2021).

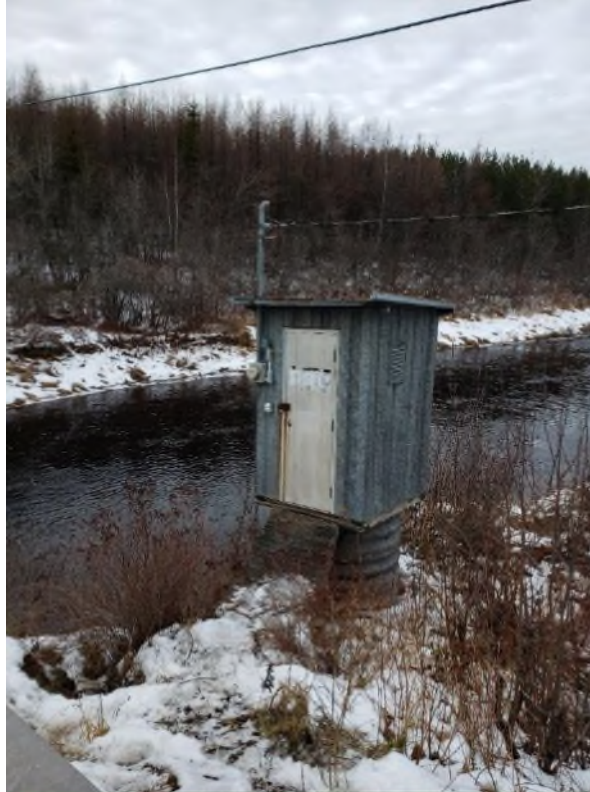
Figure 8 shows the former stilling well and gauge house at 01BS001 Coal Branch River at Beersville. This gauge house was in poor condition, which posed an OHS risk to ECCC personnel servicing the station. Similar to Catamaran Brook, historical review of the station indicated that there was potential for PHC contamination. Therefore, additional information was required to be collected prior to decommissioning this well. This well was also included in the preliminary environmental assessment conducted by environmental consultants hired by PSPC.

Figure 8. Gauge house and stilling well at 01BS001 Coal Branch River at Beersville (photograph taken on November 15, 2019).

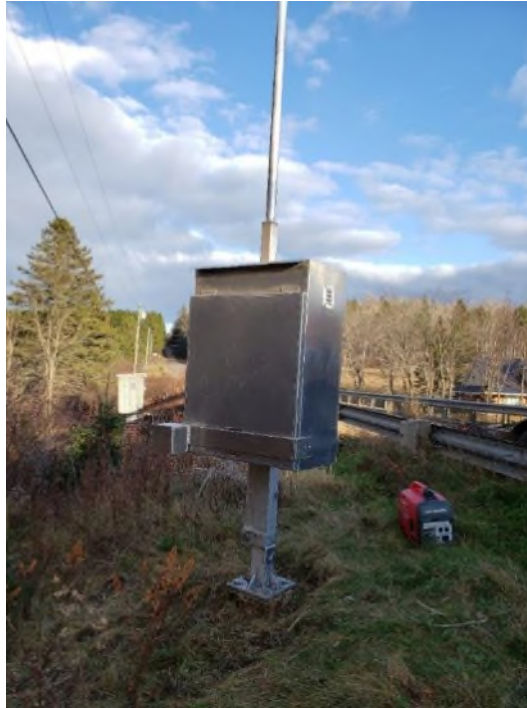
Figure 9. New tilting mast and enclosure at 01BS001 Coal Branch at Beersville (photograph taken November 18, 2020).

In the interim in 2020, a new aluminum tilting mast was installed on the far bank of the river (right bank), near the guardrail to the bridge, and in the right of way of the road as shown in Figure 9. This was installed onto a single three-inch diameter screw pile. The hydrometric monitoring equipment has been moved and installed into the new shelter.

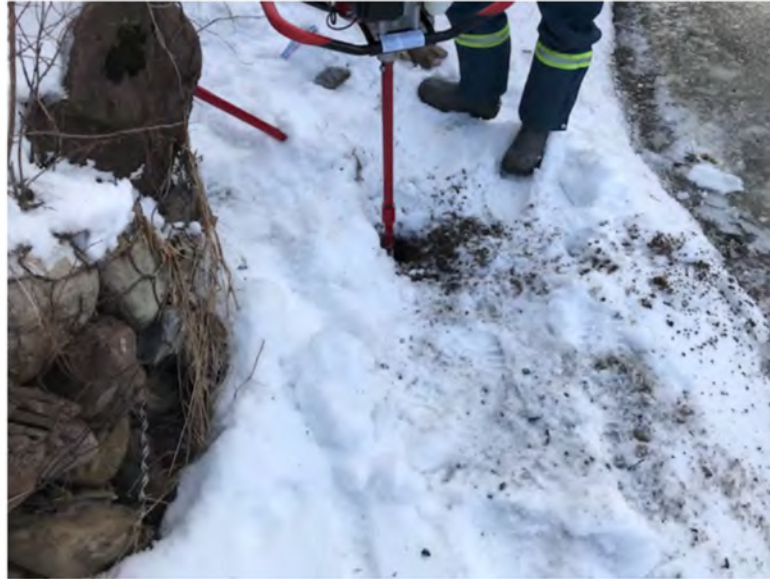
Figure 10. View of power auger used to install monitoring well (MW1) on January 20, 2021 (Photograph from GHD, 2021a).

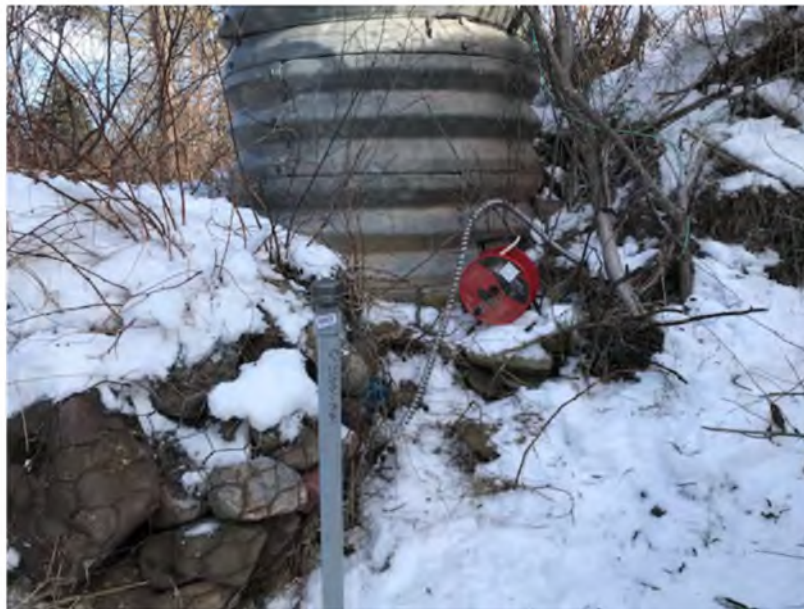
Figure 11. View of monitoring well MW1 facing east on January 20, 2021 (Photograph from GHD, 2021a).

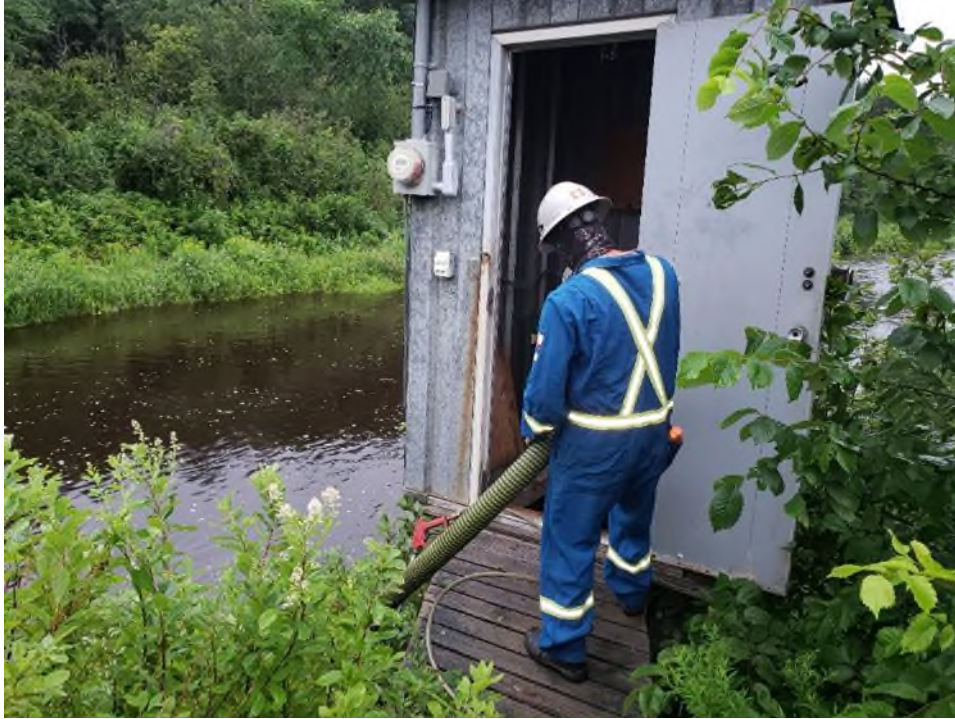
Figure 12. View of well water and sediment being pumped out (photograph taken July 22, 2021).

This recommendation was followed in the decommissioning of this well. Figure 12 shows the well being pumped which was conducted July 22, 2021. The well was then cleaned on August 25, 2021. Finally, Figures 13 and 14 show the decommissioning and remediation of the well which was conducted October 20, 2021. It should be noted that there is no need for any further work at this site.

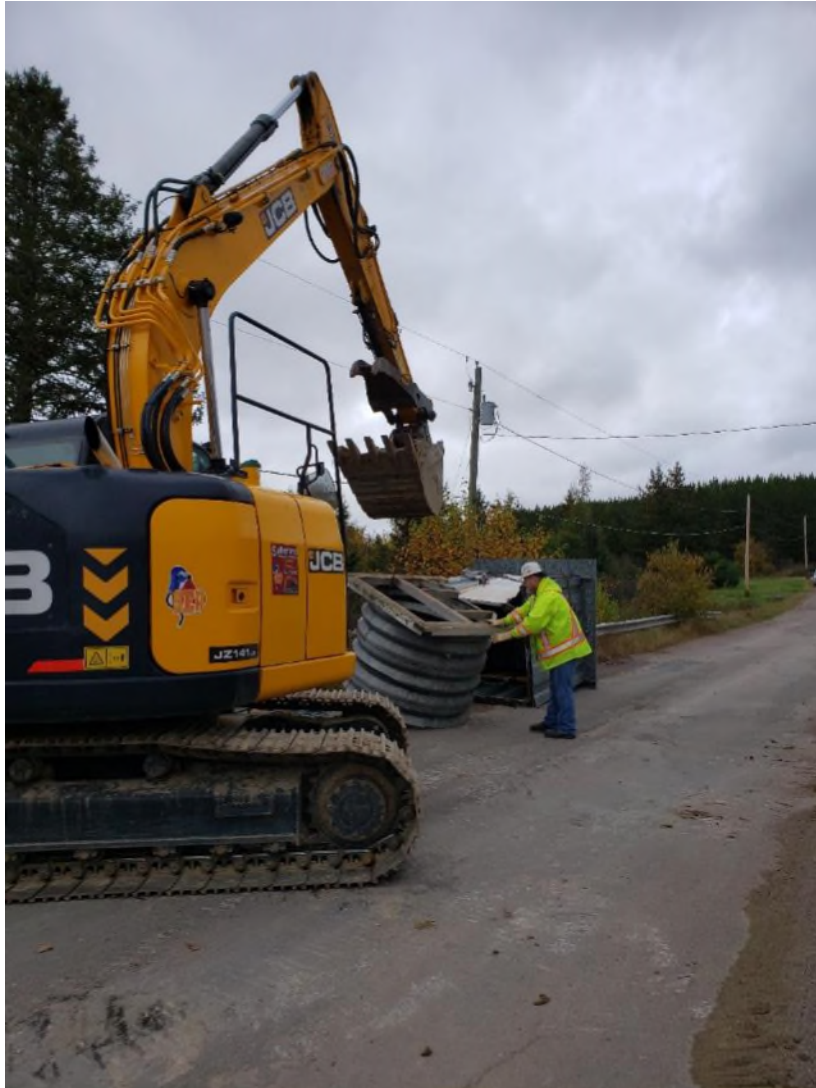
Figure 13. Shelter and well casing being removed from the site (photograph taken October 20, 2021).

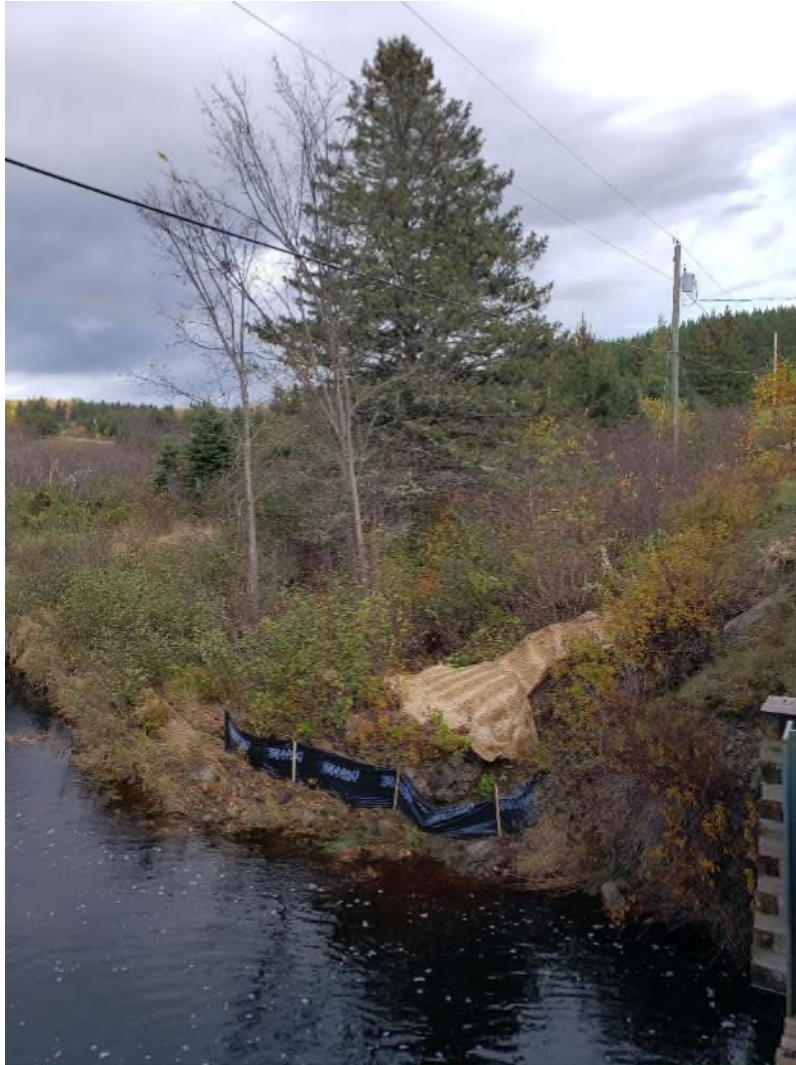
Figure 14. View of the remediated area where the former shelter was located (photograph taken October 20, 2021).

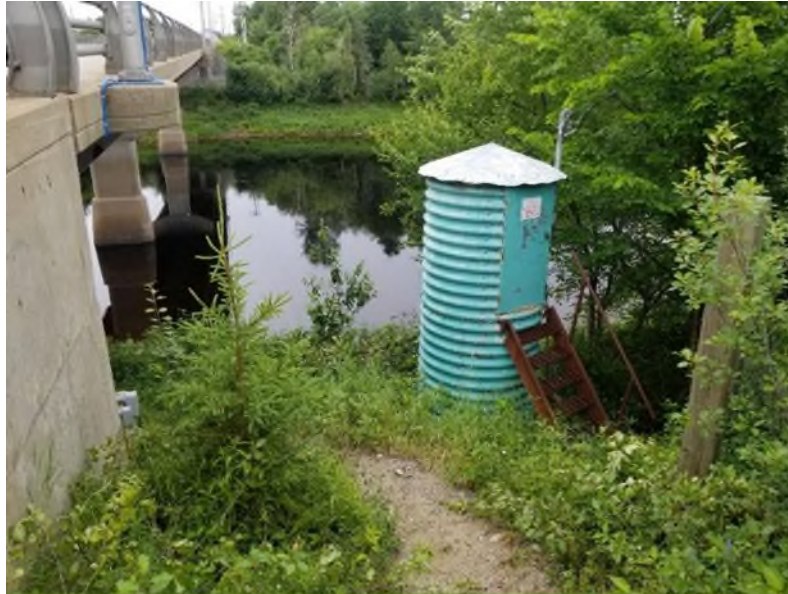
Figure 15 shows the former stilling well and shelter located at 01B0001 Southwest Miramichi River at Blackville. The shelter was in poor condition and posed an OHS concern. Therefore, this well was decommissioned January 12, 2022. This well was suspected of potential environmental contamination for PHC based on historical review. In addition, there was potential for mercury to remain at this station around the shelter. As a result of this potential contamination, a preliminary environmental assessment was conducted in conjunction with the seven other wells across the Maritimes, which was conducted by environmental consultants managed through PSPC.

Figure 15. Gauge house and stilling well at 01BO001 Southwest Miramichi River at Blackville (Photograph taken July 23, 2019).

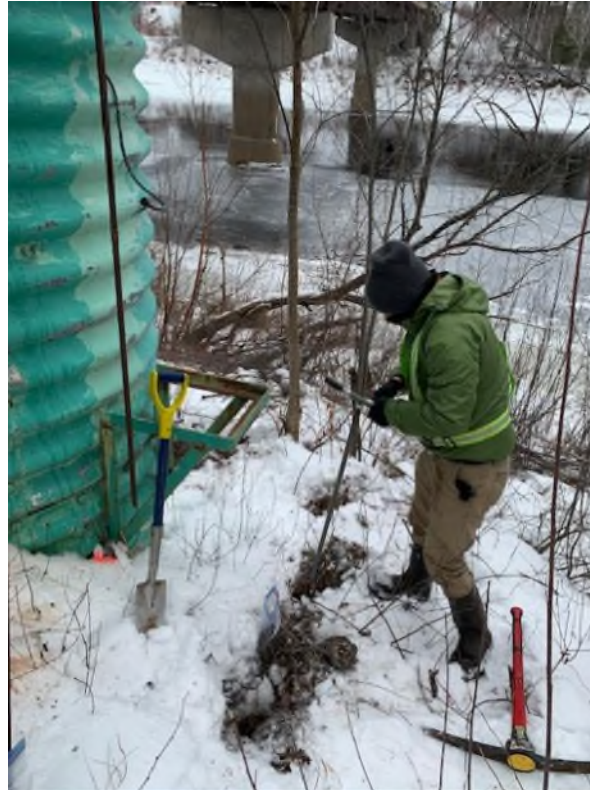
Figure 16. Installation of the shallow monitoring well at 01BO001 by GHD. Photograph taken January 18, 2021 (GHD, 2021b).

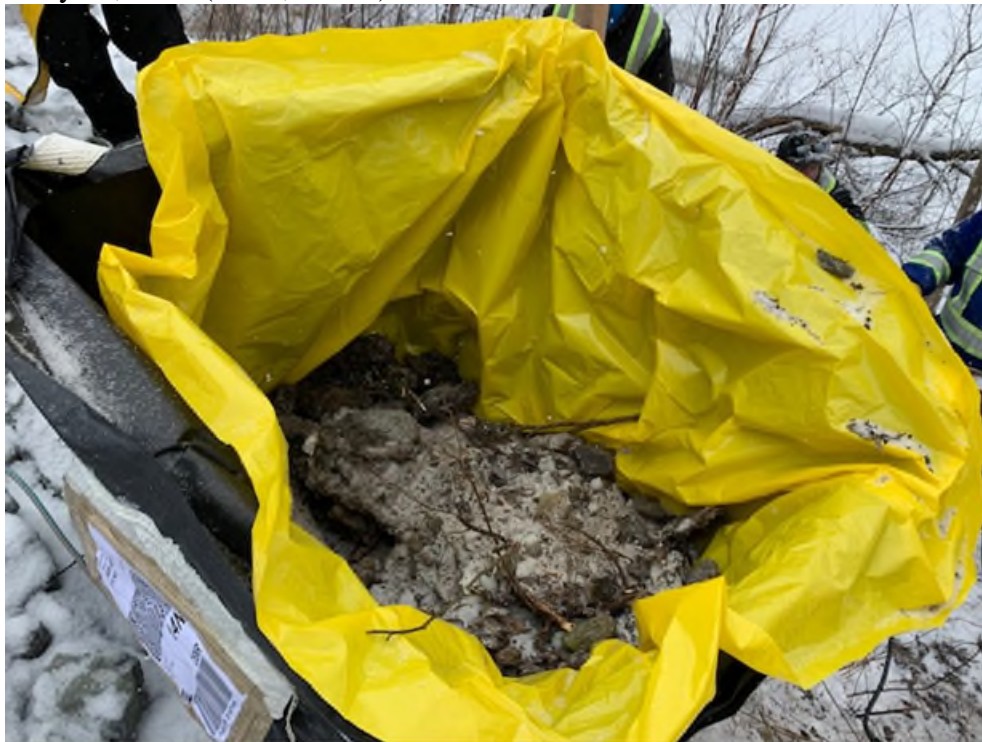
Figure 17. View of mercury contaminated soil from soil remediation (photograph taken January 12, 2022).

The former stilling well was decommissioned January 12, 2022 in accordance with the recommendation in the report from the environmental assessment facilitated through a contract with PSPC. This included taking caution when handling the lead-based painted materials and having them disposed of at an approved facility. One soil sample returned with a mercury exceedance according to applicable guidelines. This soil was (estimated 0.54 m³) was removed and placed in approved containers to disposed of at a licenced facility (Figure 17). Figures 18 and 19 show the decommissioning and remediation of the former well site.

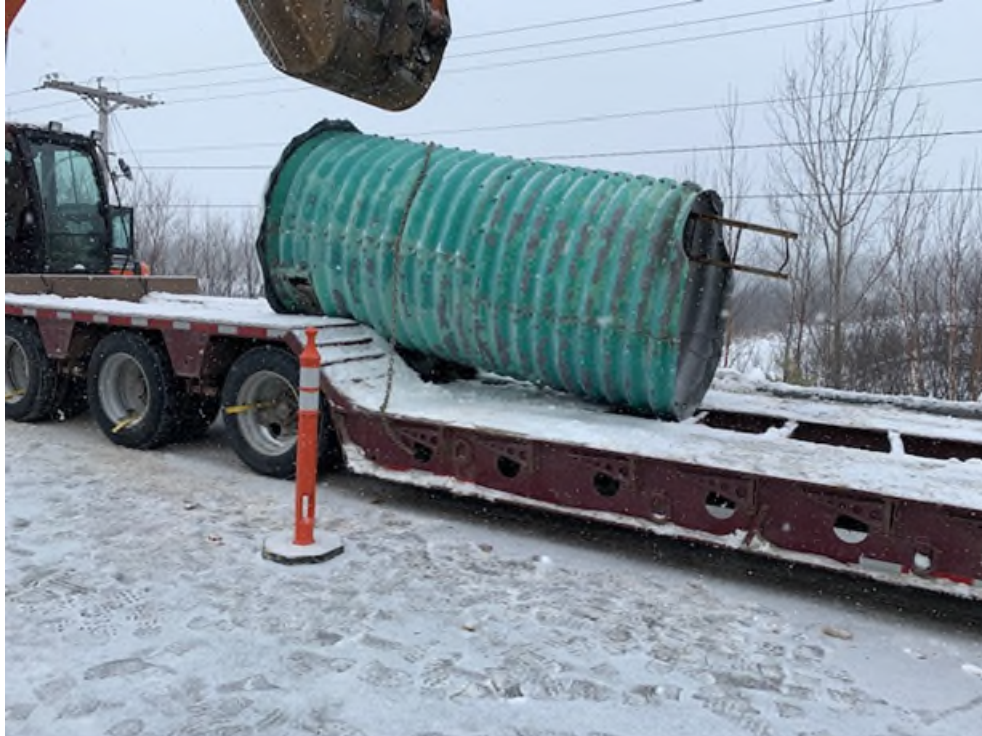
Figure 18. View of the removal of the station well top at 01BO001. Photograph taken January 12, 2022 (GHD, 2022).

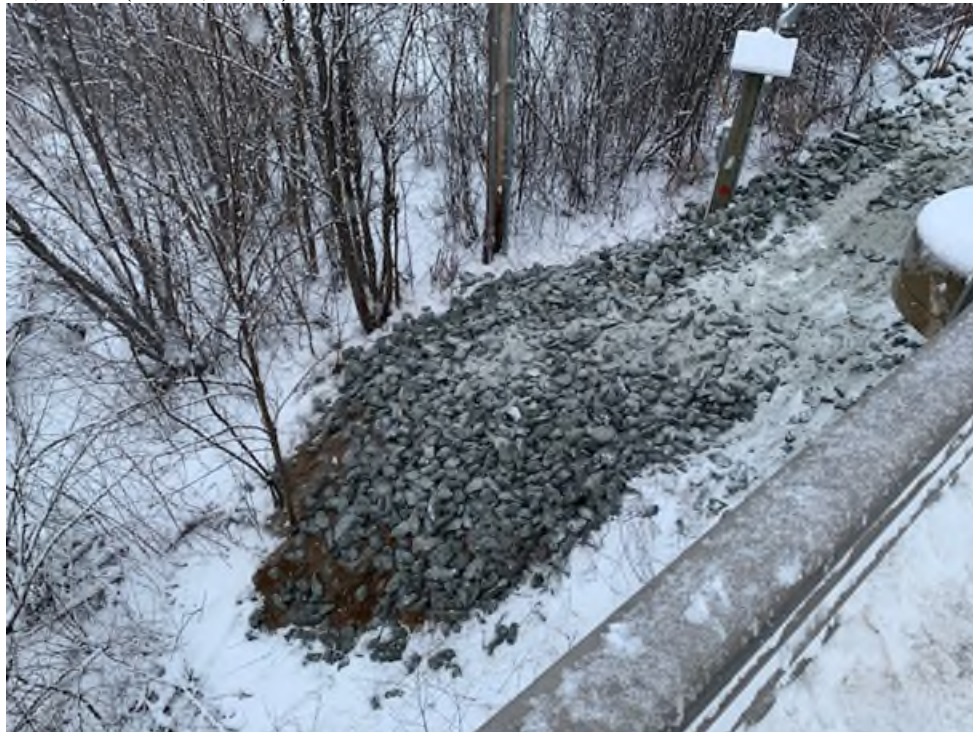
Figure 19. View of well and remedial area grading with rock. Photograph taken January 12, 2022 (GHD, 2022a).

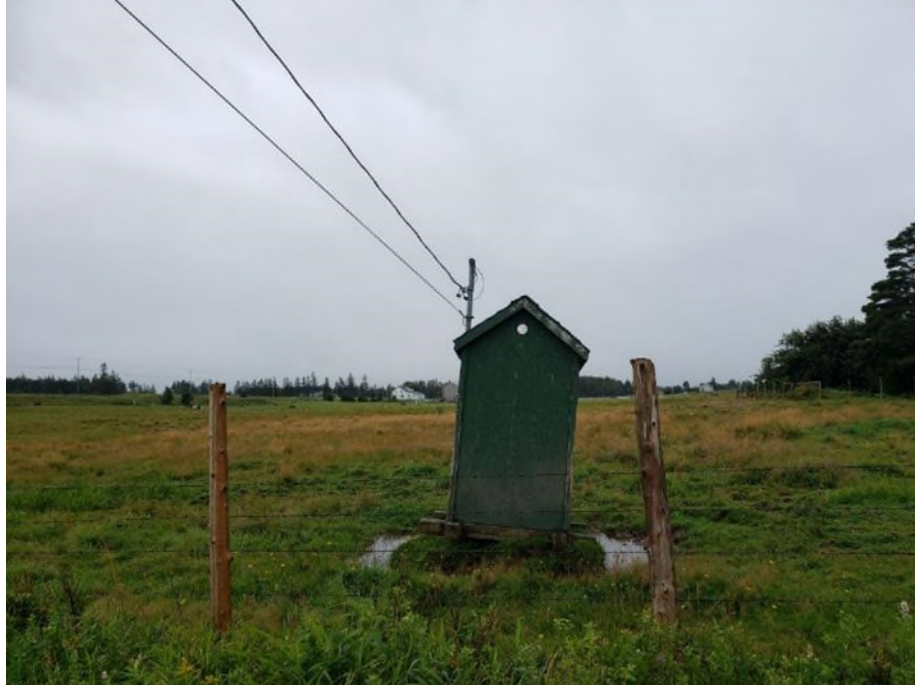
Figure 20 shows the shelter at 01BTG02 Point de Bute Groundwater prior to shelter improvements. This station is located in a cow pasture and the cows would often rub against the shelter which caused the shelter to tilt. This identified the need to fix the shelter and build a fence around the structure to prevent future tilting. A barbed wire fence with an access gate was constructed and installed November 18, 2021 (Figure 21).

Figure 20. View of tilting shelter at 01BTG02 prior to improvements (photograph taken August 6, 2021).

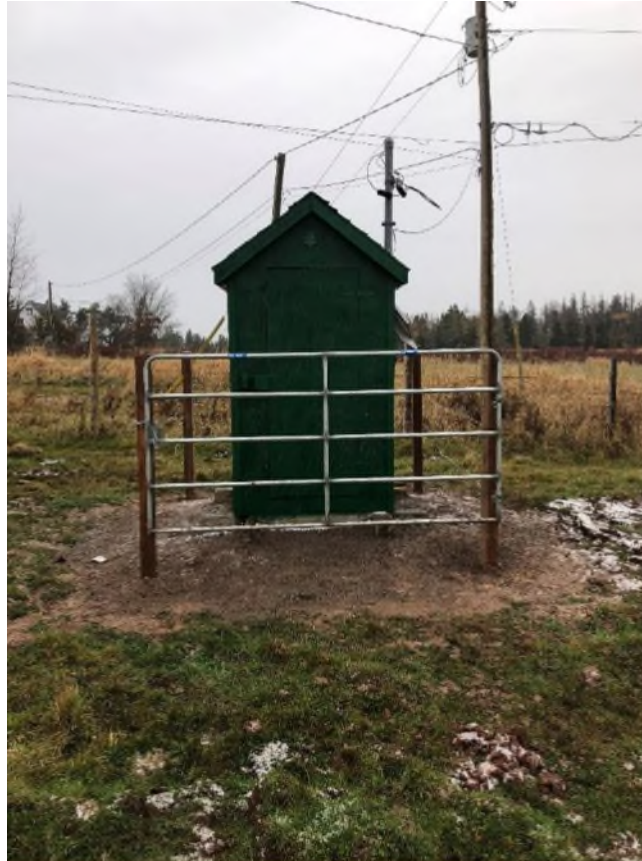
Figure 21. View of shelter after it levelled off and the installation of the fence (photograph taken November 18, 2021).

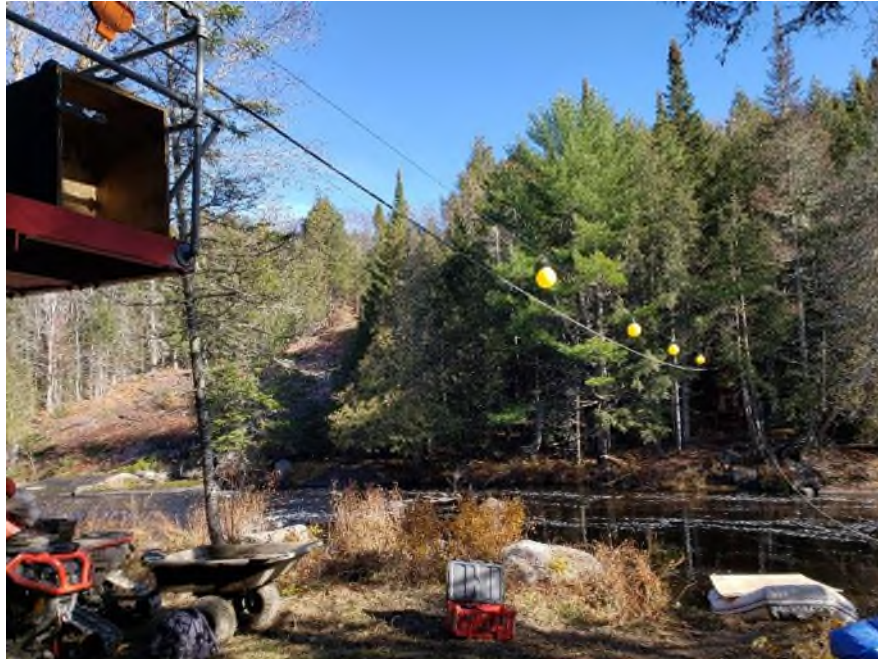
The BOC has been updated with a Barossa Double drum unit in 2018 to facilitate conventional discharge measurements (Figure 22). The BOC was partially renovated in November 2020; however, additional renovations were needed to bring the BOC to operational standards. The additional renovations were conducted by an internal team from ECCC in November 2021. The renovations included the addition of ready-mix concrete bags to the right bank concrete mass anchor (Figures 23 and 24). Additional concrete was mixed on site and added to the right bank anchor in Nov. 2021. A total of 52 bags (66 lbs/30 kg/bag) were added to the anchor for a total weight of 1,560 kg addition. The final total weight of the anchor on RB is estimated at 6,500 kg (existing concrete + steel plates + additional concrete). The hardware and cable on the backstays for both banks were replaced (Figure 25). New aircraft warning markers were installed. A new load limiting leash was designed for the site to allow for a safer measurement. This BOC is now upgraded and operational and training of operations staff is anticipated for December 2022.

Figure 22. Barossa double drum winch bank-operated cableway at 01AK001 Shogomoc Stream near Trans Canada (Photograph November 4, 2021).

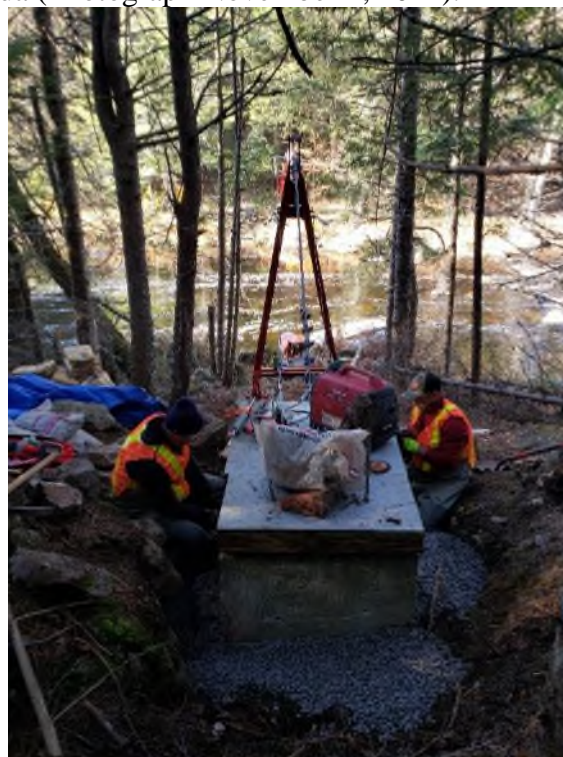
Figure 23. Constructing concrete formwork to upgrade the right bank mass anchor at 01AK001 Shogomoc Stream near Trans Canada (Photograph November 3, 2021).

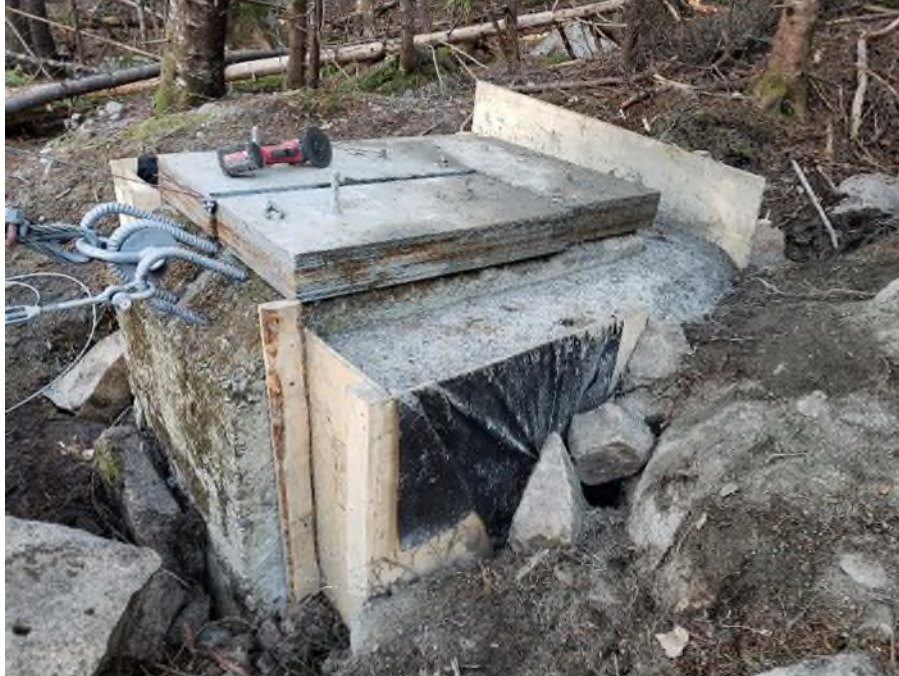
Figure 24. Concrete and steel weight additions to the right bank concrete mass anchor at 01AK001 Shogomoc Stream near Trans Canada (Photograph November 5, 2021).

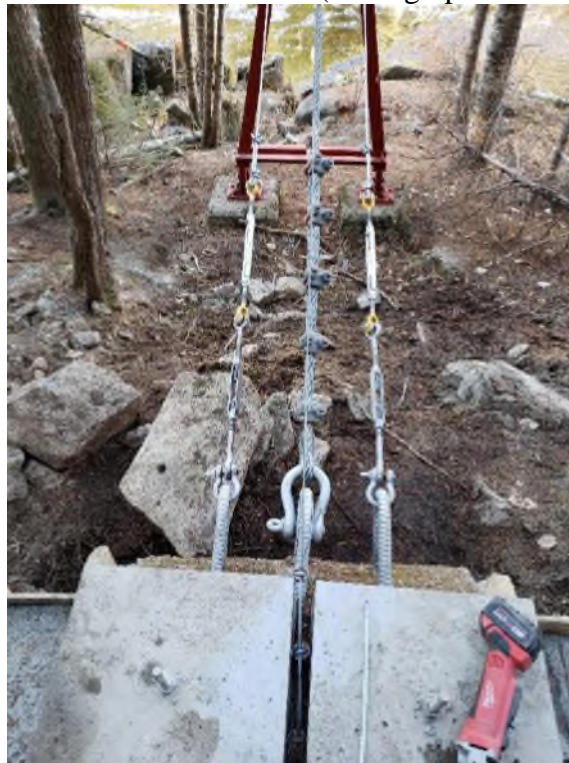
Figure 25. New hardware on the cableway backstays on the right bank at 01AK001 Shogomoc Stream near Trans Canada (Photograph November 5, 2021).

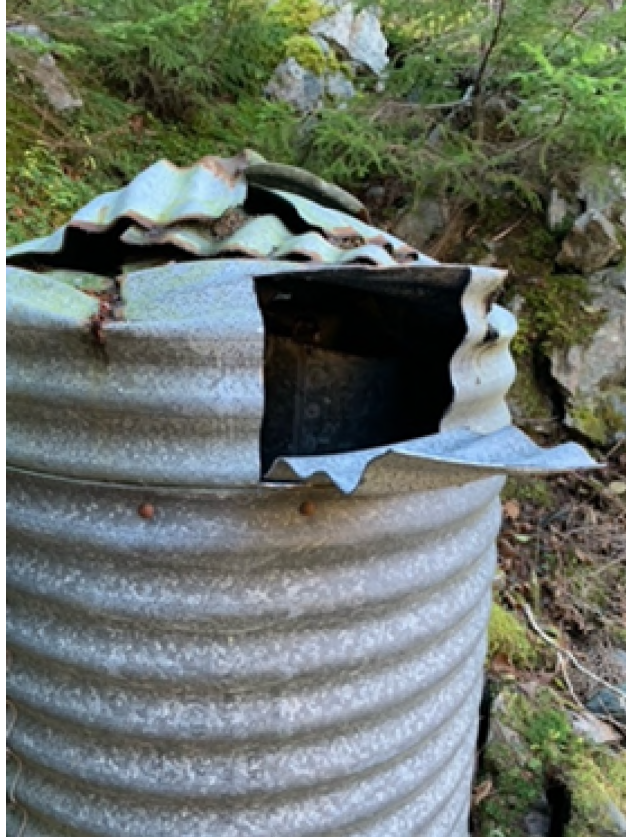
Figure 26. View of stilling well at 01BV006 with access hole cut for sampling purposes (photograph taken November 27, 2021).

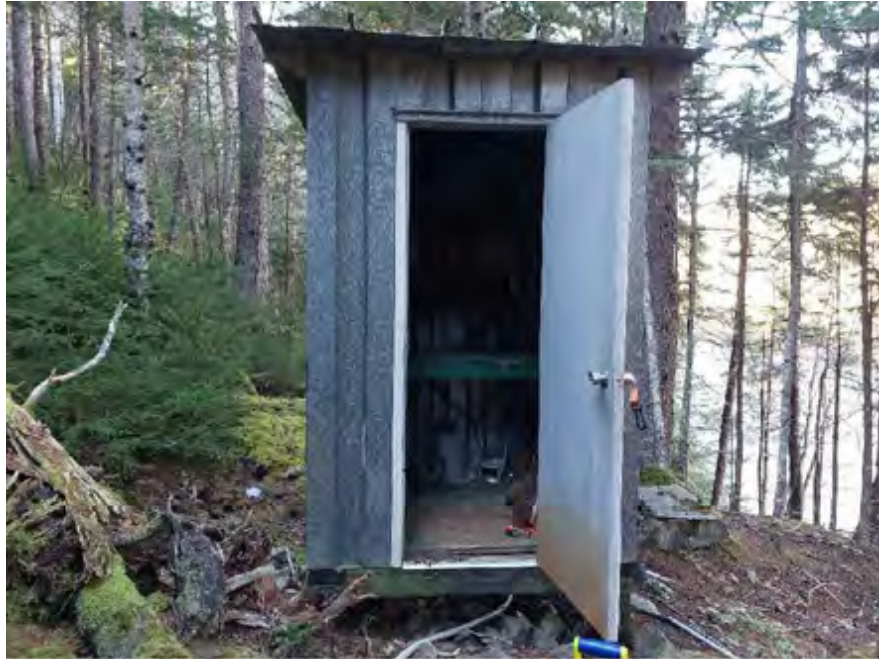
Figure 27 shows the stilling well, which is inactive at this site has been updated to the pressure system. This well is fully exposed with the top bent inward and welded shut. Figure 28 shows the shelter used to house the equipment for the pressure system. The stilling well and cableway at this location will eventually require decommissioning (Figure 29).

Figure 27. Shelter containing the equipment for the pressure system. Photograph taken mid-November, 2021 (GHD, 2022d).

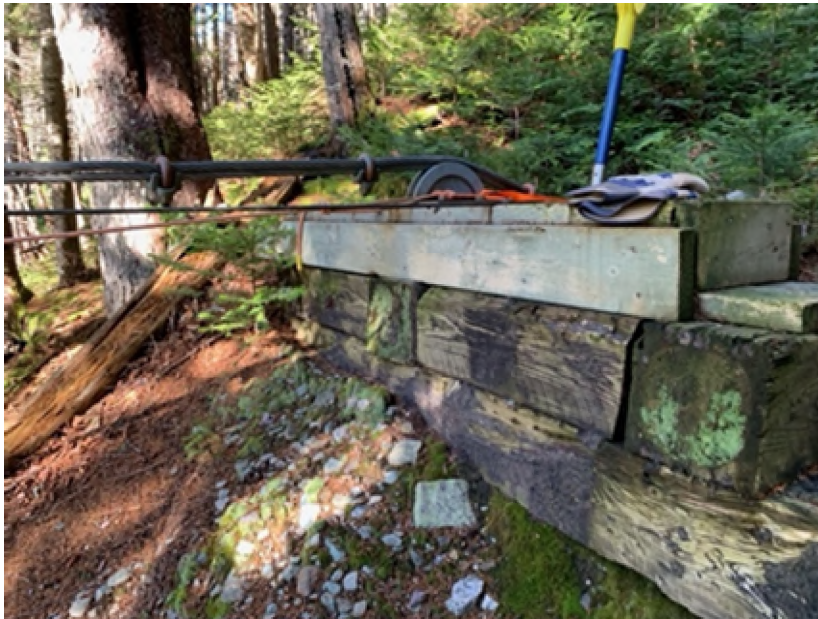
Figure 28. View of creosote-treated cableway timbers on the right bank of the river. Photograph taken mid-November, 2021 (GHD, 2022d).

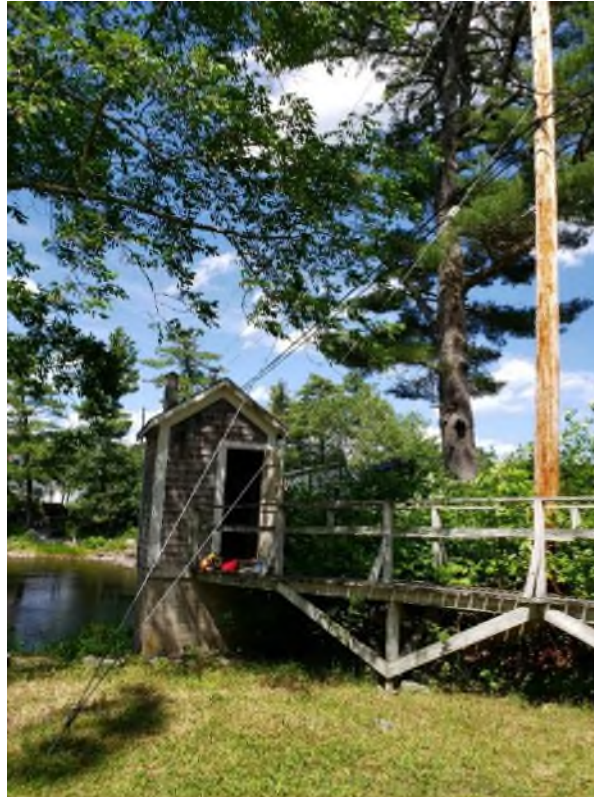
Figure 29. The stilling well and walk-in gauge house at the inactive station 01EE001 Medway River at Charleston (Photograph taken on July 21, 2020).

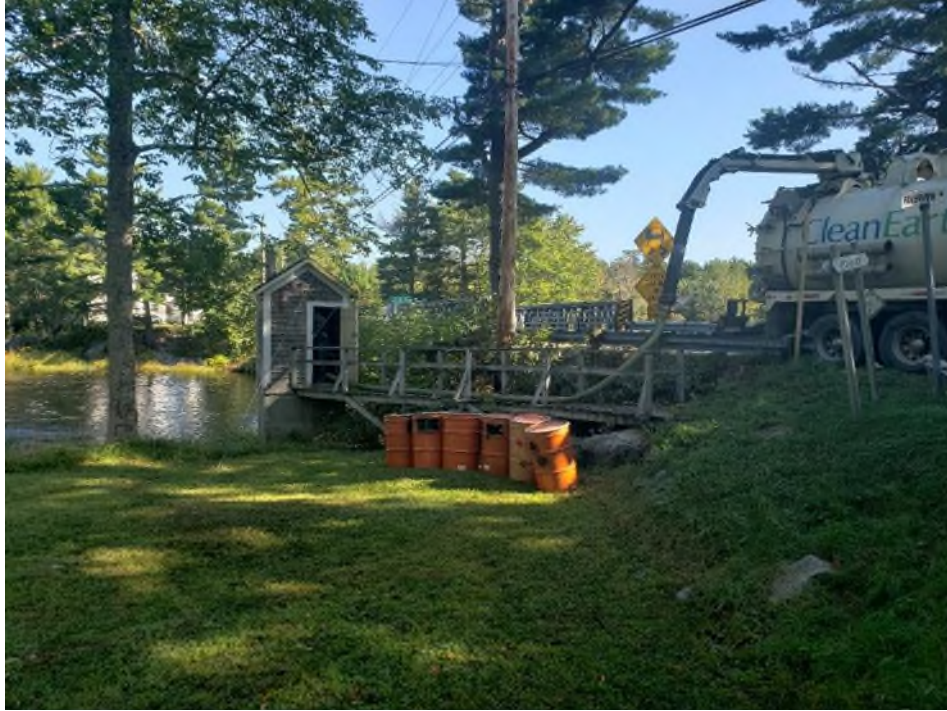
Figure 30. View of sediment being removed from the stilling well prior to decommissioning to be taken to an approved soil handling facility (photograph taken September 22, 2021).

During decommissioning caution was taken when handling the lead based painted materials which were disposed of at an approved disposal facility. The hydrocarbon impacted sediment at the bottom of the well was removed to be taken to an off-site approved soil handling facility prior to decommissioning of the hydrometric station and stilling well (Figure 31). The shelter was removed from the well once this was completed. The stilling well was then decommissioned with the well casing cut off below grade and the ground remediated (Figures 32 and 33). It should be noted that there is no need for any further work at this site.

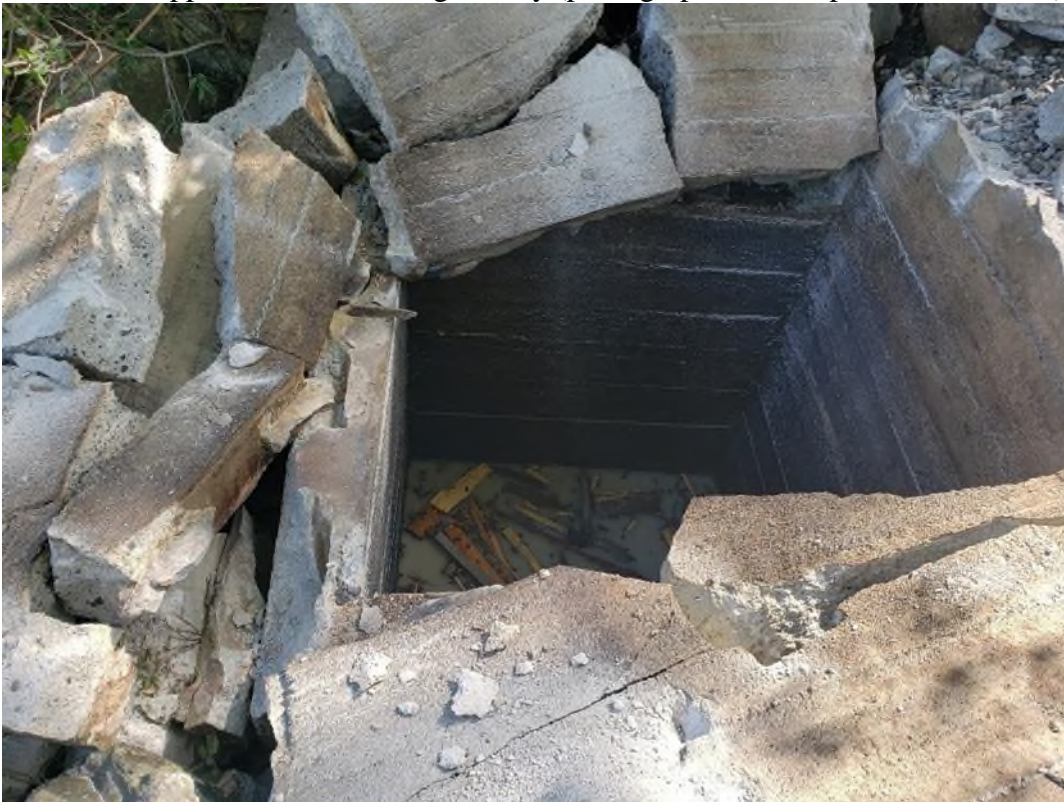
Figure 31. View of the broken well casing during the decommissioning (photograph taken September 22, 2021).

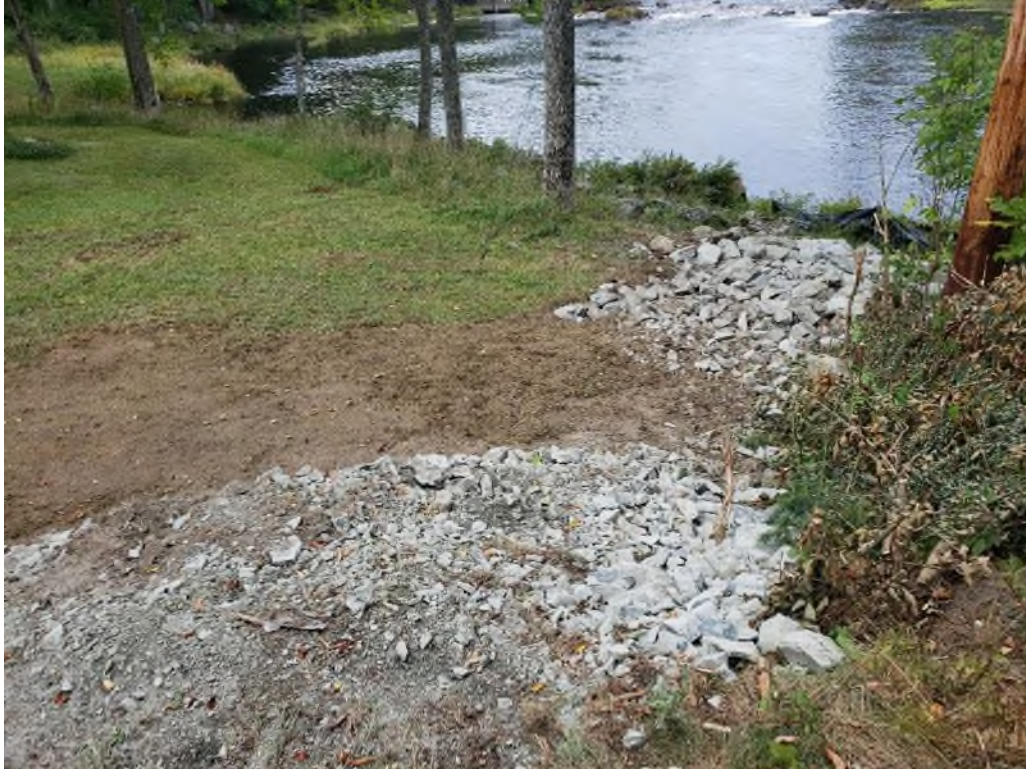
Figure 32. Restored ground where the former 01EE001 hydrometric station was located to match existing land cover (photograph taken September 22, 2021).

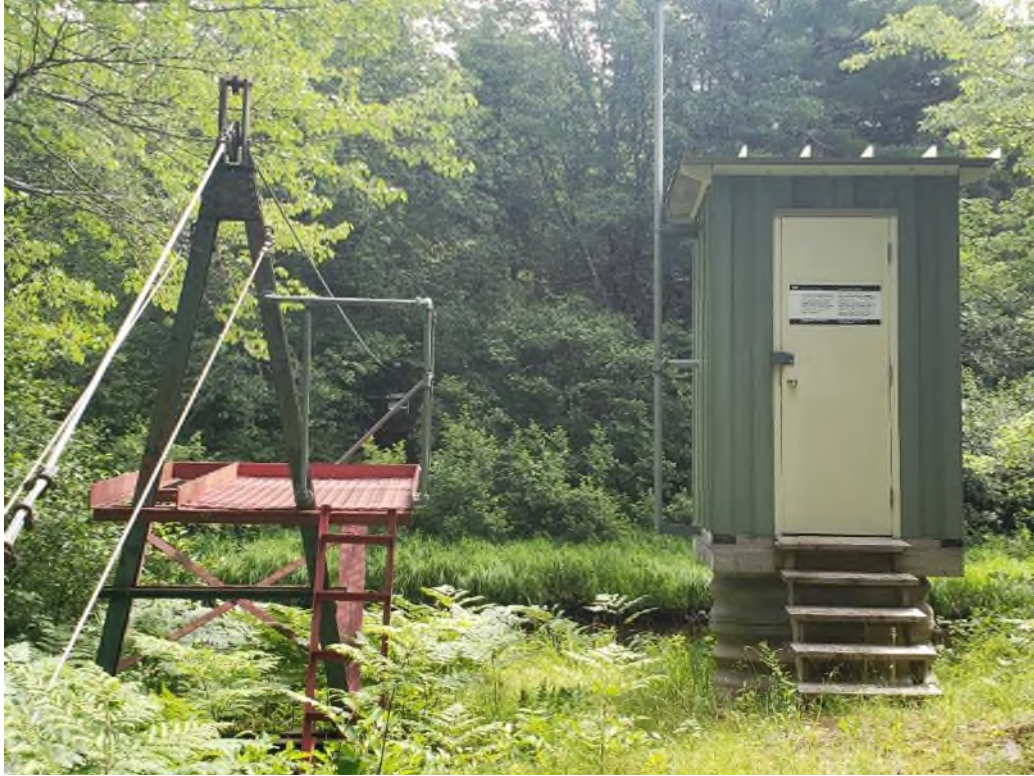
Figure 33. Shelter and an A-frame of the cableway on the left bank at 01DL001 (photograph taken July 22, 2020).
