**MEMORANDUM OF AGREEMENT
FOR
WATER QUANTITY SURVEYS**

**REPORT FOR FISCAL YEAR
2021-2022**

| Appendix D Hydrometric Infrastructure and Construction in Atlantic Canada Project Summary Report 2021 – 2022..... | 24 |

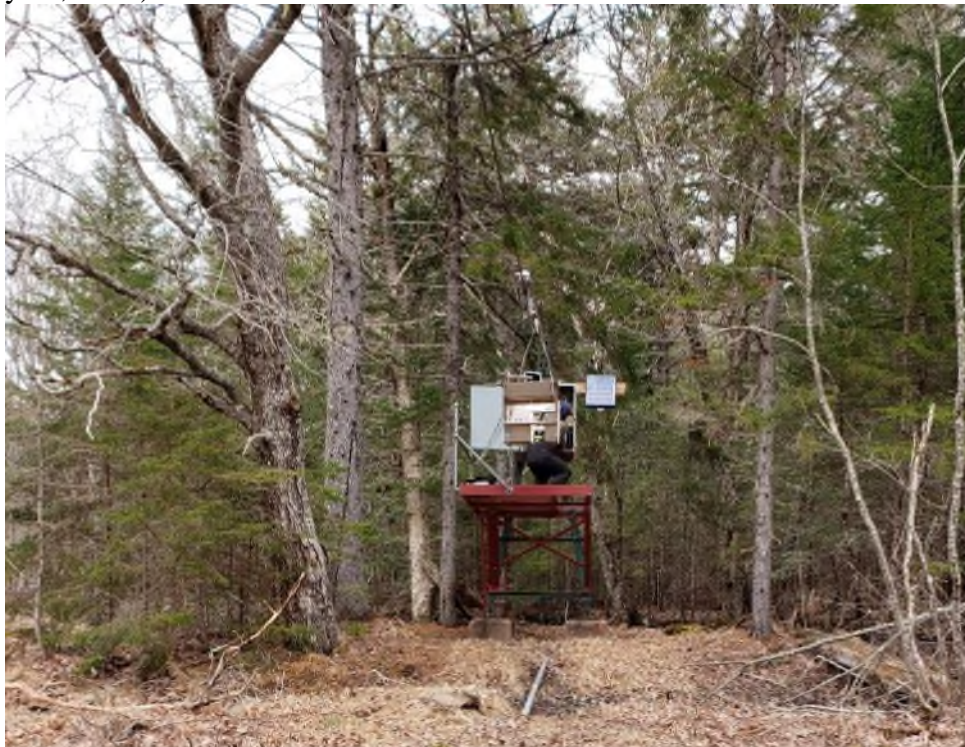
Figure 34. View of the A-frame on the right bank of Kelley River showing the inactive cablecar and the temporary gauge (photograph taken April 23, 2021).

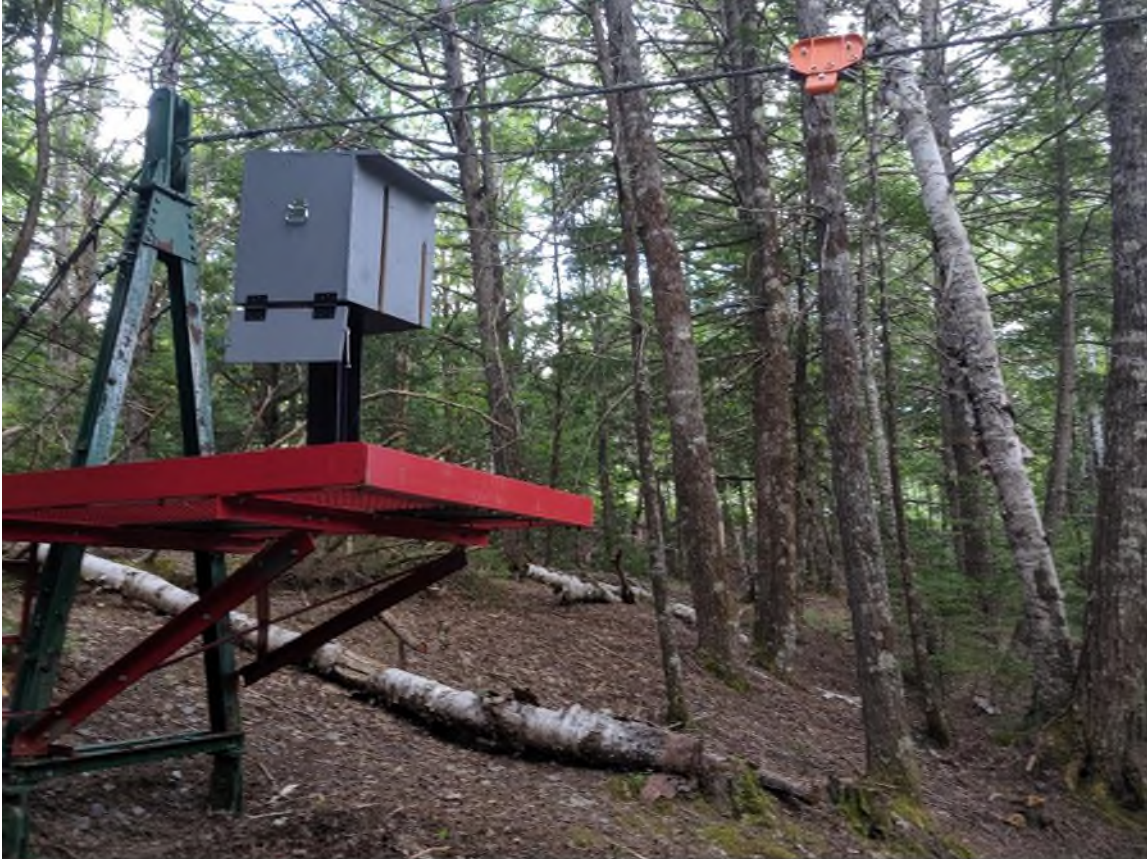
Figure 35. View of the cableway at 01ED007 on the left bank of Mersey River (photograph taken August 9, 2020).

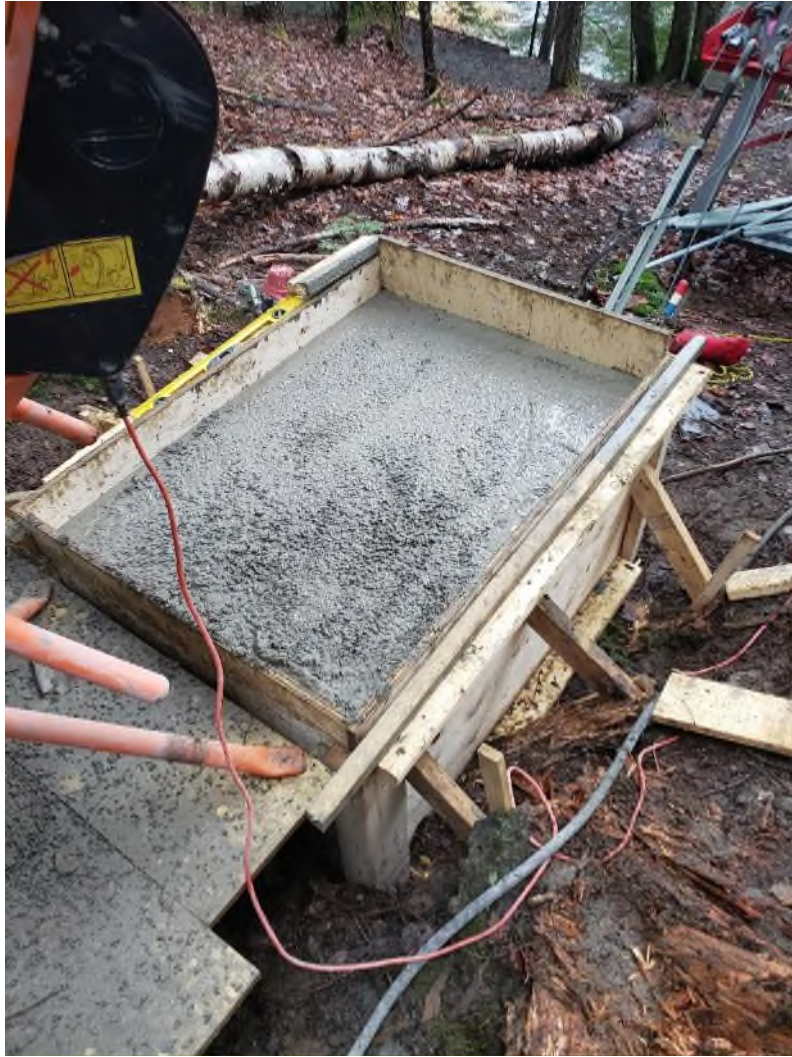
Figure 36. Additional mass added to the cableway anchor system on the left bank (photograph taken November 19, 2021).

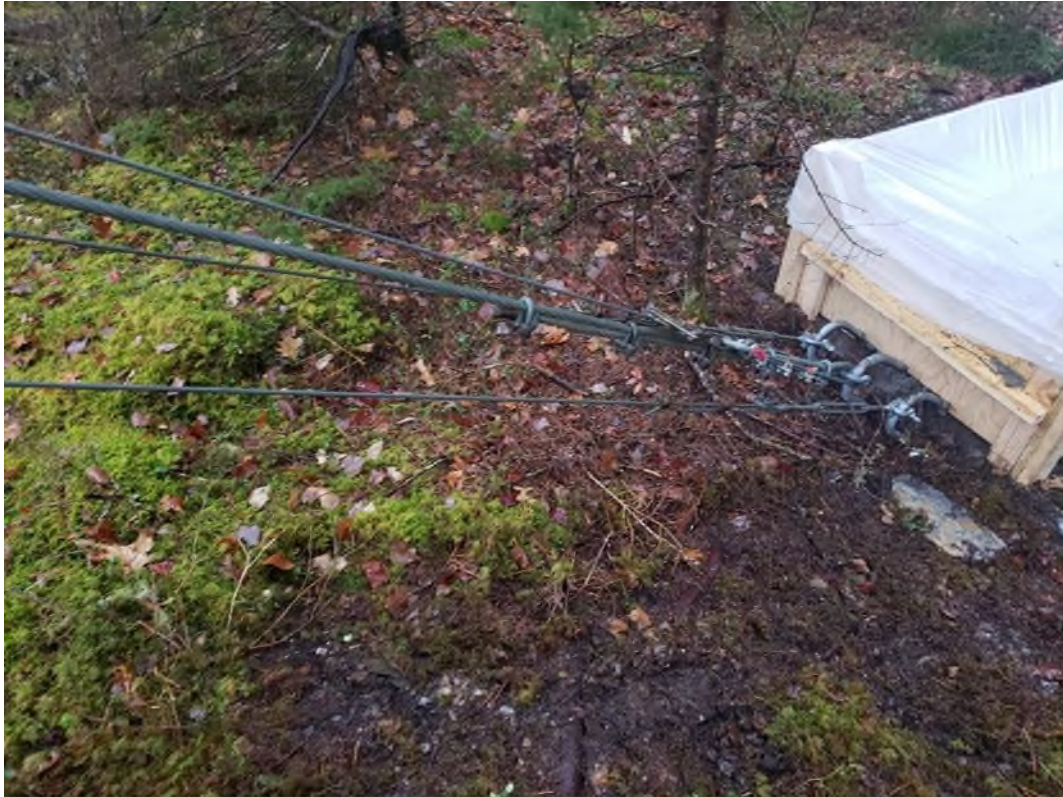
Figure 37. Additional mass added to the cableway anchor system on the right bank (photograph taken November 19, 2021).

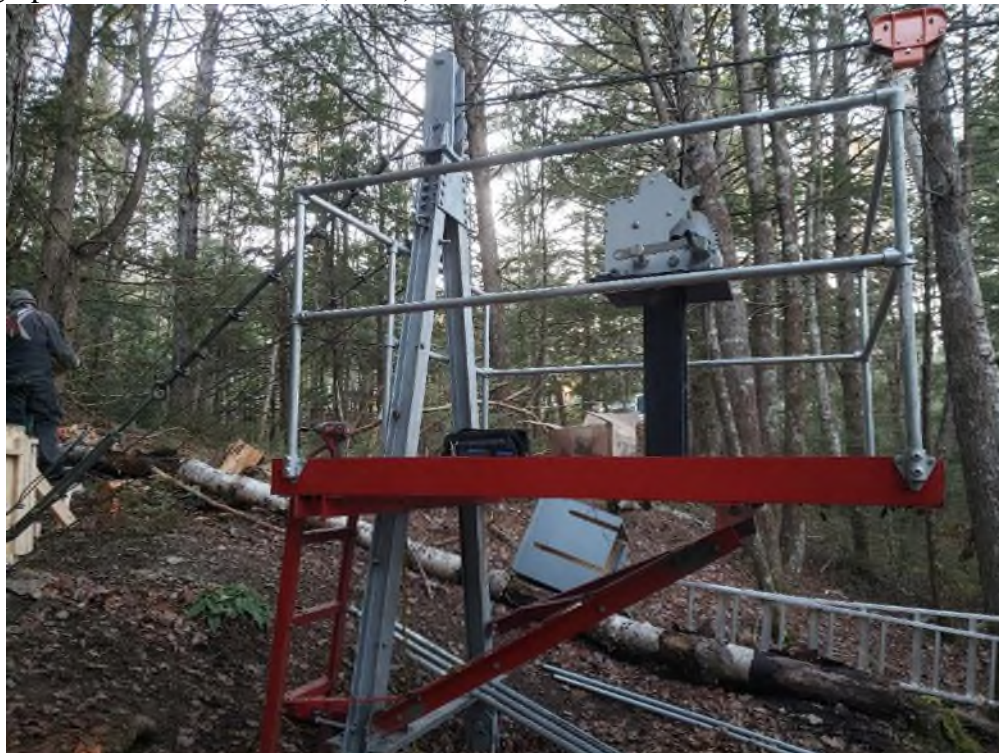
Figure 38. View of the railing added to the cableway platform on the left bank (photograph taken November 19, 2021).

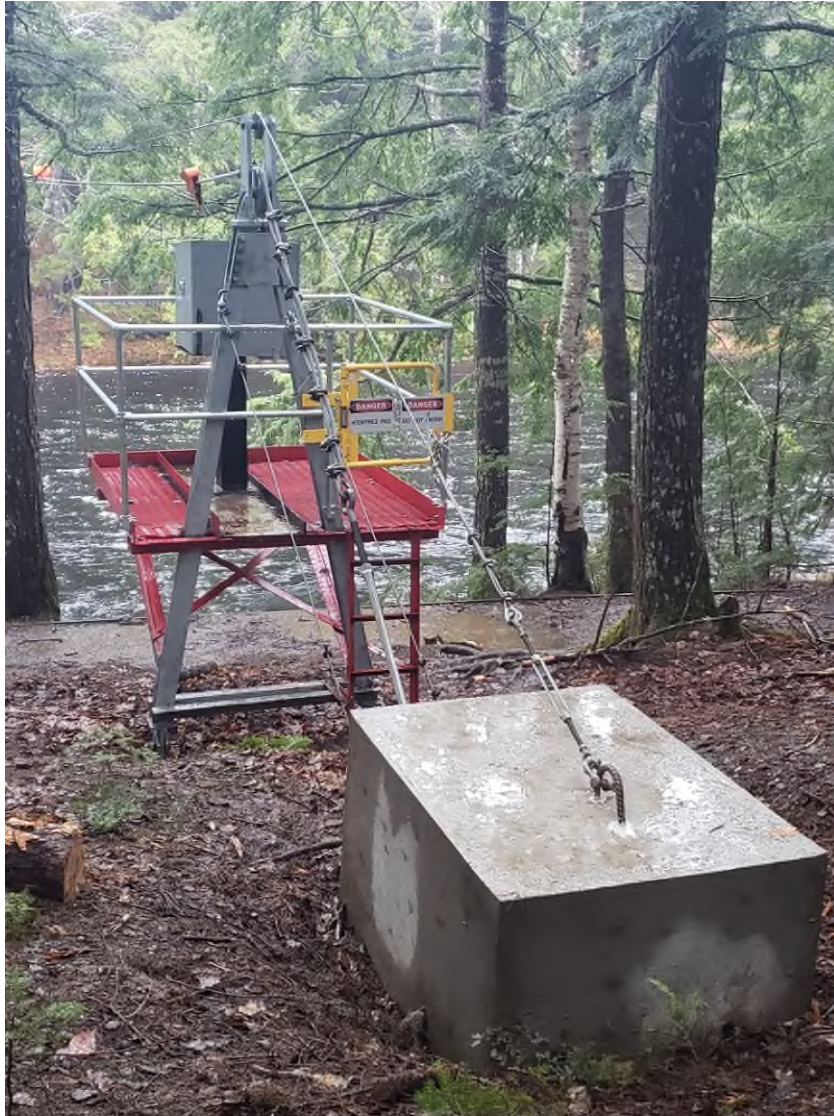
Figure 39. View of the renovated BOC at 01ED007 Mersey River below Mill Falls on the left bank (Photograph taken November 19, 2021).

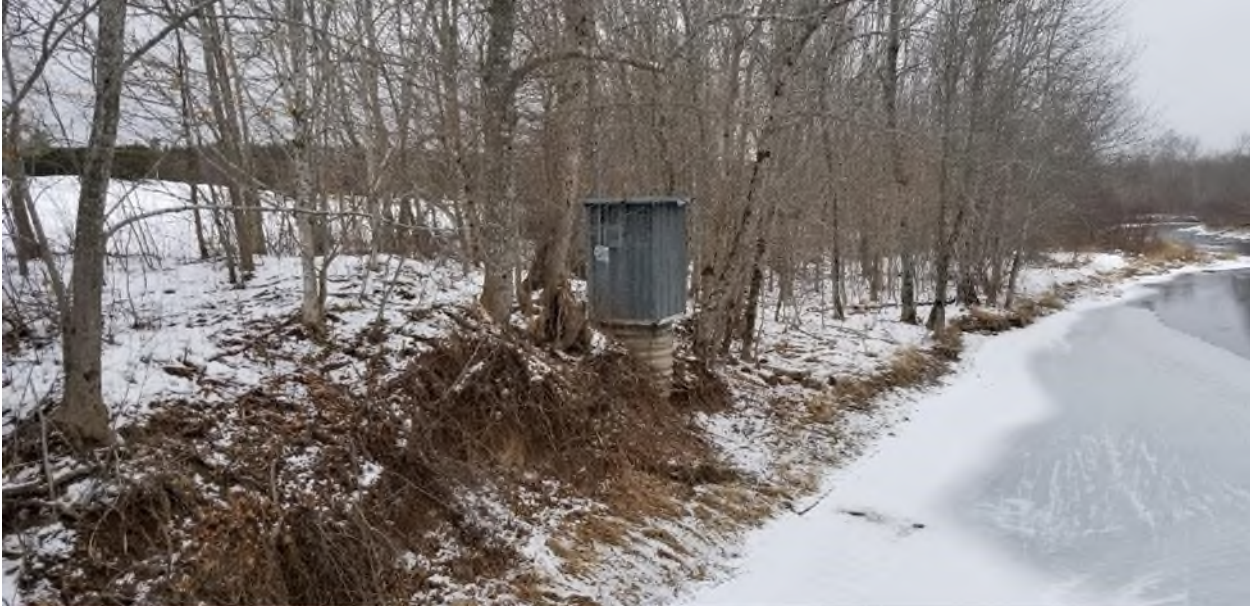
Figure 40. Former stilling well and shelter on left bank of Middle River of Pictou (photograph taken January 28, 2021).

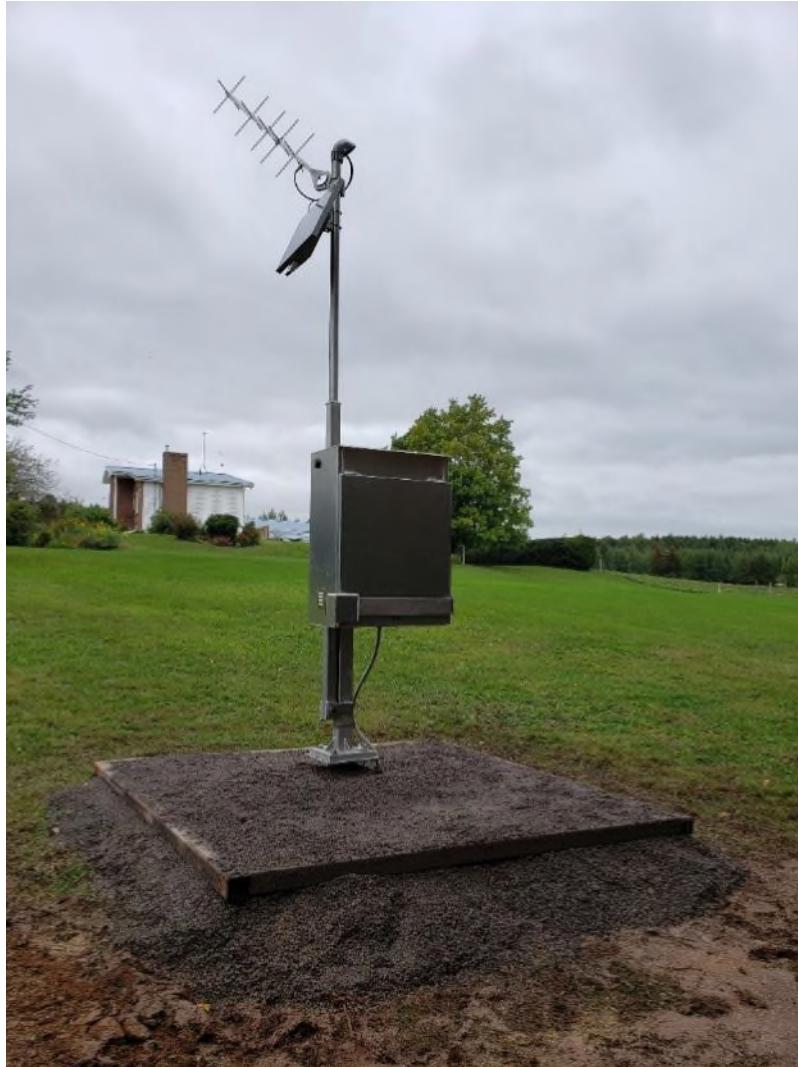
Figure 41. New look-in shelter housing the pressure system at 01DP004 (photograph taken September 29, 2021).

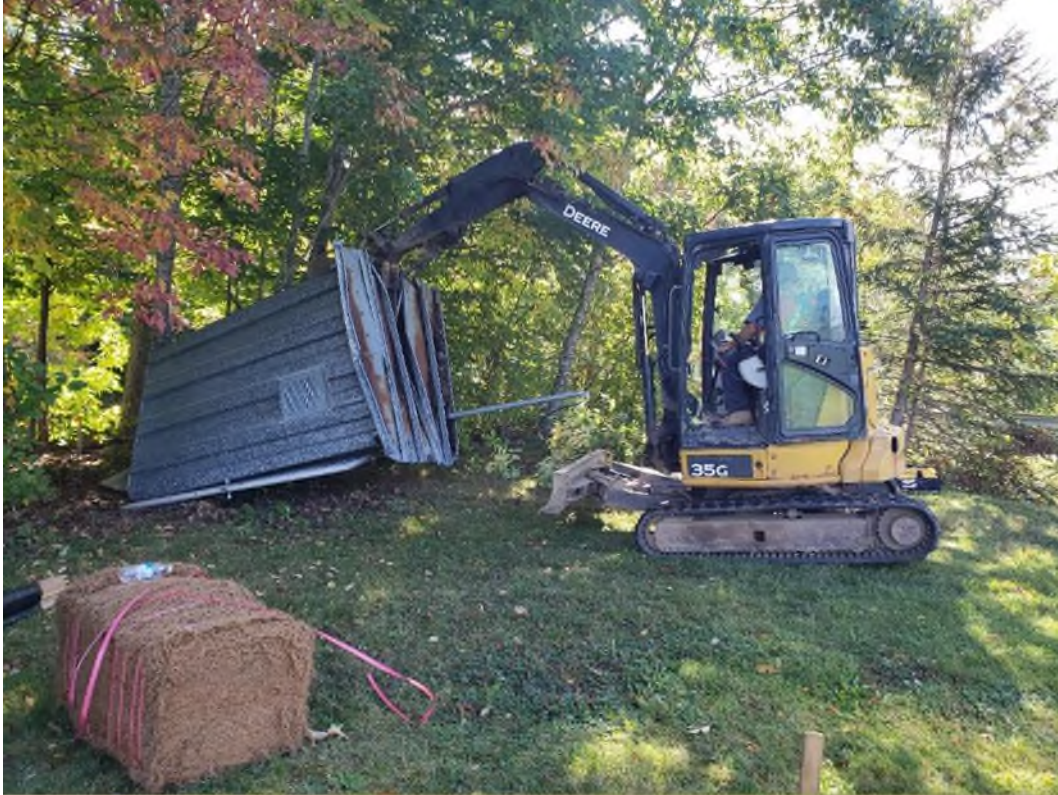
Figure 42. View of the removal of the shelter during the decommissioning at 01DP004 (photograph taken September 27, 2021).

A preliminary environmental assessment was conducted that sampled the water and sediment at the bottom of the stilling well. Neither sample had concentration of a contaminant that exceeded relevant guidelines. The stilling well was decommissioned September 27, 2021 (Figure 43). Site restoration was completed for the bank including seeding the ground to encourage new growth and discourage the erosion of the bank (Figure 44). It should be noted that there is no need for any further work at this site.

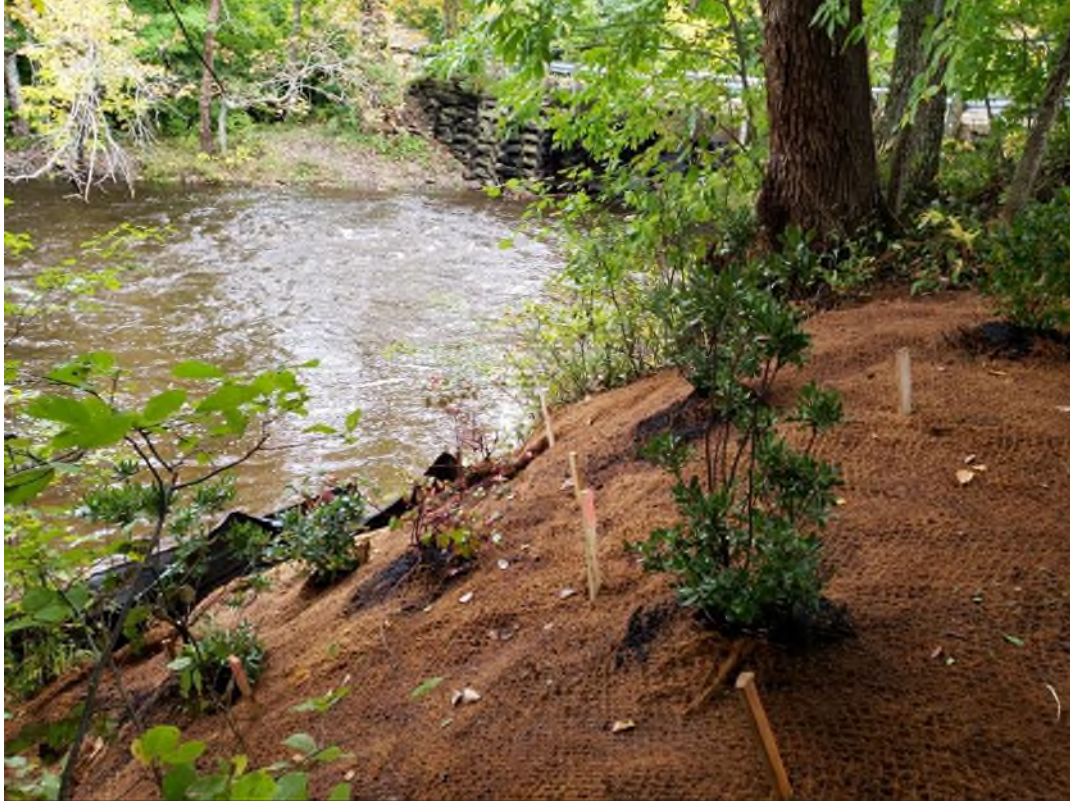
Figure 43. Restored and stabilized bank with native vegetation (Bayberry, Summer Sweet and Red Osier Dogwood) at 01DP004 after well was cut below grade and filled in (photograph taken September 29, 2021).

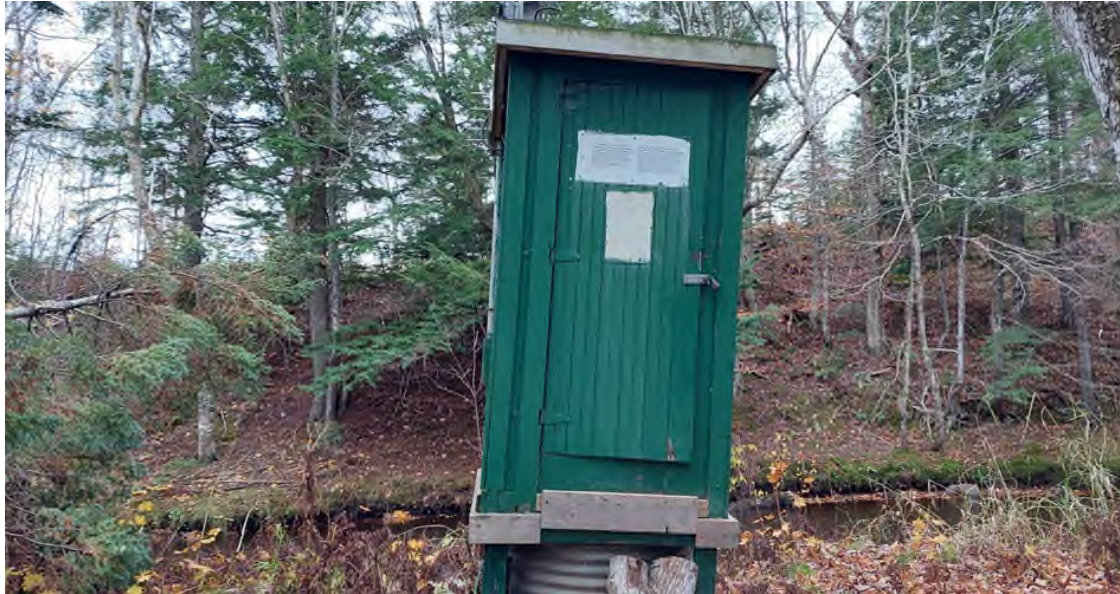
Figure 45 shows the stilling well at 01AC003 Carruthers Brook near St. Anthony is in poor condition as the shelter is leaning. This station has been converted to a pressure system therefore, the stilling well is no longer required. Based on historical information this well had potential PHC contamination; therefore, an environmental assessment was required prior to decommissioning the stilling well.

Figure 44. Tilting shelter located at 01AC003. Photograph taken late-October, 2021 (GHD, 2022c).

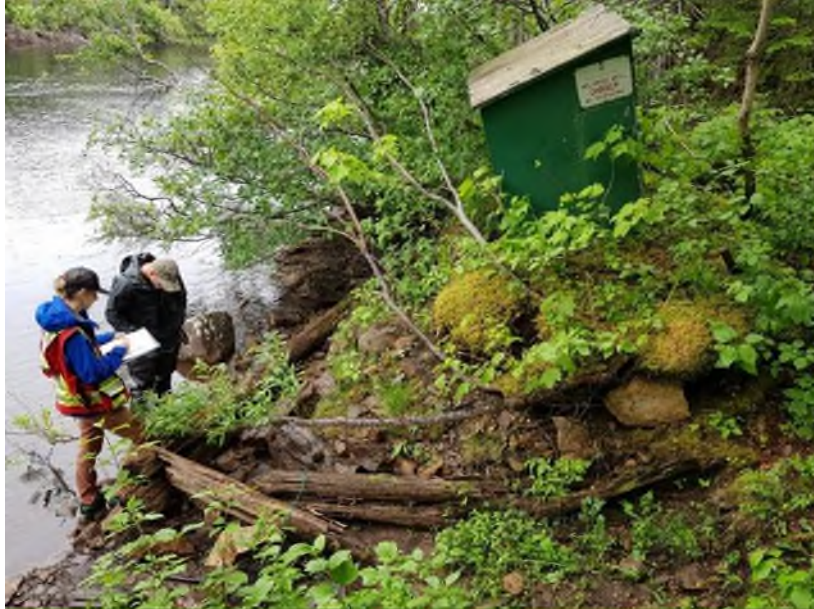
This station had an inactive former gauge house consisting old steel casing well and look-in style shelter that is in poor condition (Figures 45 and 46). The current gauge house is not associated with this well and the current gauge house is in good condition requiring no work. During a site visit in July 2019, potential PHC product was observed in the stilling well. This old well required decommissioning so that it does not pose a risk to the public or environment. In addition, there is a manned cableway constructed of pressure treated timbers that was no longer required that required decommissioning (Figure 47).

Figure 45. Abandoned stilling well and look-in shelter at 02YC001 Torrent River at Bristol's Pool (Photograph taken on July 15, 2019).

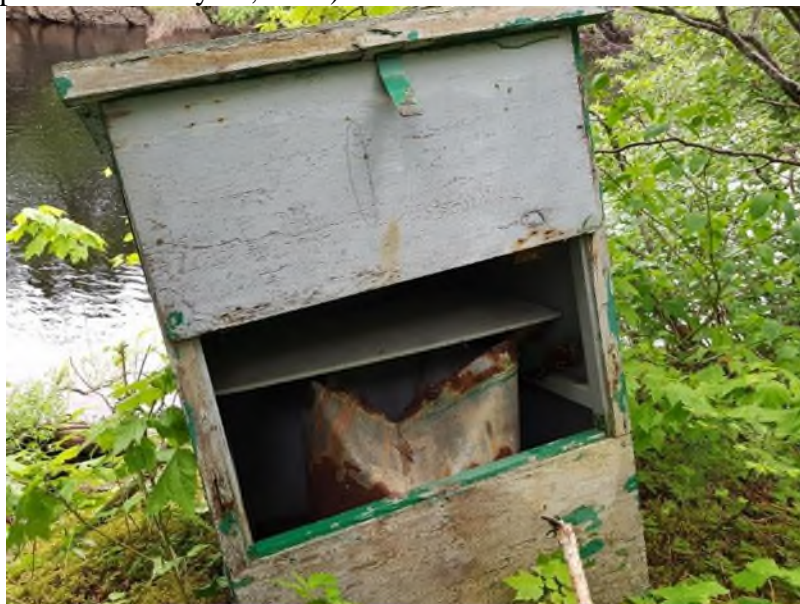
Figure 46. Abandoned stilling well and look-in shelter at 02YC001 Torrent River at Bristol's Pool (Photograph taken July 15, 2019).

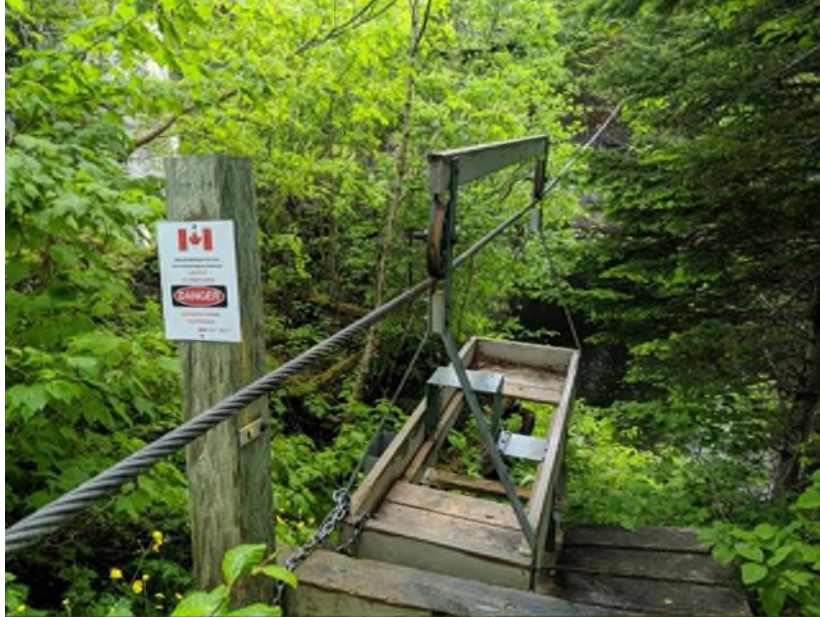
Figure 47. Inactive manned cableway at 02YC001 Torrent River at Bristol's Pool (Photograph taken July 15, 2019).

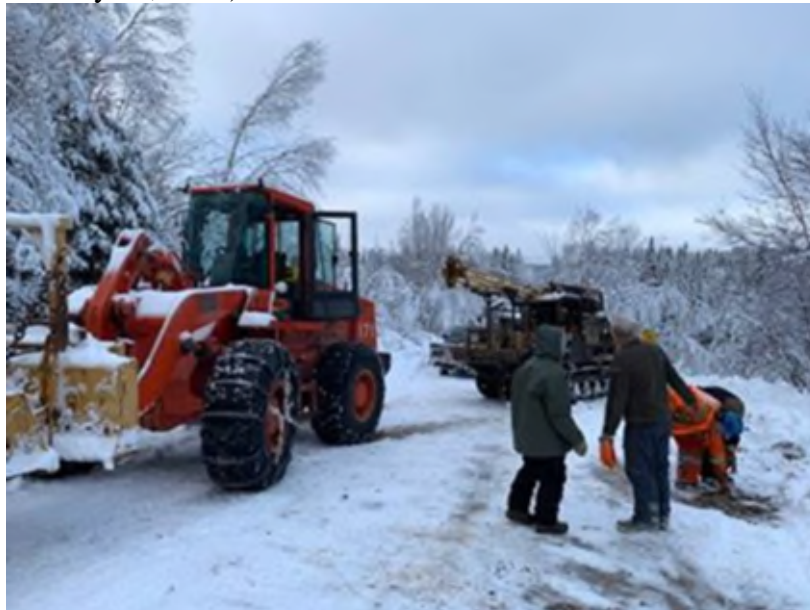
Environmental consultants were retained through PSPC for this project since there was potential for PHC observed. In December 2020, they conducted an intrusive investigation of the area surrounding the old well to develop an understanding of the extent of the potential contamination. This included grubbing of the site to improve site access with the heavy equipment (Figures 48 and 49). As well, they installed two monitoring wells and conducted hand dug test pit sampling.

Figure 48. Equipment deployment on site for environmental assessment work. Photograph taken December 2020 (GHD, 2021c).

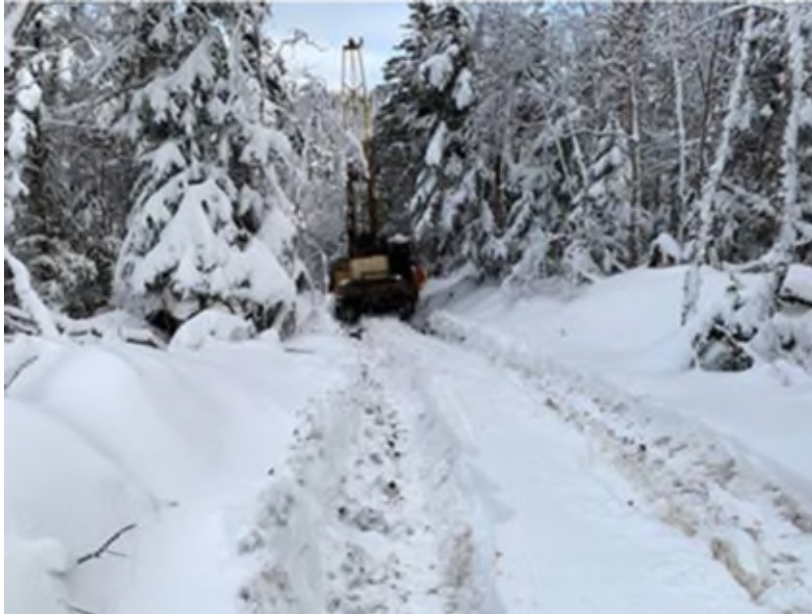
Figure 49. Drill rig entering the site. Photograph taken December 2020 (GHD, 2021c).

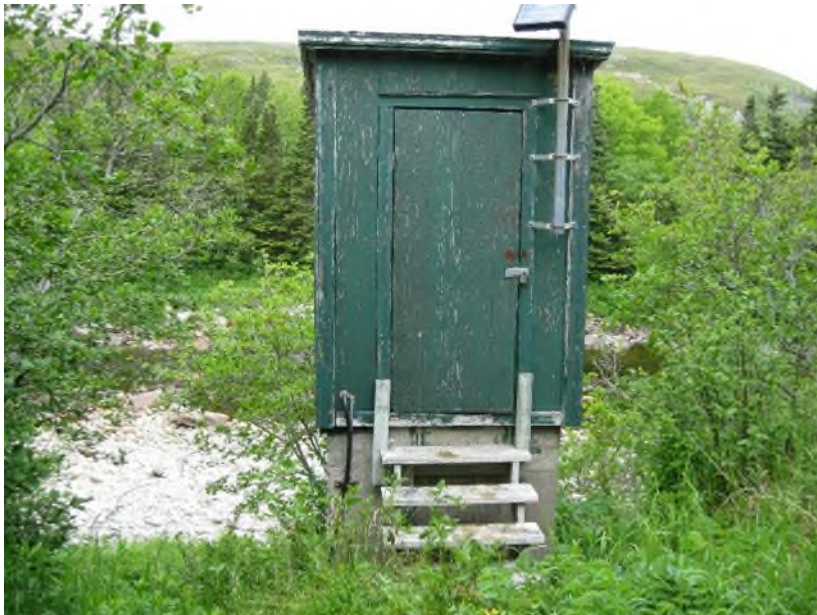
Figure 50 shows the former inactive concrete stilling well and walk-in shelter that was in poor condition at this station. The site also has a cableway with one wood creosote treated A-frame located on the right bank (Figure 51). A new shelter was installed by the PSPC retained contractors which was an aluminum tilting mast style look-in shelter mounted on a pre-cast concrete pad (Figure 52).

Figure 50. Walk-in shelter above the concrete stilling well at 02ZB001 Isle aux Morts below Highway Bridge (Photograph taken June 21, 2012).

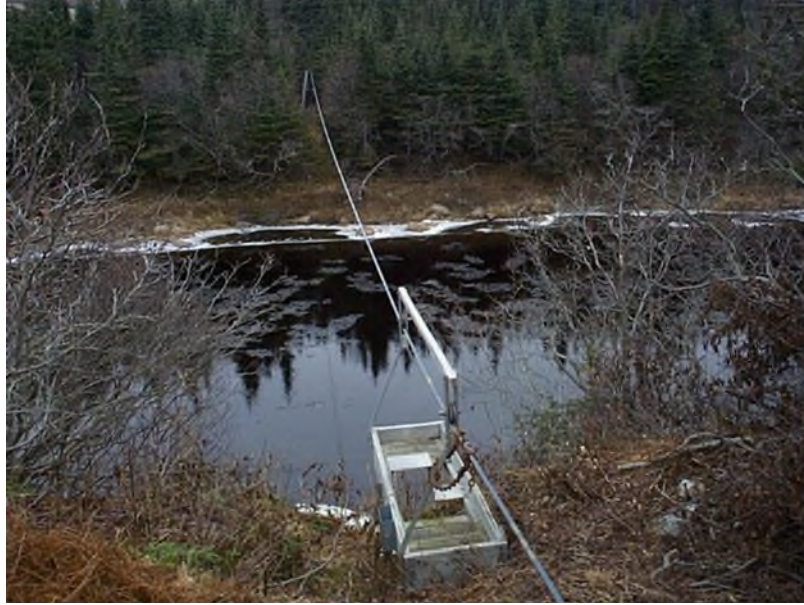
Figure 51. Inactive manned cableway located at 02ZB001 Isle aux Morts below Highway Bridge (Photograph taken November 21, 2007).

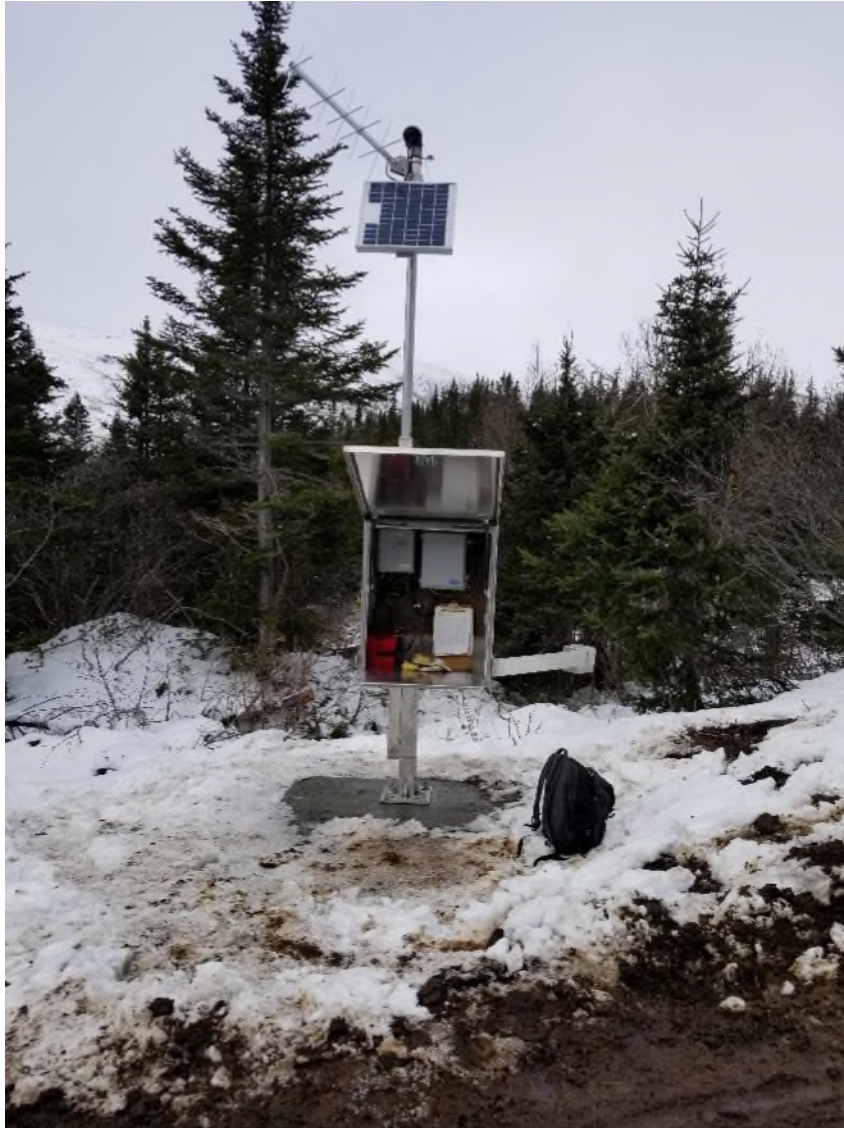
Figure 52. New aluminum tilting mast style look-in shelter installed on a pre-cast concrete pad at 02ZB001 Isle aux Morts River below Highway Bridge (Photograph taken February 10, 2022).

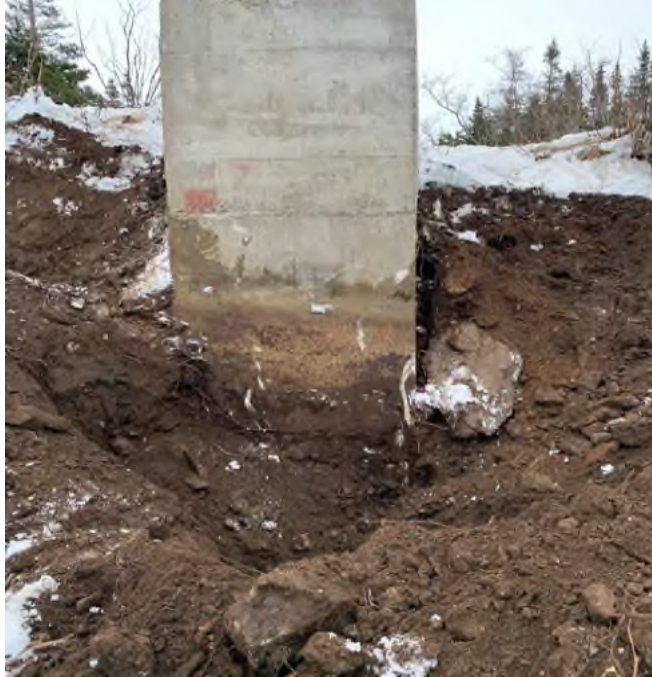
Figure 53. View looking south of the excavation of the concrete stilling well. Photograph taken February 9, 2022 (GHD, 2022e).

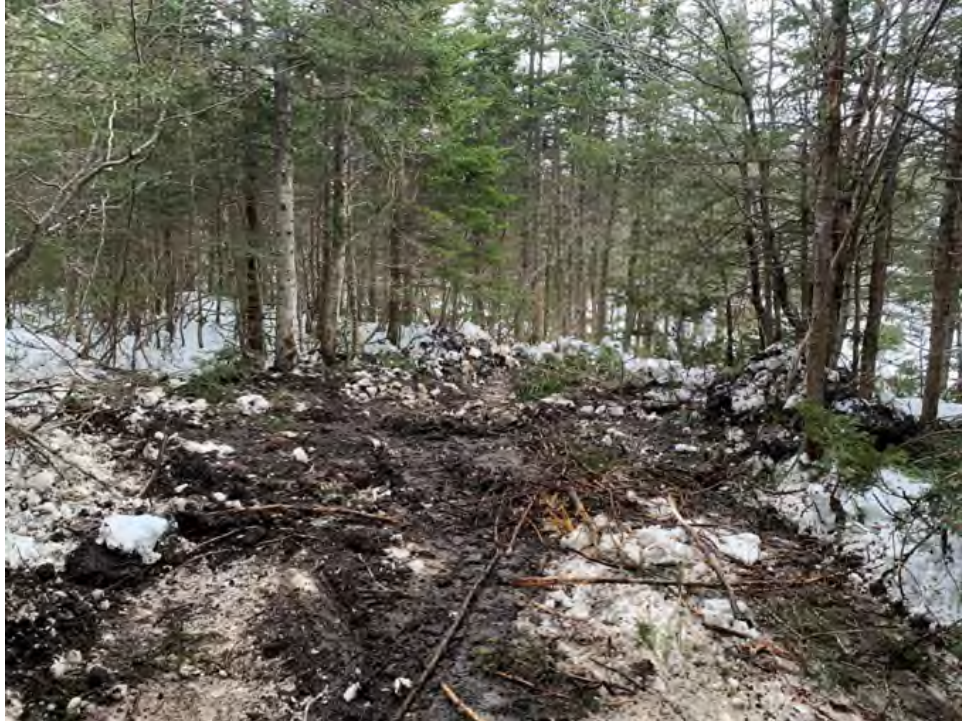
Figure 54. View of the north side of the river following the backfilling of the area of the former A-frame of the cableway. Photograph taken February 10, 2022 (GHD, 2022e).

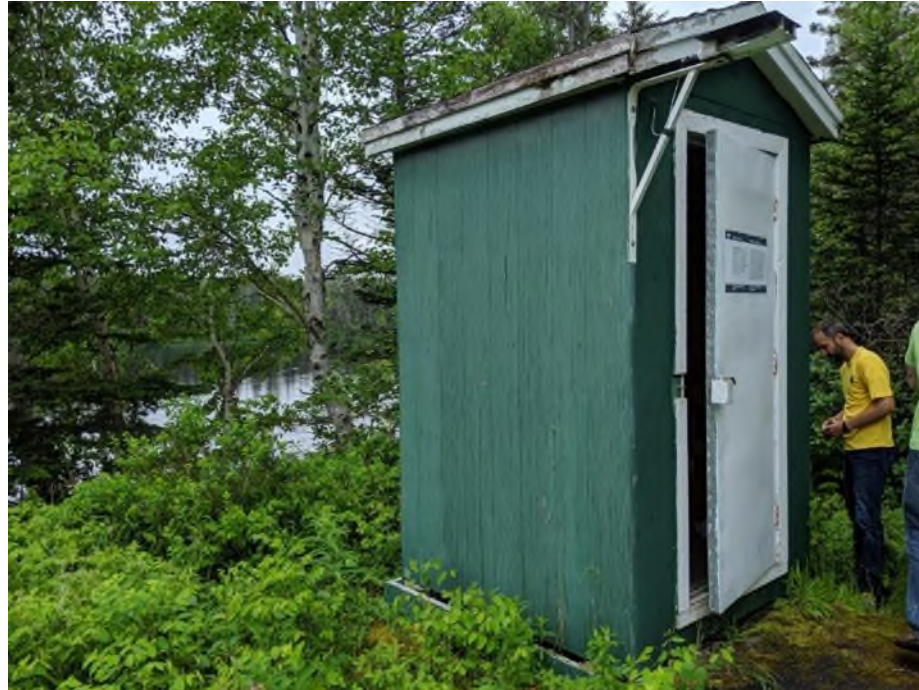
Figure 55. View of former shelter at 01YO011 (photograph taken July 17, 2019).

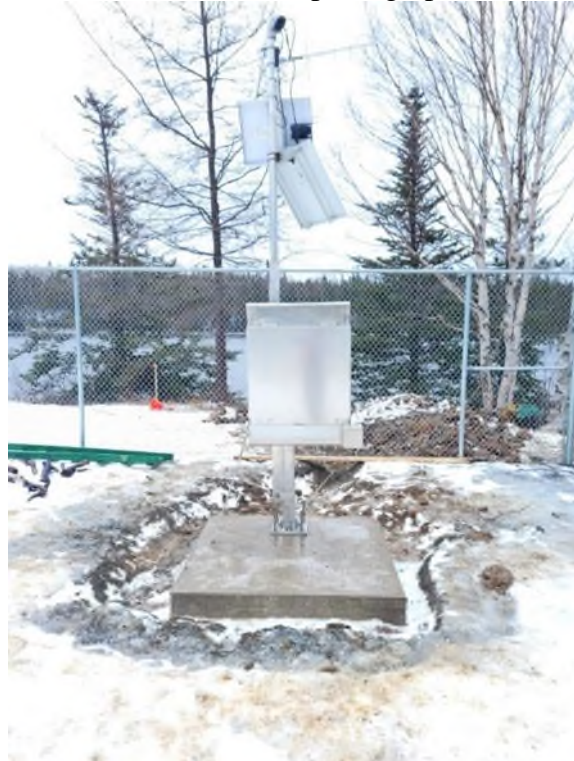
Figure 56. Look-in shelter and pre-cast concrete pad at 01YO011 (photograph taken February 23, 2022).

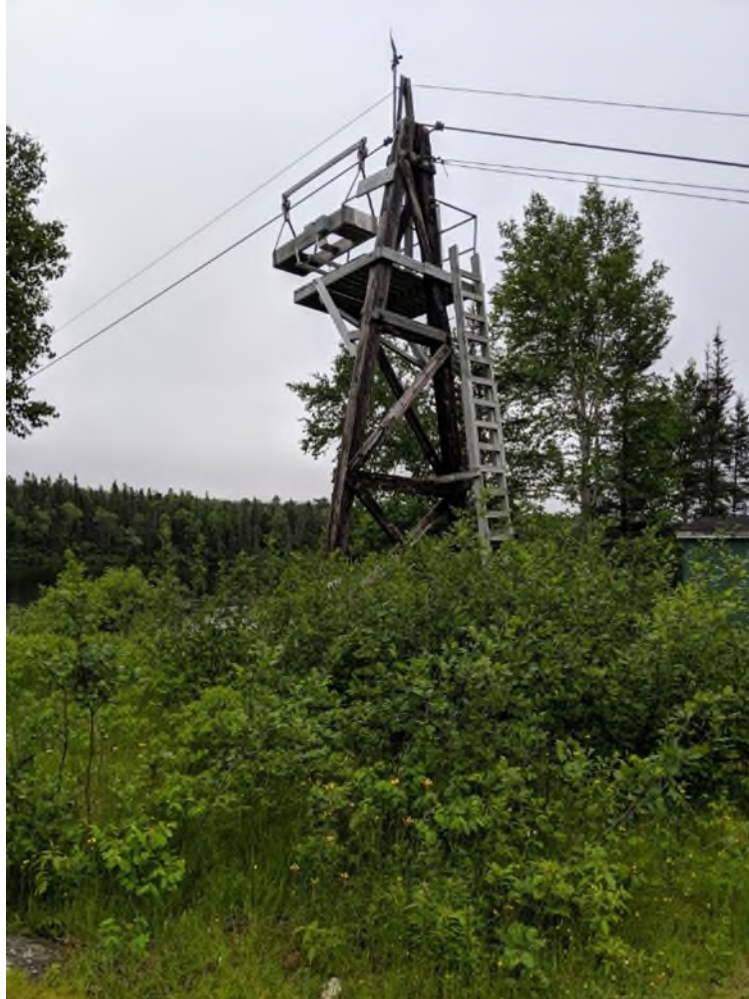
Figure 57. View of former creosote treated timber cableway A-frame and platform located on the left bank of Exploits River (photograph taken July 17, 2019).

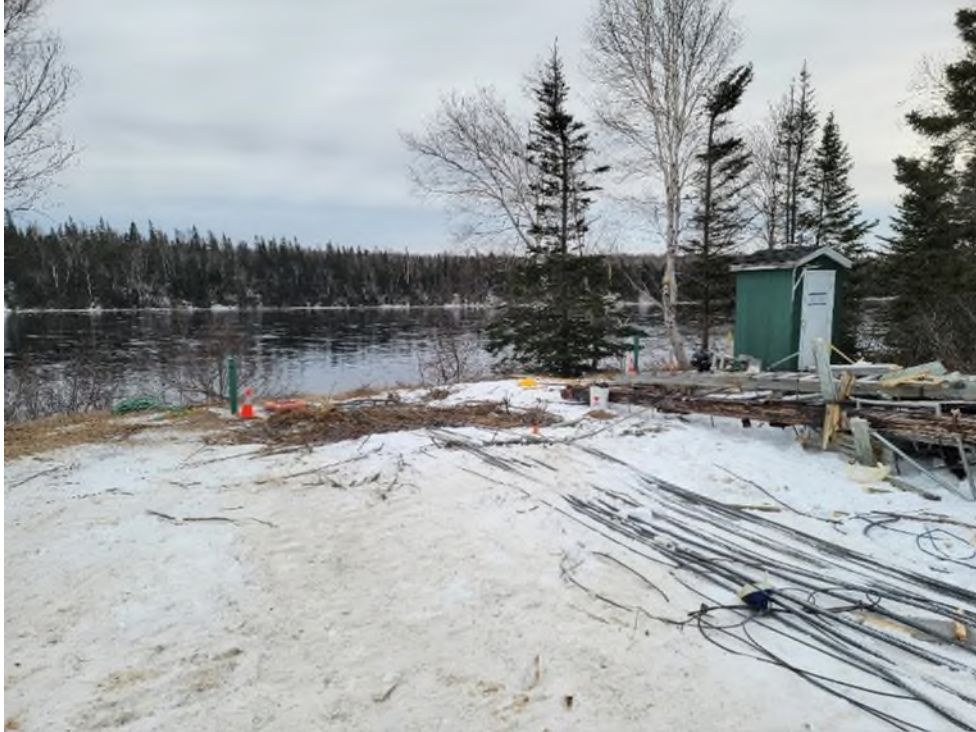
Figure 58. View of cableway decommissioning on the left bank (photograph taken February 22, 2022).

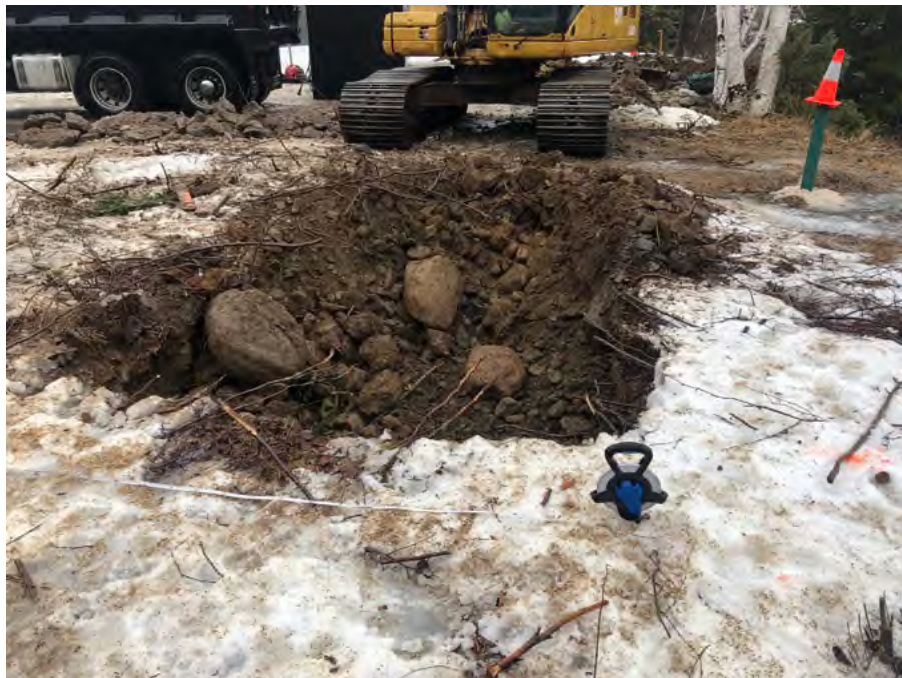
Figure 59. View following the removal of the PAH contaminated soil near the former cableway. Photograph taken February 23, 2022 (GHD, 2022b).

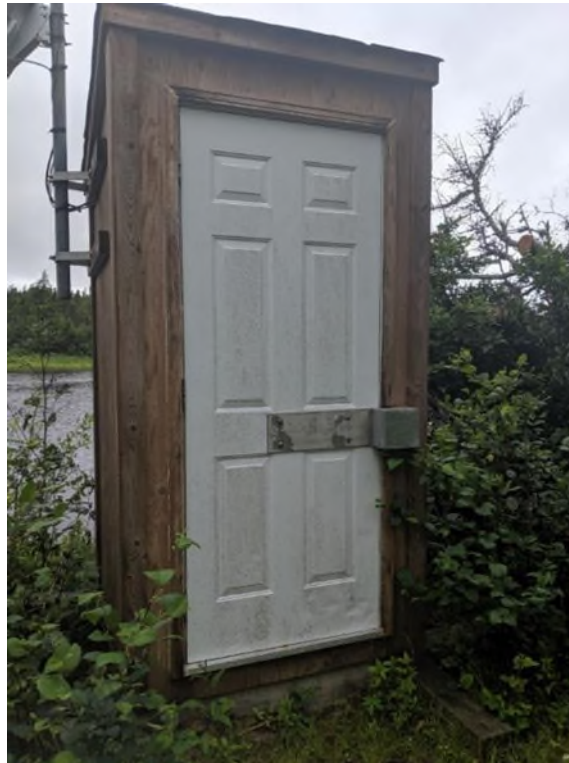
Figure 60. Former walk-in shelter above the stilling well at 02ZK001 Rocky River near Colinet (Photograph taken on July 18, 2019).

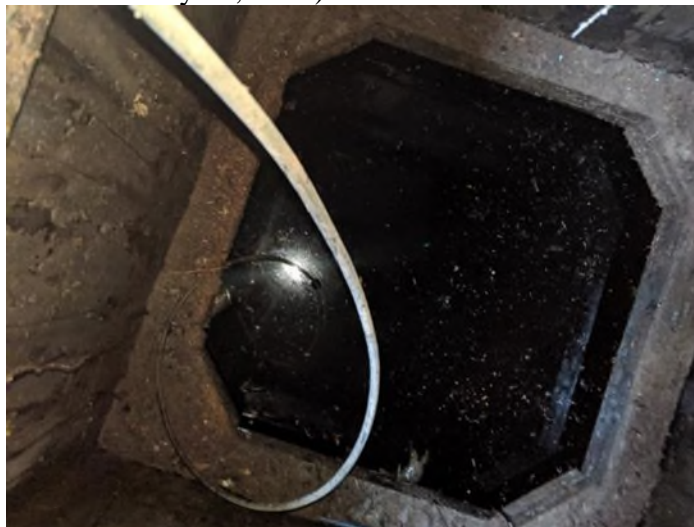
Figure 61. Creosote stave well at 02ZK001 Rocky River near Colinet (Photograph taken on July 18, 2019).

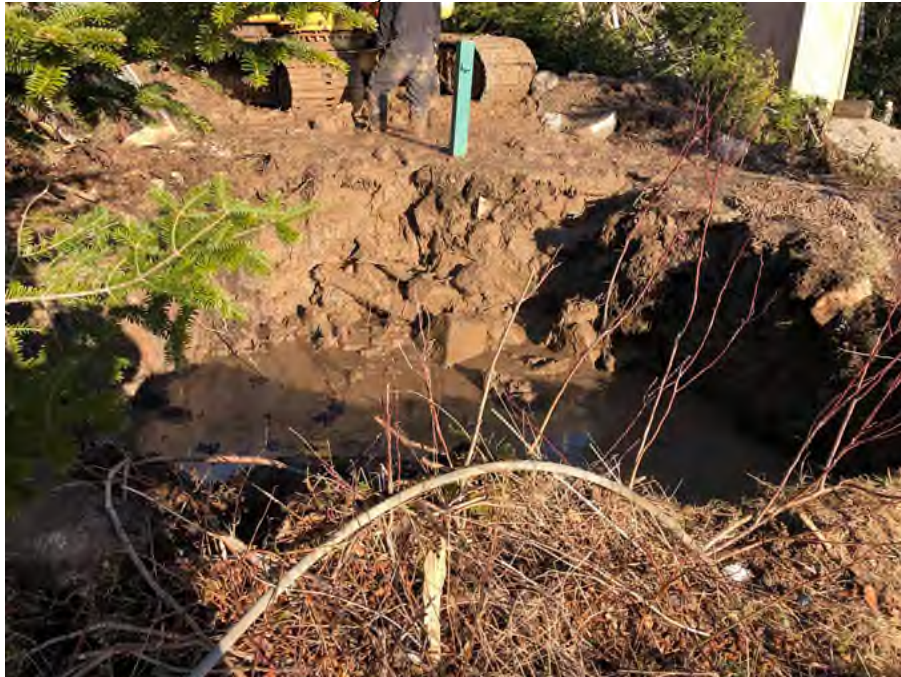
Figure 62. View following the removal of the potentially contaminated soil around the former stilling well. Photograph taken February 10, 2022 (GHD, 2022f).

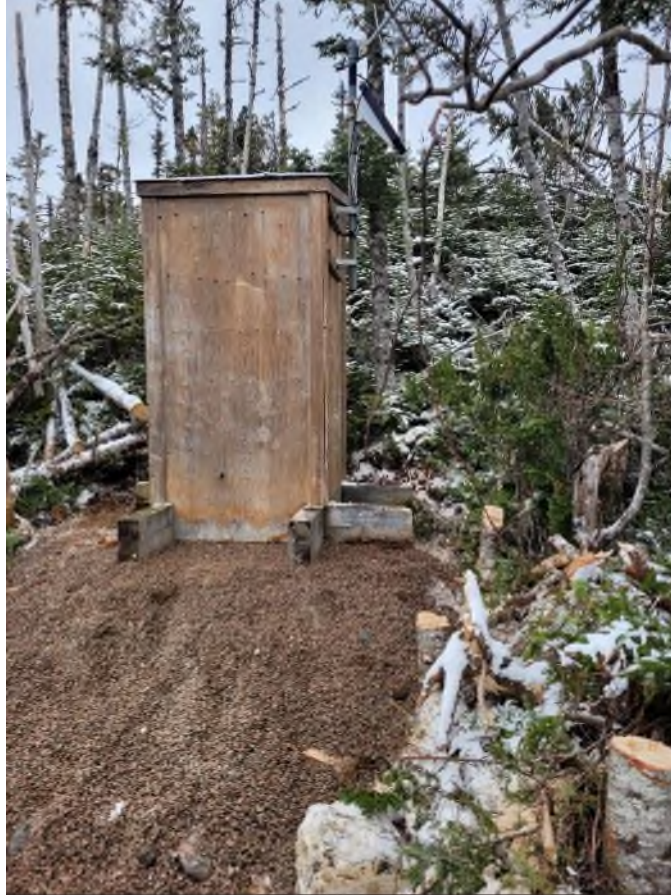
Figure 63. View of the new location of the shelter at 02ZK001 Rocky River near Colinet. Photograph taken in February 8, 2022 (GHD, 2022f).

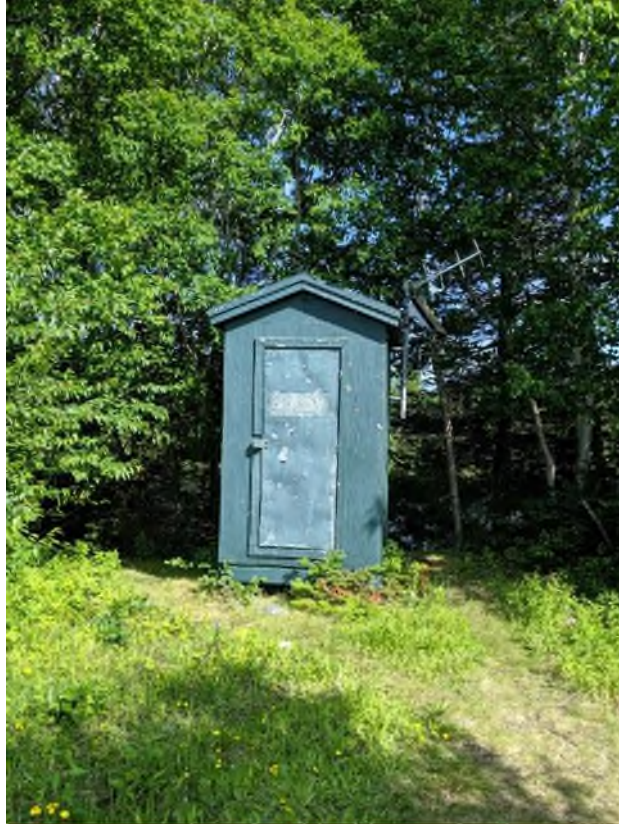
Figure 64. View of former shelter at 02YS005 Terra Nova River at Glovertown (photograph taken July 17, 2019).

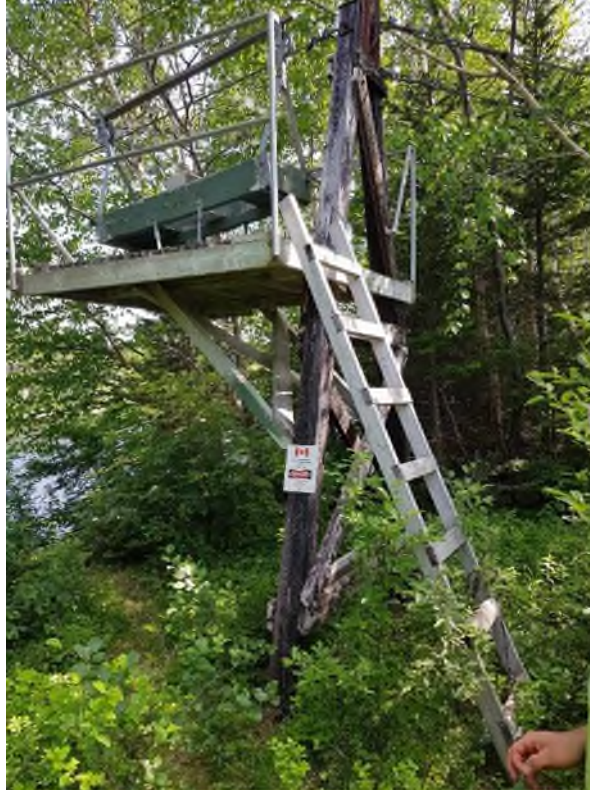
Figure 65. Creosote-treated wooden cableway at 02YS005 Terra Nova River at Glovertown on left bank of the river (photograph taken July 17, 2019).
