**MEMORANDUM OF AGREEMENT
FOR
WATER QUANTITY SURVEYS**

**REPORT FOR FISCAL YEAR
2021-2022**

| Appendix D Hydrometric Infrastructure and Construction in Atlantic Canada Project Summary Report 2021 – 2022..... | 24 |

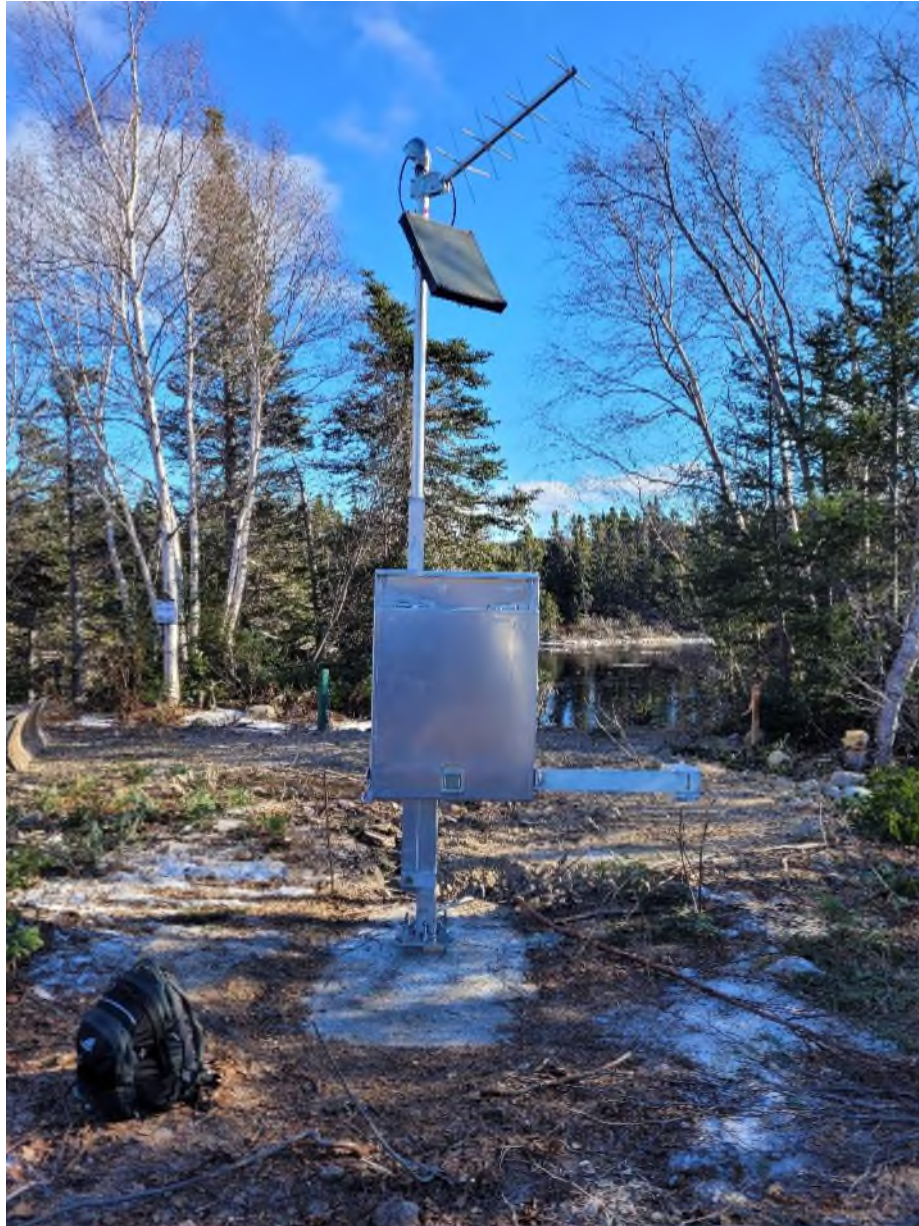
Figure 66. New aluminum tilting mast for look-in style shelter at 02YS005 Terra Nova River at Glovertown installed on the former cableway concrete mass anchor (Photograph taken February 1, 2022).

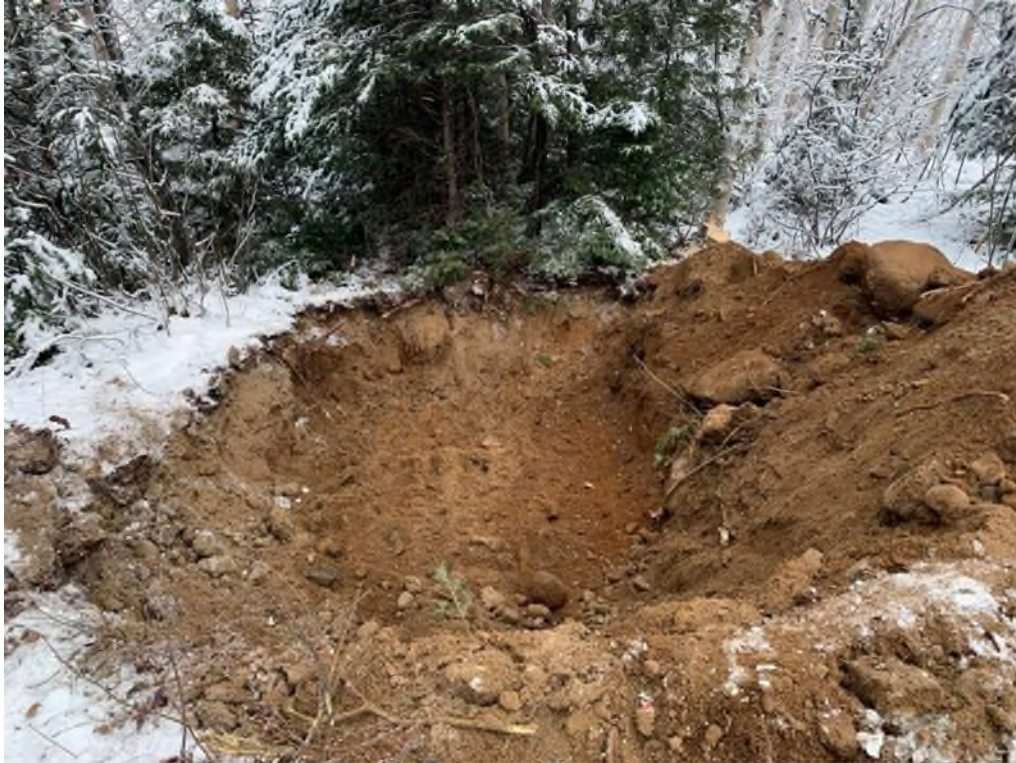
Figure 67. View of the location that the PAH contaminated soil was excavated (photograph taken January 25, 2022).
