Real-Time Water Quality Deployment Report

Rattling Brook Network

June 29, 2022 to August 2, 2022

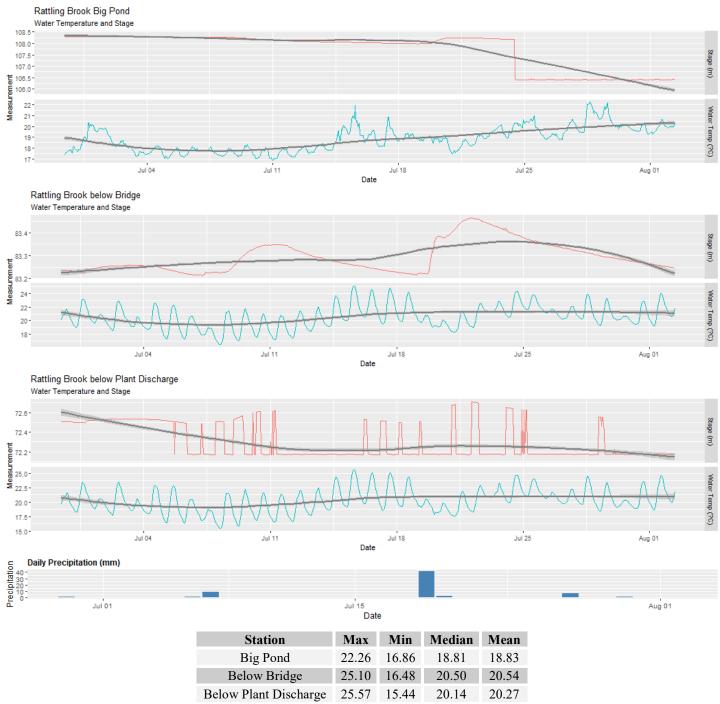
High water temperature was observed at all stations due to low water levels during this deployment period.

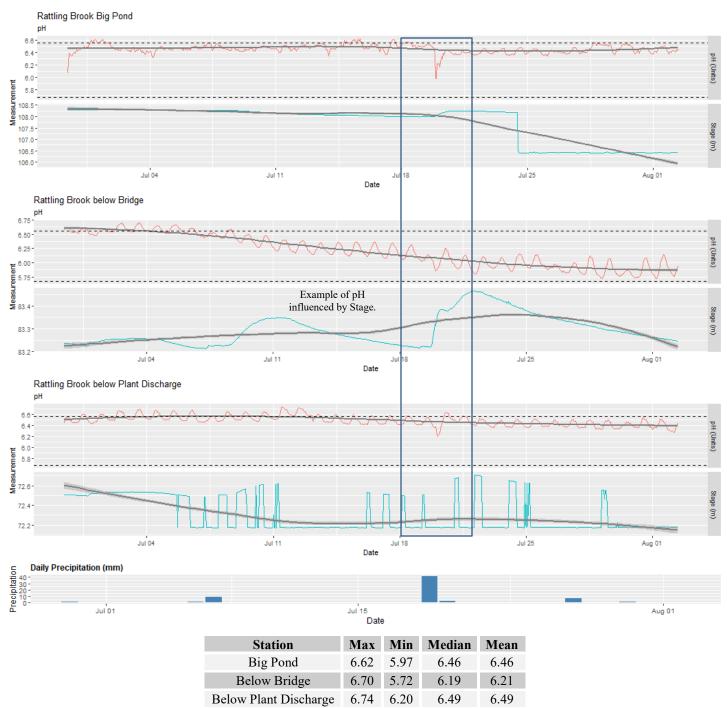
pH values were generally consistent with the majority of values within the site-specific guidelines (5.67-6.56 pH Units).

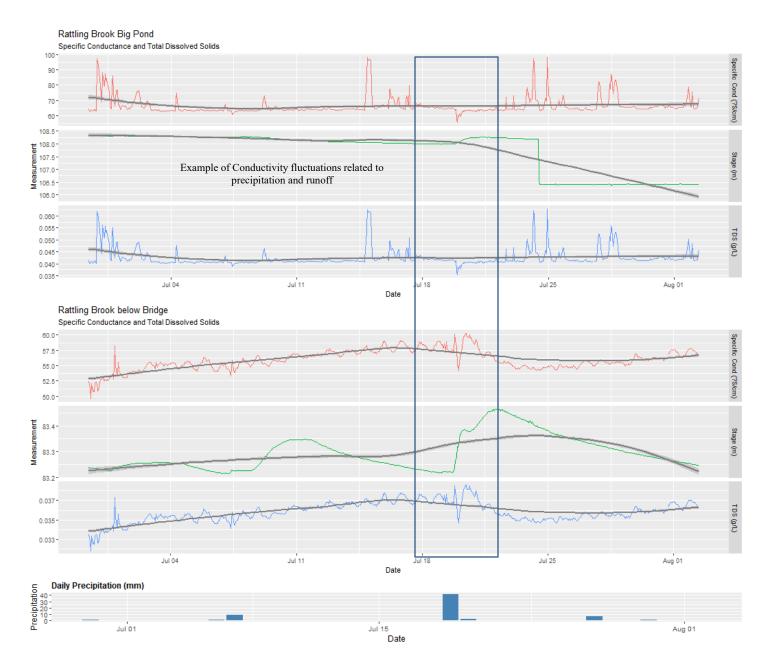
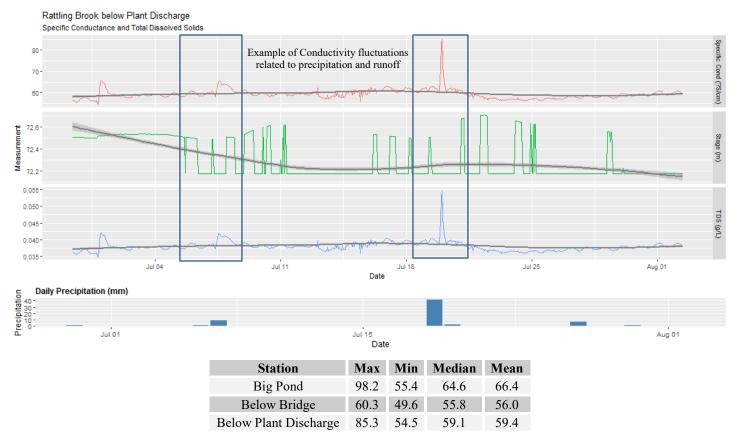
Specific conductivity was relatively stable at all stations. There were peaks at both Below Bridge and Plant
Discharge stations throughout the deployment that could be attributed to low levels in the river and
precipitation. Variation in conductivity at Big Pond station may be due to wave/wind action stirring sediments
around the instrument.

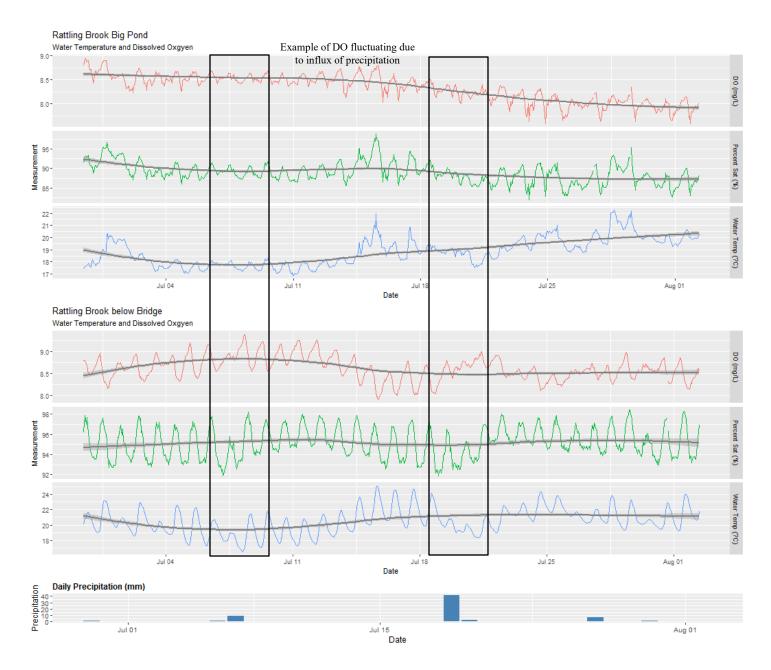
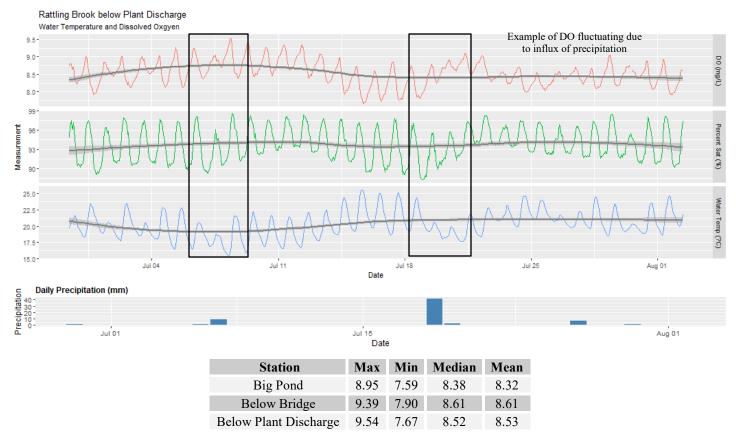
- During this deployment as water temperature increased and water level decreased, dissolved oxygen values were low due to a reduction in saturation levels. This is expected through the summer months.
- During this deployment, all measurements were above the CCME dissolved oxygen guideline of 6.5 mg/L for the protection of other life stage cold-water biota.

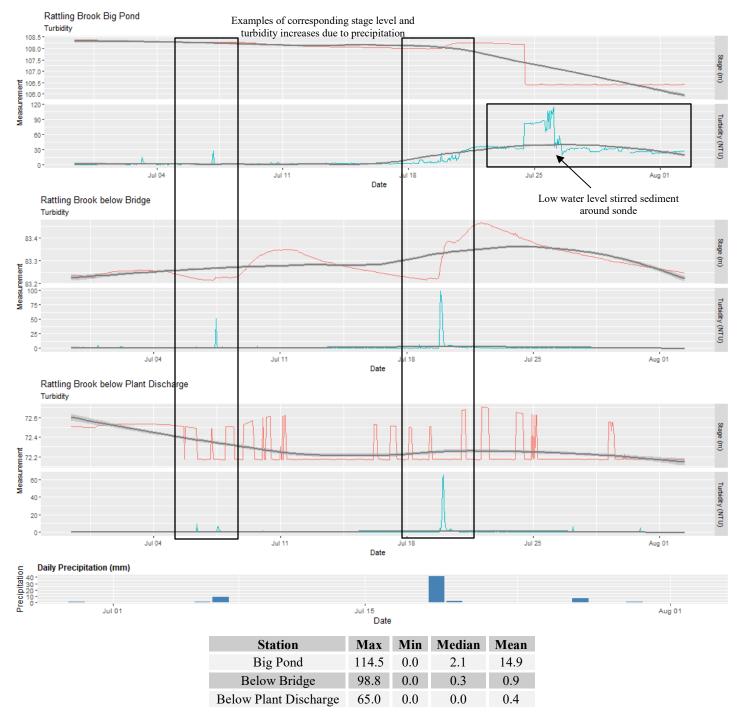
Turbidity levels were low during this deployment period with variation only observed during precipitation events at Below Bridge and Plant Discharge stations. Big Pond station experienced a spike on July 23rd that

could be attributed to low water levels, fallen trees, and wave action stirring sediment around the sensor. See photo below.
