Annual Weather Station Maintenance Report

2016

Government of Newfoundland & Labrador
Department of Environment and Climate Change
Water Resources Management Division

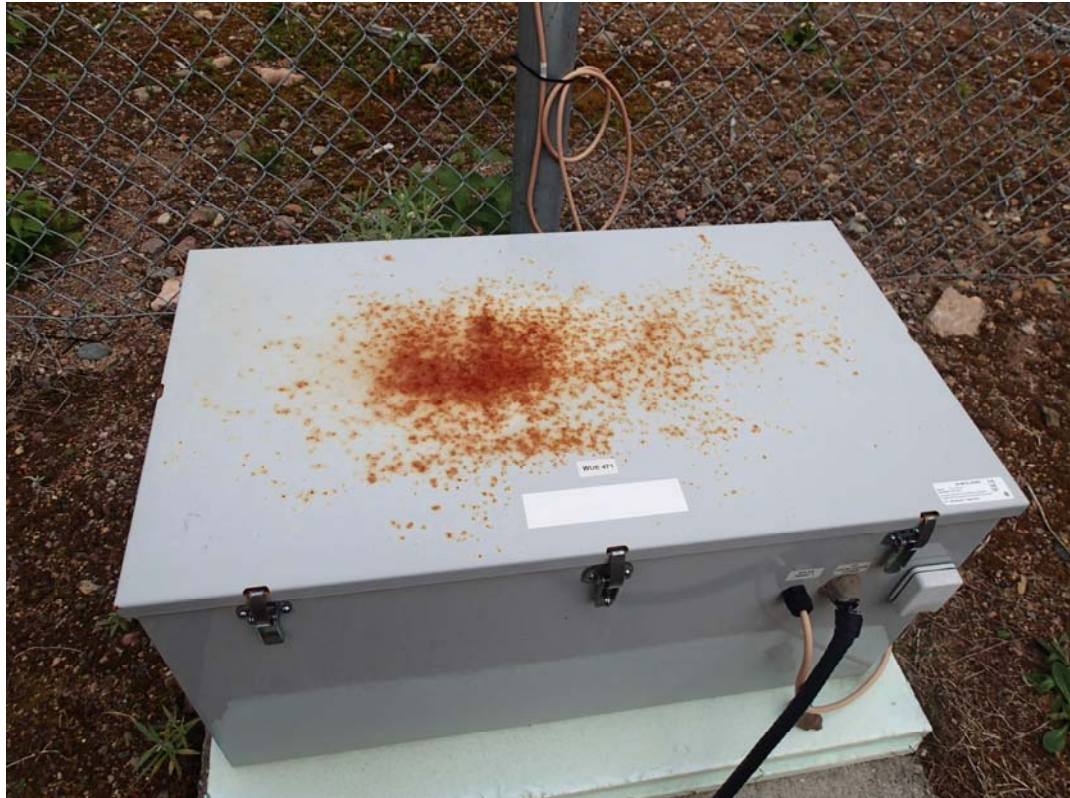
Figure 4: Battery Box Enclosure Rust conditions at Sandy Lake near Birchy Narrows (Camp 55)

- Model: Kipp & Zonen SP LITE Pyranometer
 - Serial: 091169
 - Cleaned lens
- Compound
 - Battery Box requires sanding and Tremclad paint to prevent the enclosure to rust (See Figure 4)

- Battery Box requires sanding and Tremclad paint to prevent the enclosure to rust

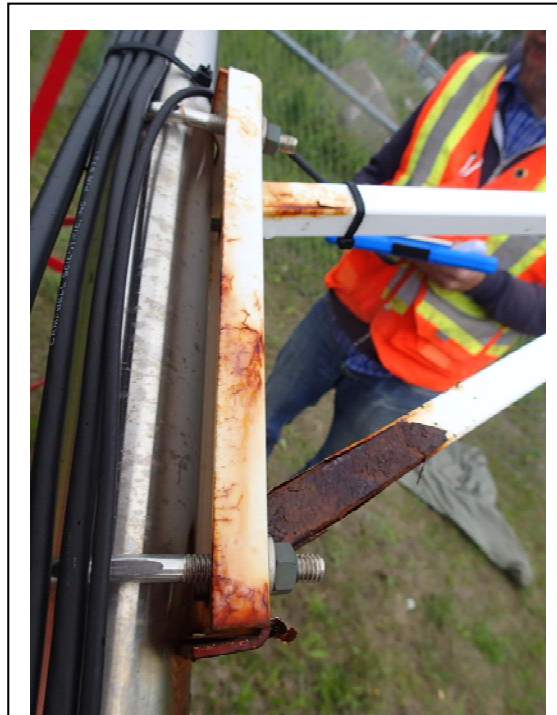
Figure 6: Solar Radiation mounting arm corrosion at Humber River at Humber Village Bridge Station

- Solar Radiation
 - Model: Kipp & Zonen SP LITE Pyranometer
 - Serial: 080395
 - Cleaned lens
 - Noted corrosion on mounting arm (See Figure 6), order replacement

- Order new precipitation sensor
- Compound needs landscaping
- Order replacement mounting arm

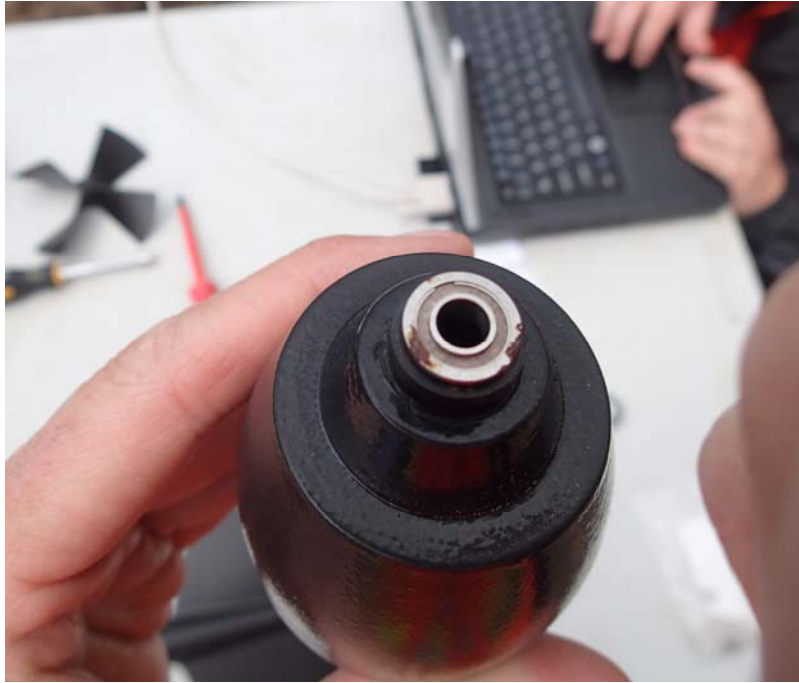
Figure 8: Anemometer bearing corrosion - Upper Humber River above Black Brook

- Model: RM Young Alpine
 - Serial: Young 05178A Rev D
 - Bearings replaced - noted corrosion (See Figure 8)
- Temperature/Relative Humidity:
 - Model: HC-S3

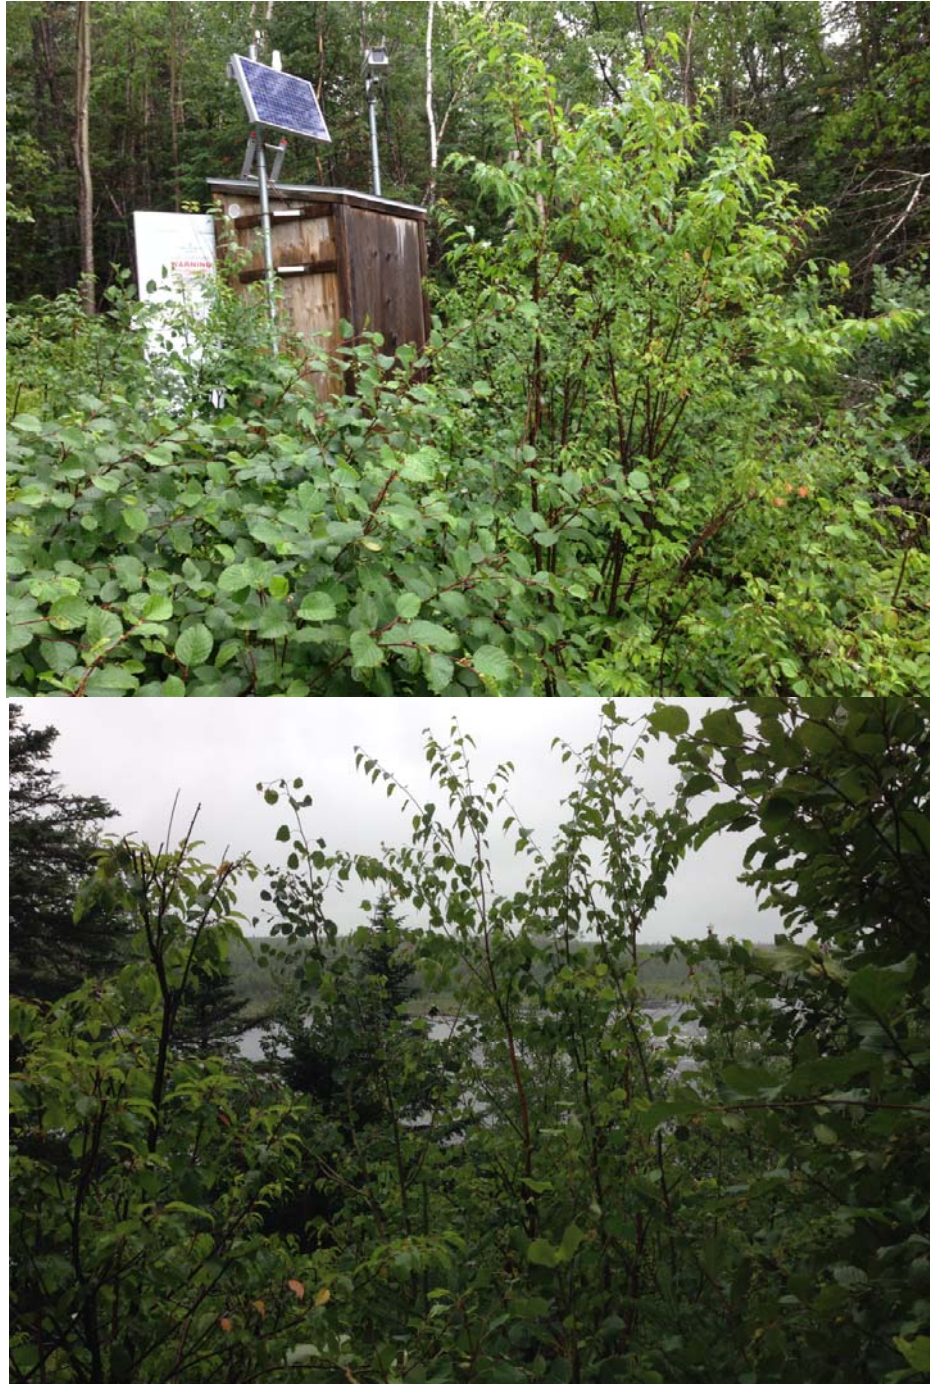
Figure 13: Overgrowth at Exploits River at Badger Steps camera station

- Site was overgrown needs landscaping
- Changed Locks

- Site is highly overgrown and needs specialised landscaping due to the steep incline to ensure the viewpoint needed for the flood forecasting model
- Regular scheduled maintenance
