Annual Weather Station Maintenance Report

2018

Government of Newfoundland & Labrador
Department of Municipal Affairs and Environment
Water Resources Management Division

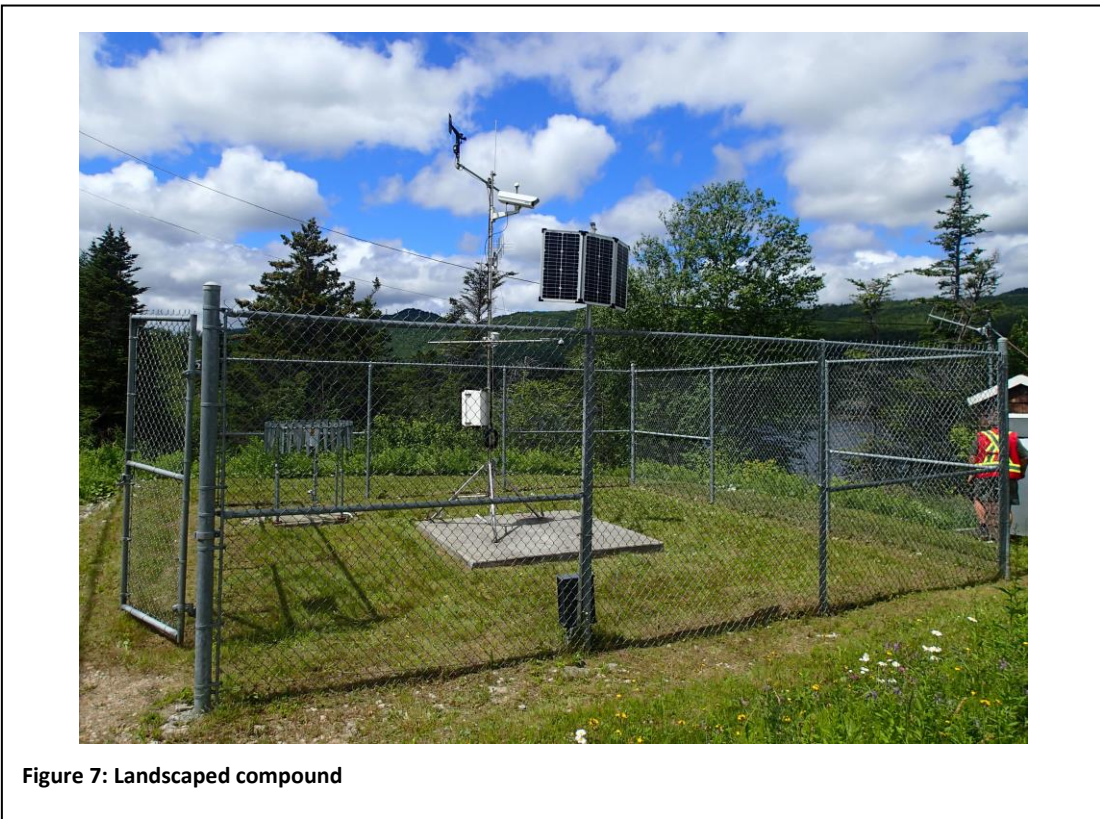
- Cross piece on the fence needs replacement
 - Landscaped (See Figure 7)

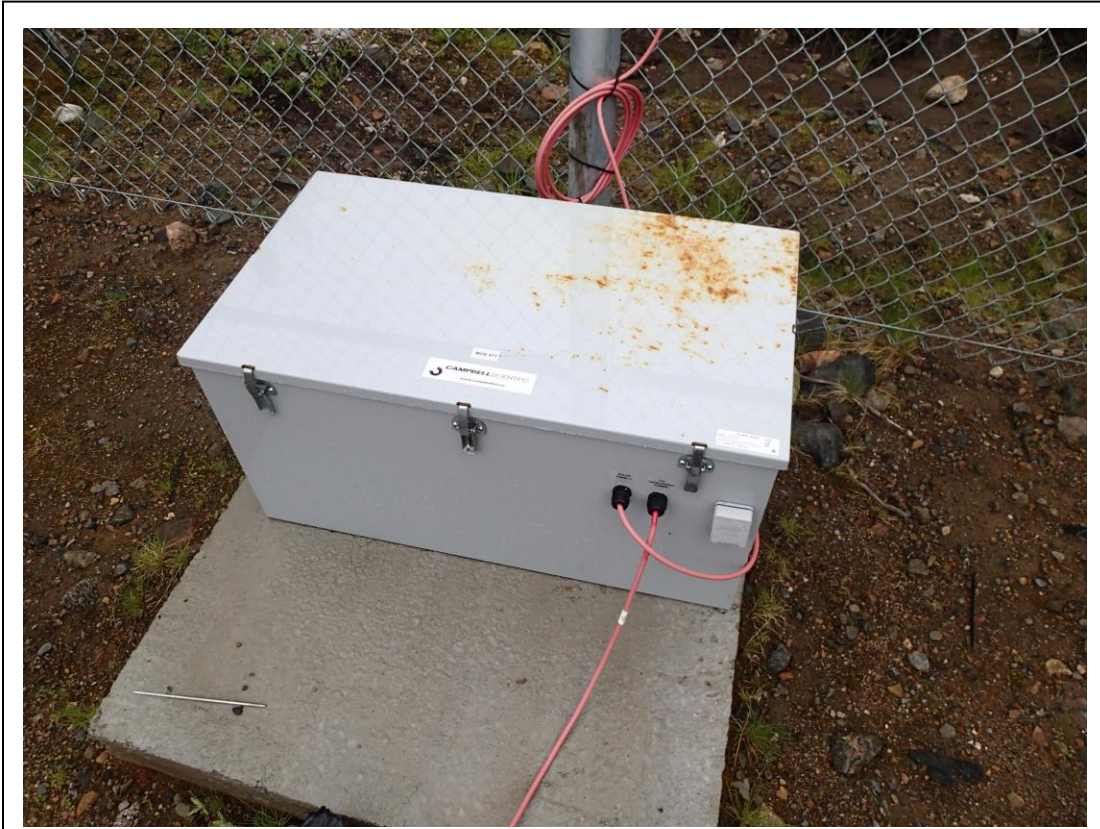
Figure 9: Battery Box Enclosure Rust conditions at Upper Humber at Black Brook

- Serial: 091168
 - Cleaned lens
- Snow Water Equivalent:
 - Model: CS725
 - No maintenance needed
- Compound
 - Battery Box requires sanding and Tremclad paint to prevent the enclosure from rusting (See Figure 9)

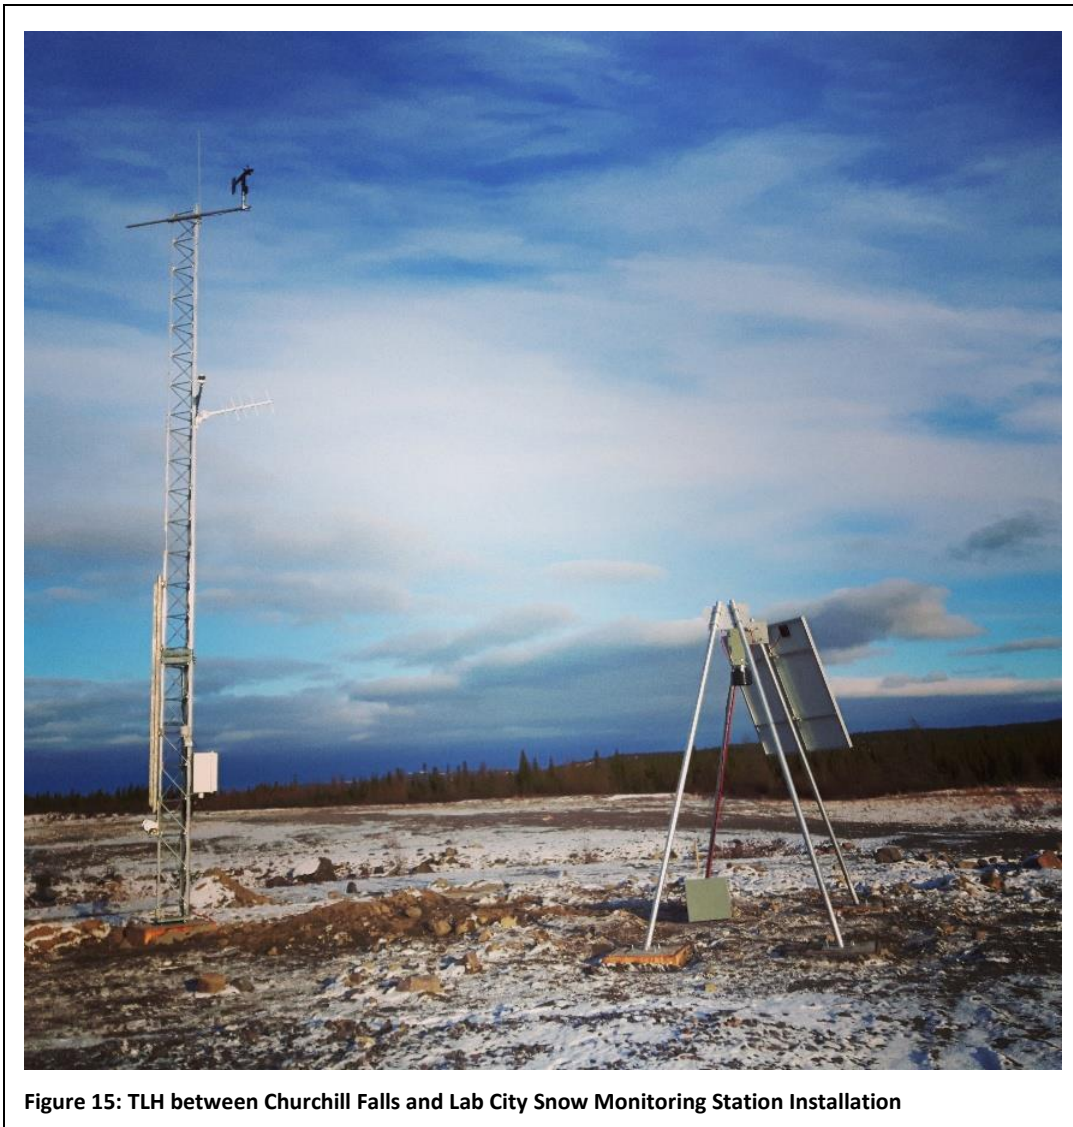
Figure 15: TLH between Churchill Falls and Lab City Snow Monitoring Station Installation

Tasks accomplished: Installation occurred Oct 16-23rd 2017.
